DOCUMENT 00 91 01

ADDENDUM NO. 1

ANDREW P. HILL

BUILDING INFORMATION	
FACILITY	Andrew Hill High School
DATE	July 15, 2014
BUILDING	Large Gym
ROOF SQ FT	10,500

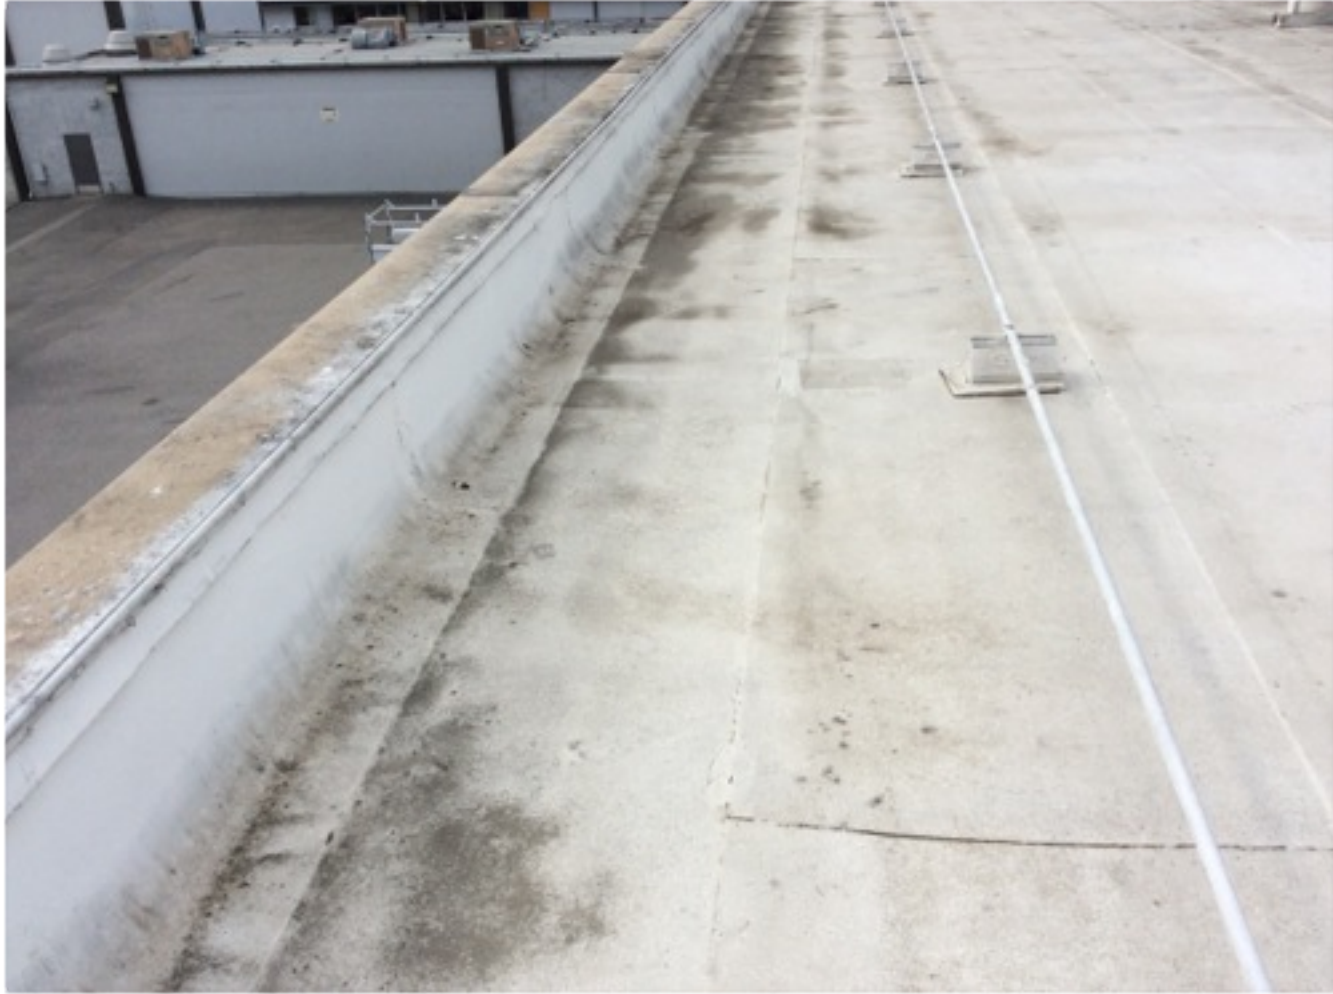
The photo below shows that enhanced crickets are needed - no slope to scuppers.

- d) Building F – Large Gym
Inspect roof, check for leaking and repair roof if necessary. Repair or patch exposed membranes. Reseal/recoat HVAC Duct and the post base of the ductwork. Reseal, paint with rustproof capsheet flashing around the roof. Address and fill large ponding areas. Raise height or enhance the crickets to have slope for water flows to scuppers.

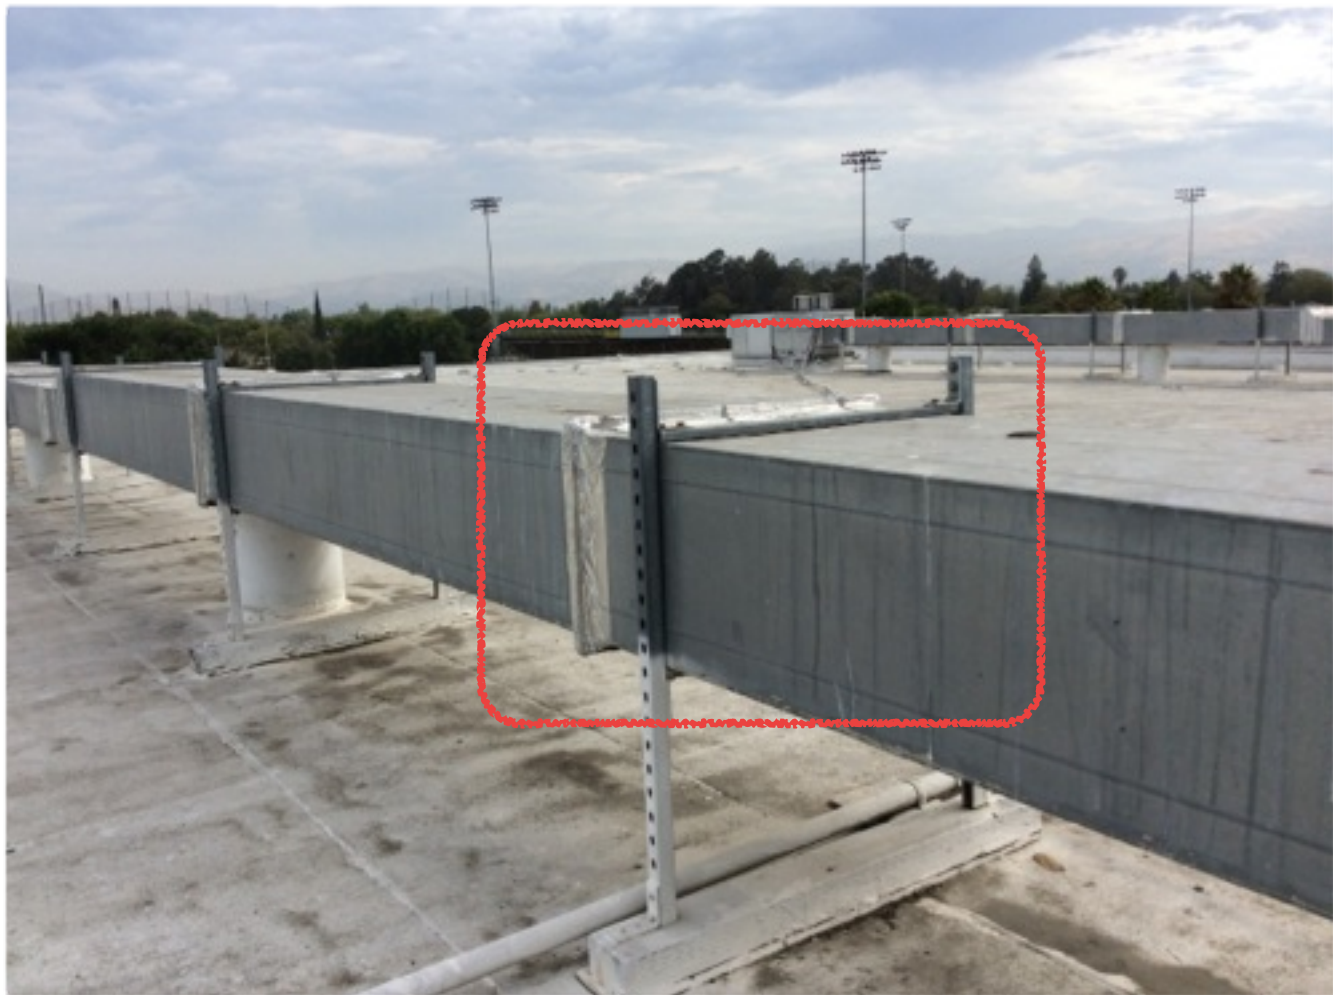
The photo below shows the AC ducting needing to be resealed.
