BUILDING INFORMATION	
FACILITY	Oak Grove HS
DATE	October 23, 2014
BUILDING	A Admin, H1, H2
ROOF SQ FT	25,000

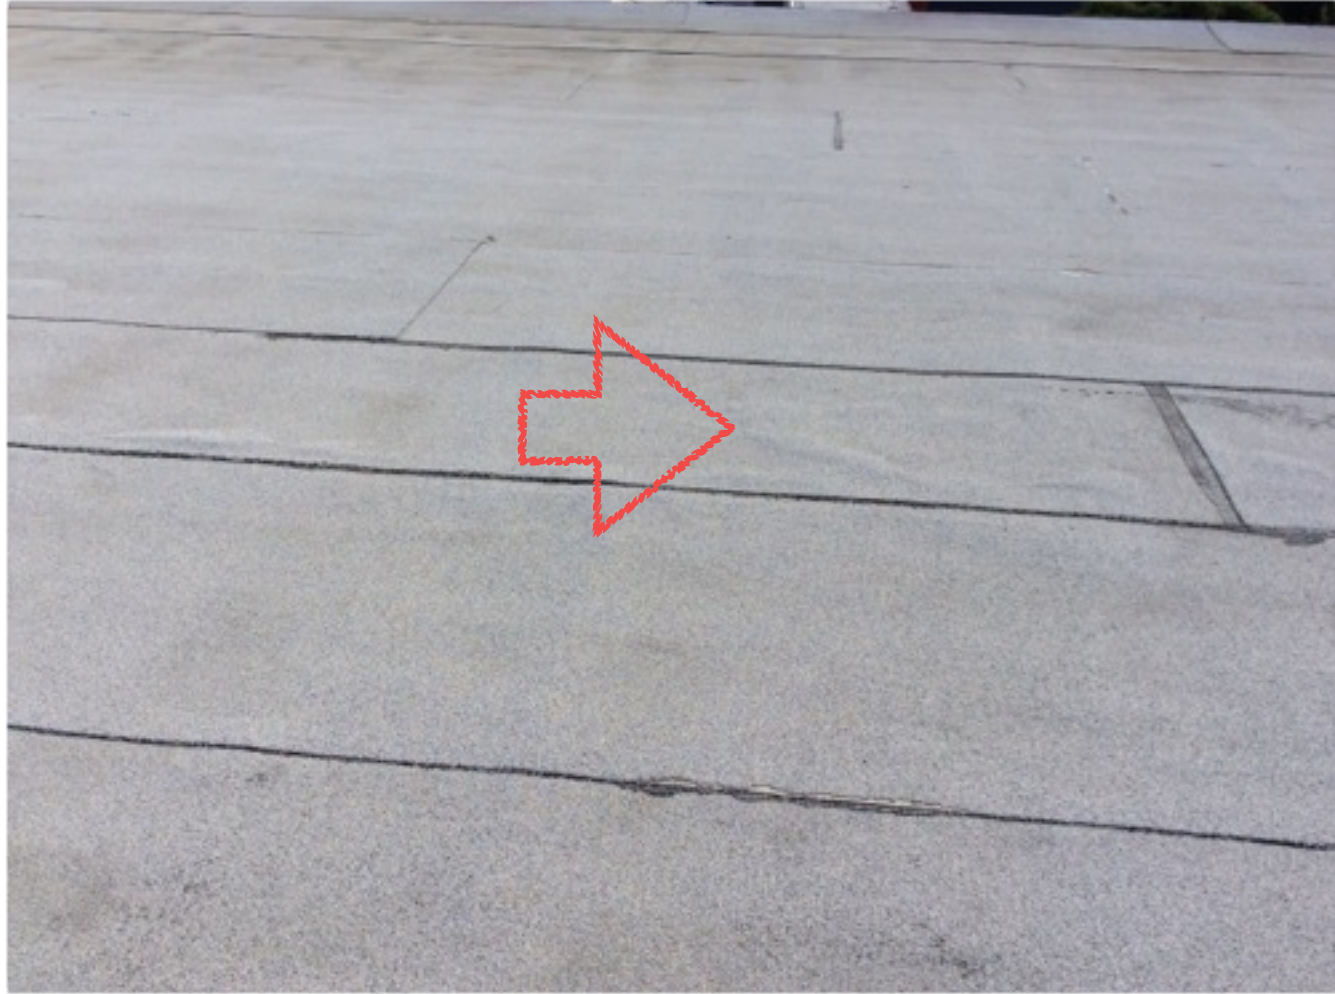
The photo below shows the first signs of ridging.

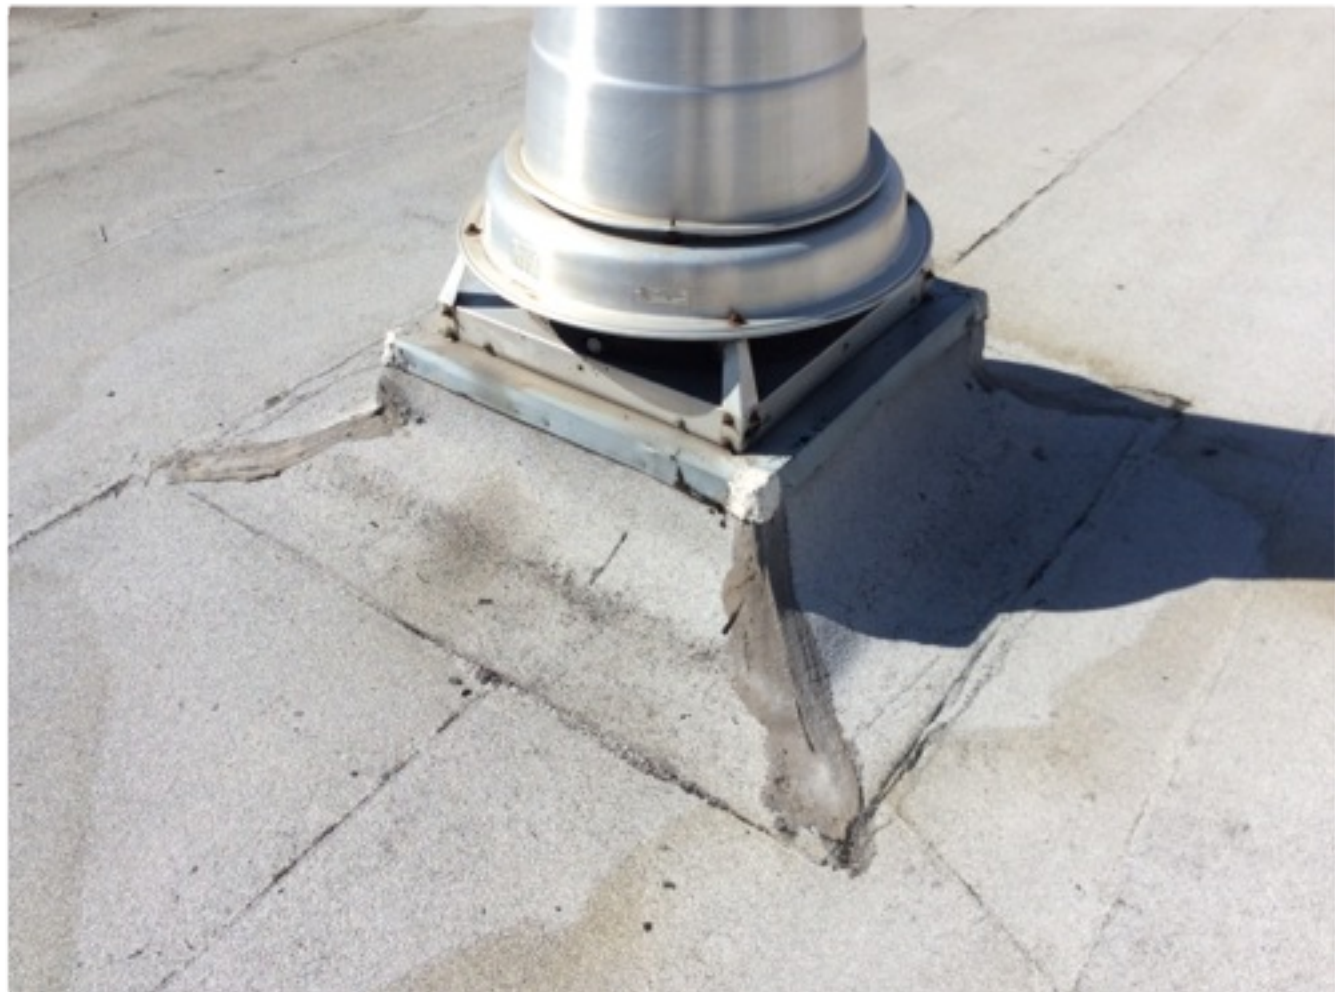
ADDITIONAL NOTES
 ROOFS ARE AGING WELL. MANAGE FOR ANOTHER FIVE YEARS OF LIFE. H1 and H2 DO NEED REPAIRS TO PENETRATIONS. A DOES NOT.

The photo below shows penetration details in need of repair on H1 and H2.

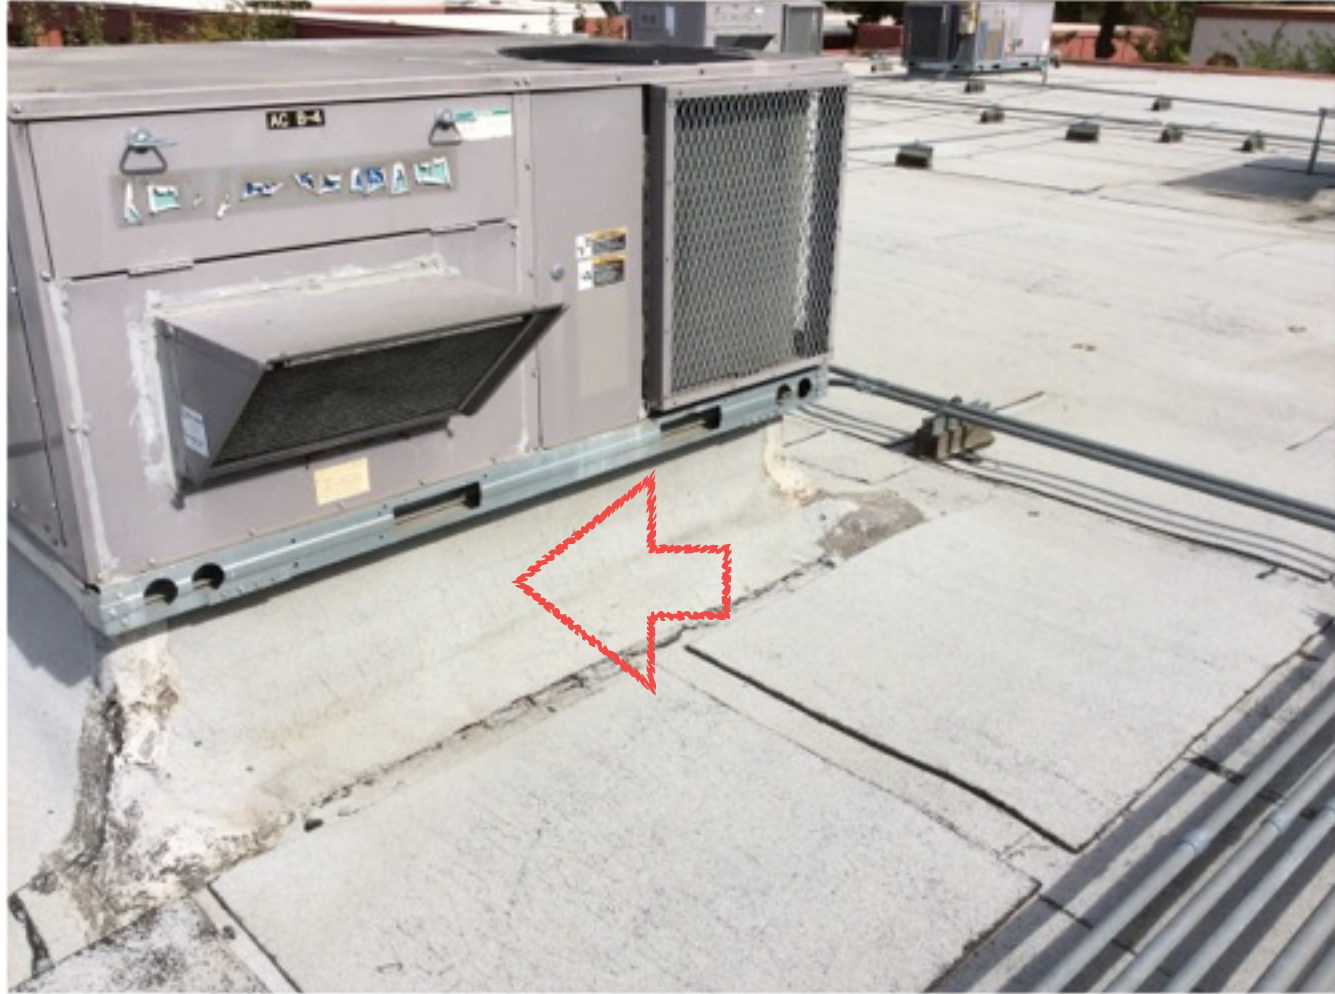
The photo below shows the first signs of craze cracking.

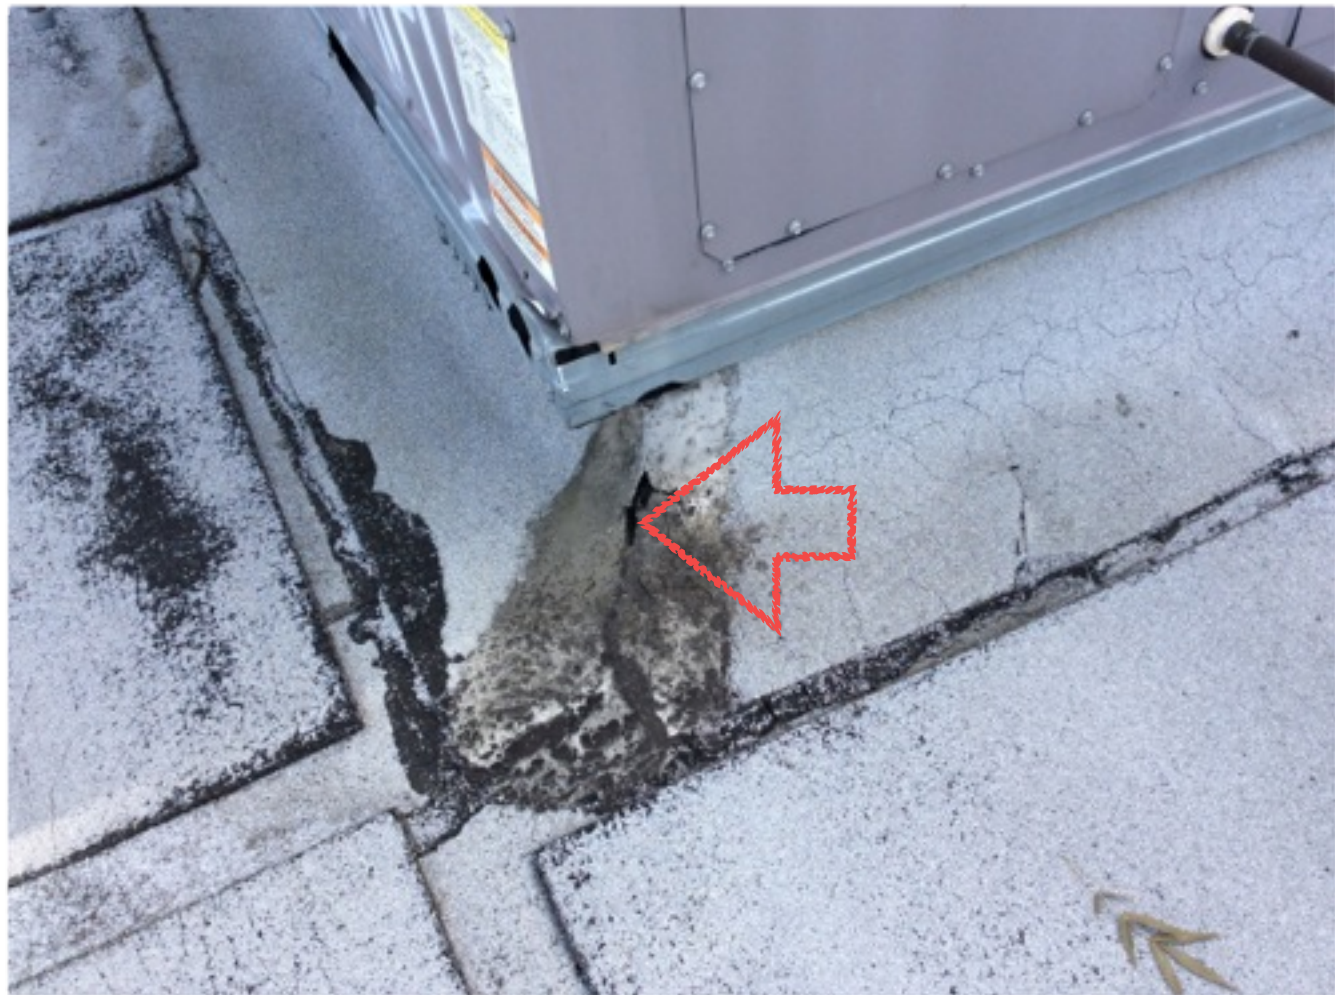
The photo below shows an open hole in the penetration corner.

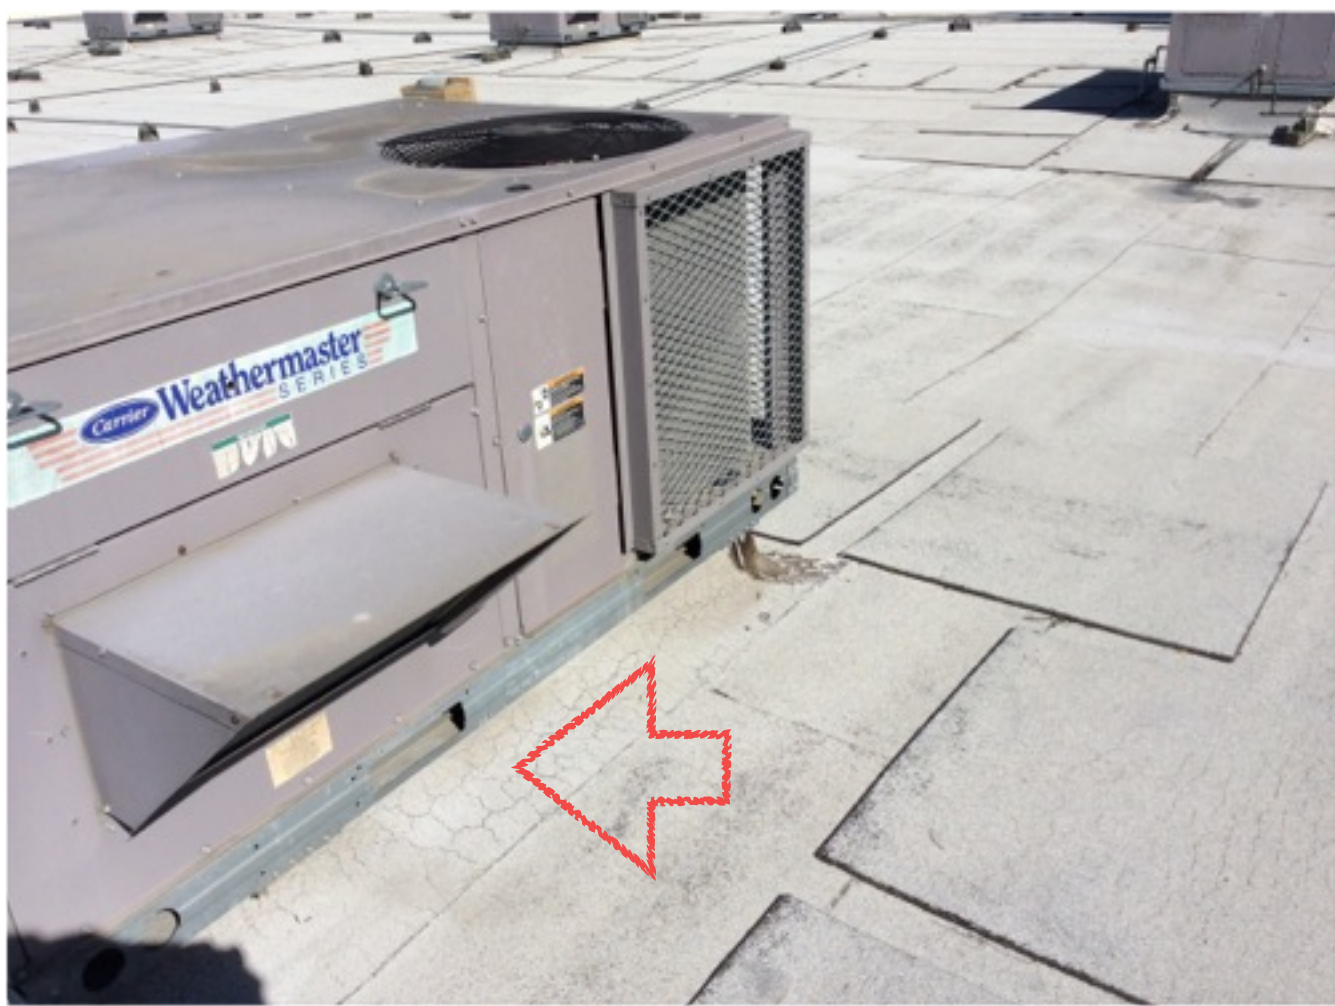
The photo below shows the roof aging with craze cracking on the penetration details.

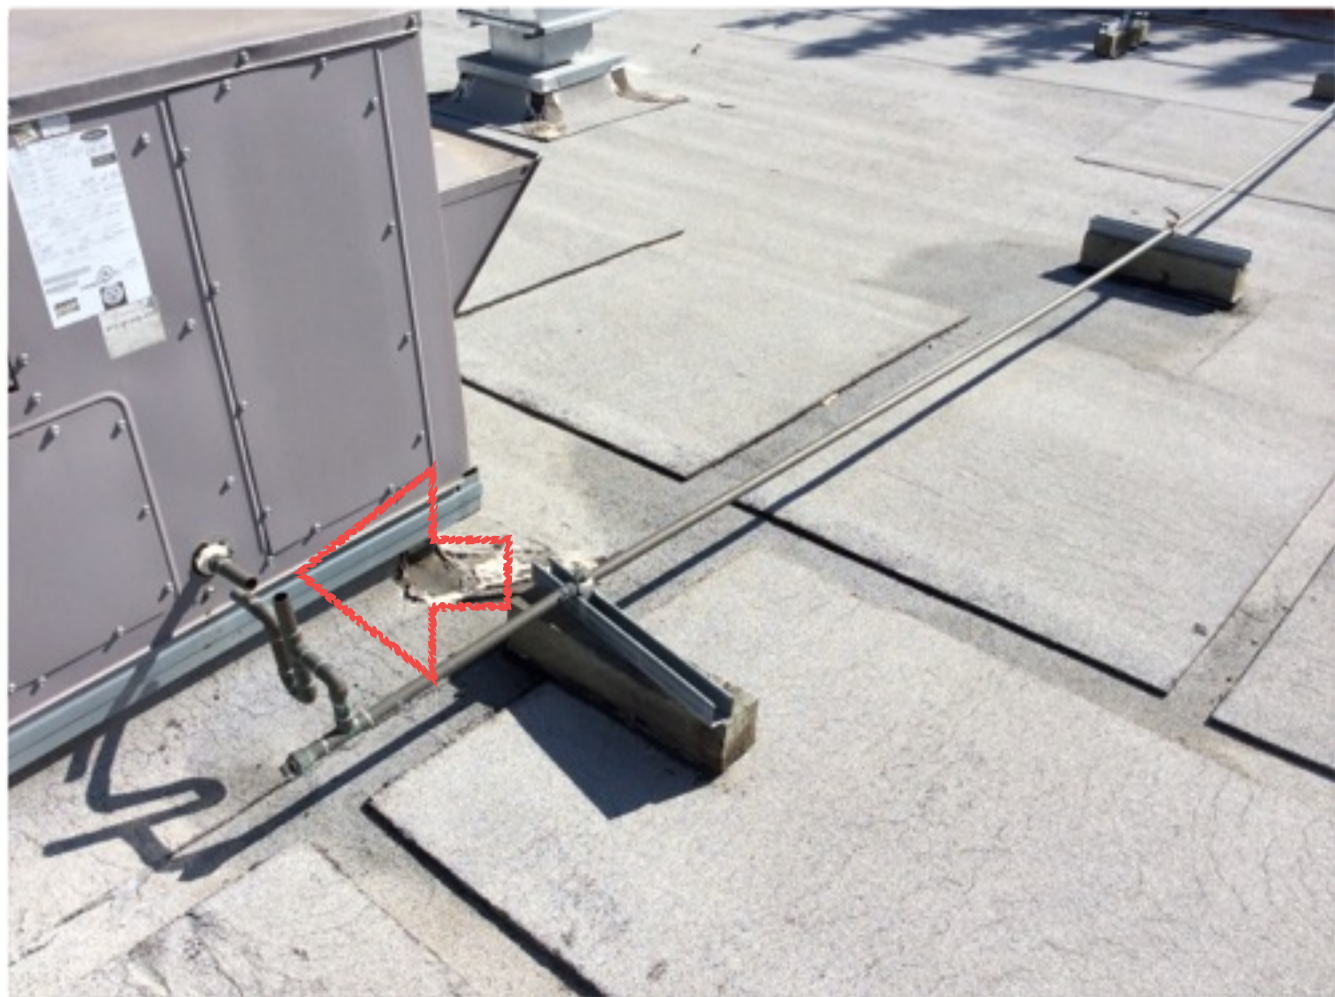
More than one AC unit needs repair and is leaking directly onto the roof.

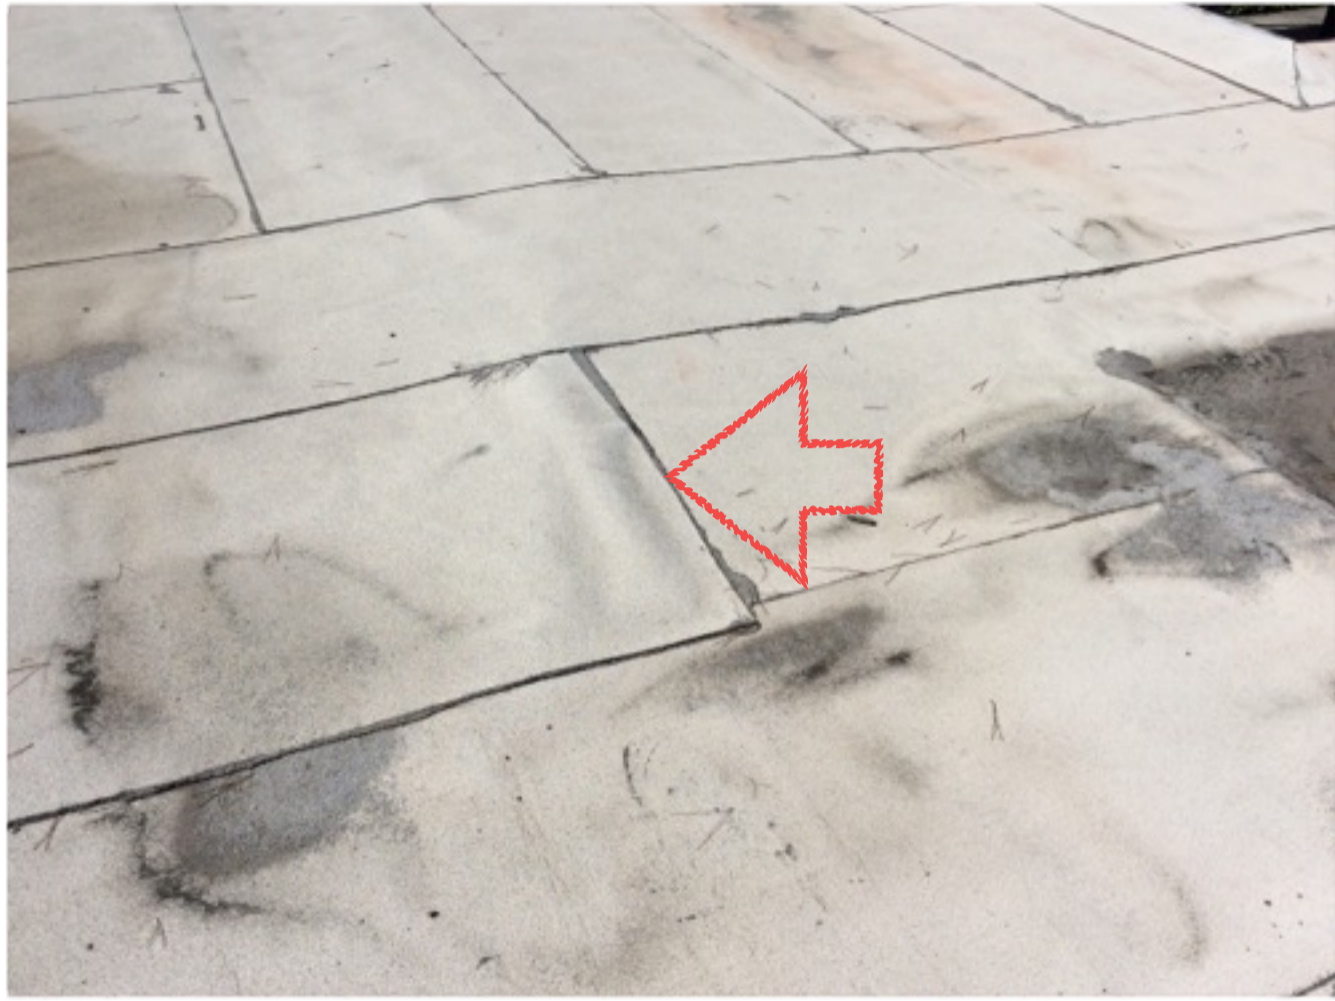
The photo below shows some small blistering.

ADDITIONAL NOTES
 ROOF IS NEW HOWEVER SOME OF THE PENETRATION SEAMS ARE FAILING. HAVE CONTRACTOR REPAIR UNDER WARRANTY. BLISTERS TOO SMALL TO REPAIR - INSPECT PERIODICALLY AND ESPECIALLY BEFORE THE CONTRACTORS WARRANTY IS UP.

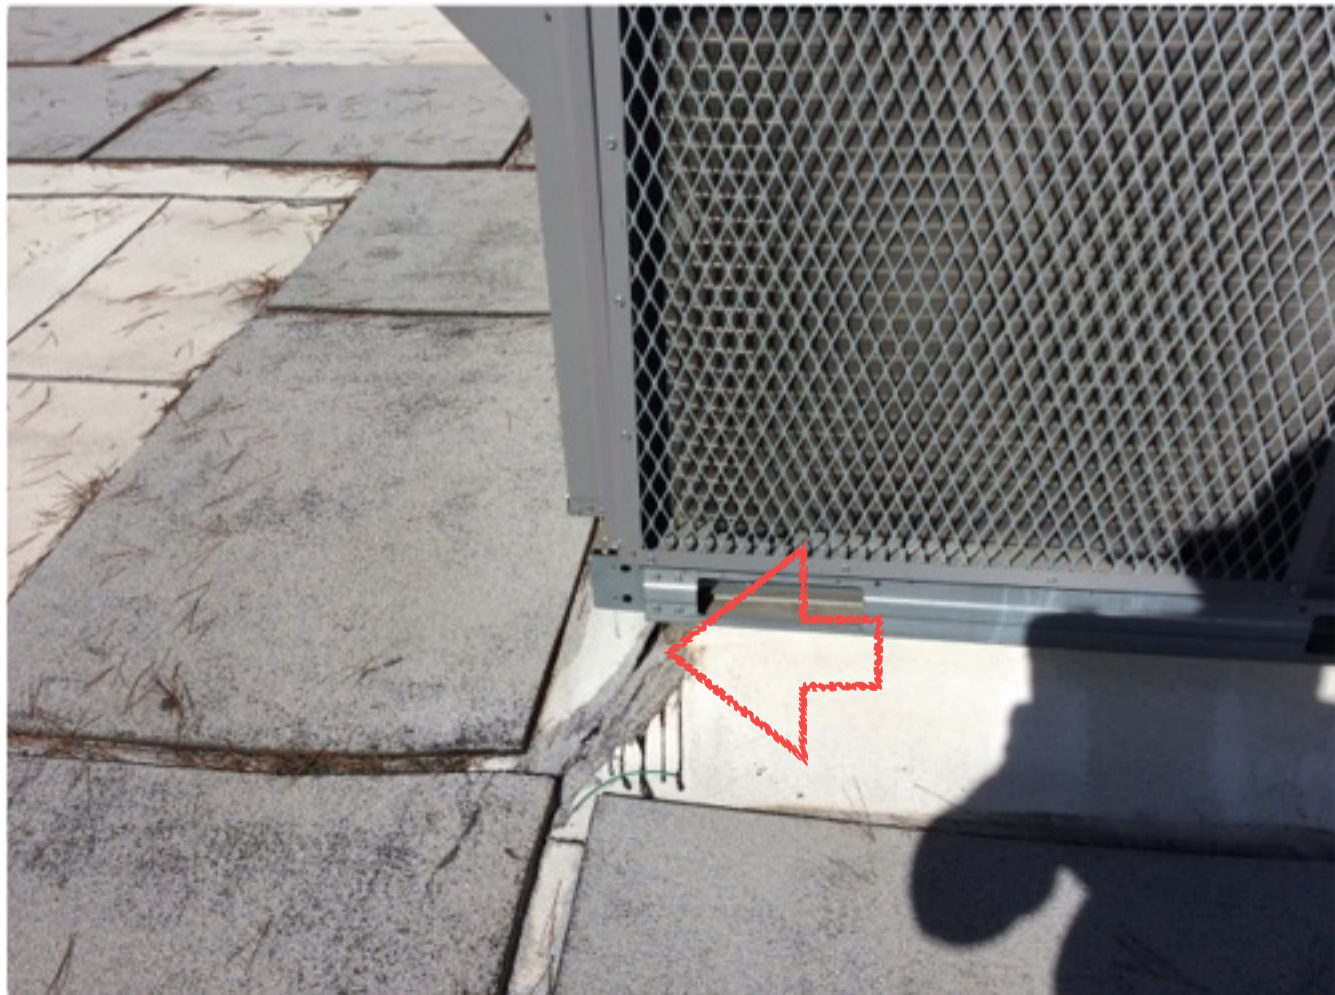
The photo below shows an open hole in the penetration corner.

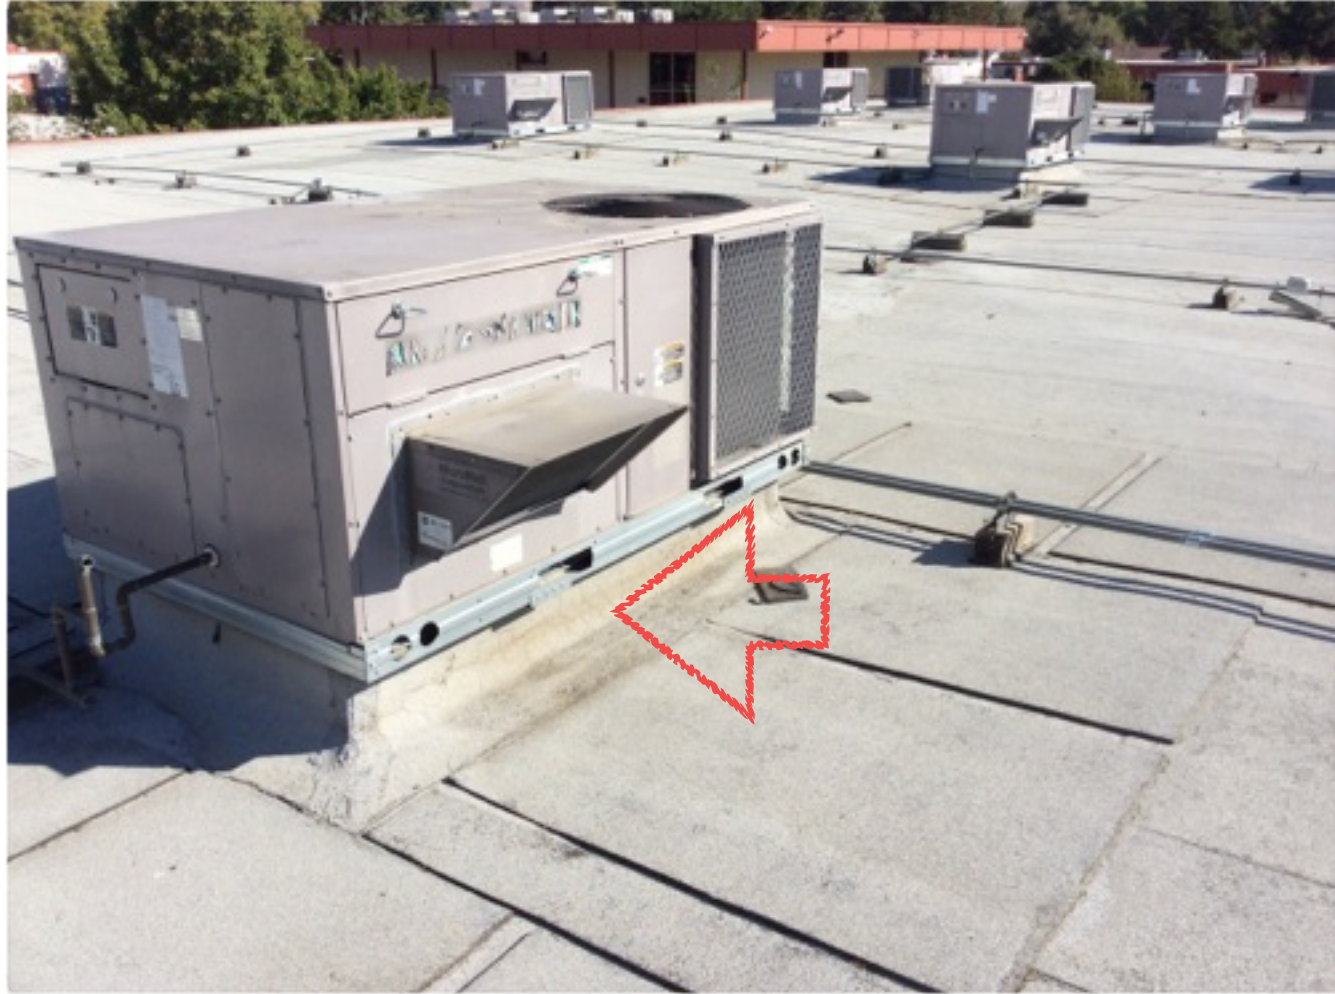
The photo below shows the first signs of craze cracking.

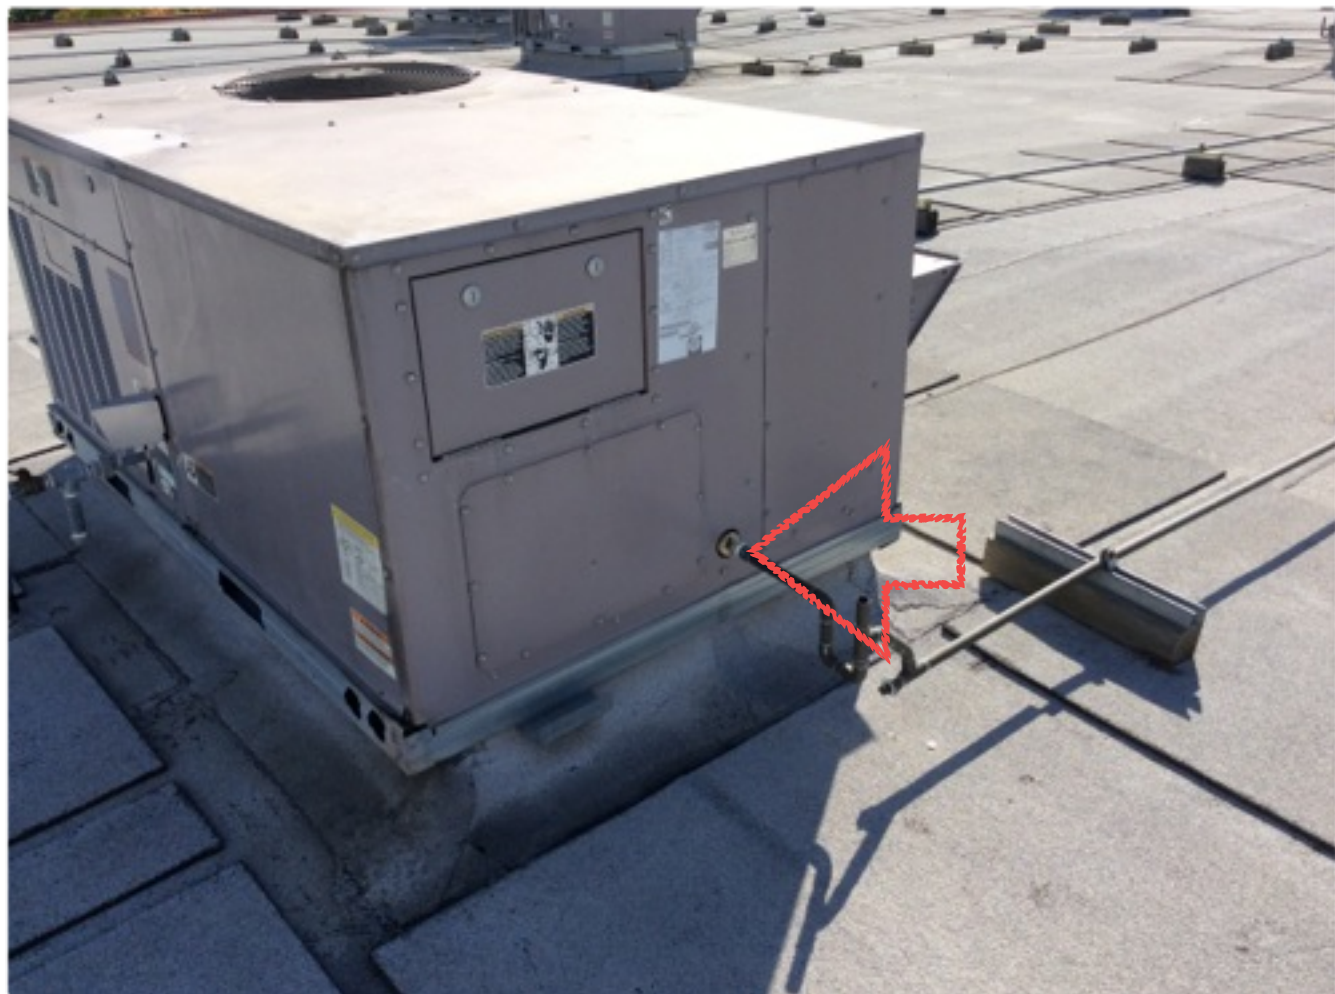
Two AC units are leaking onto the roof and need repairs.

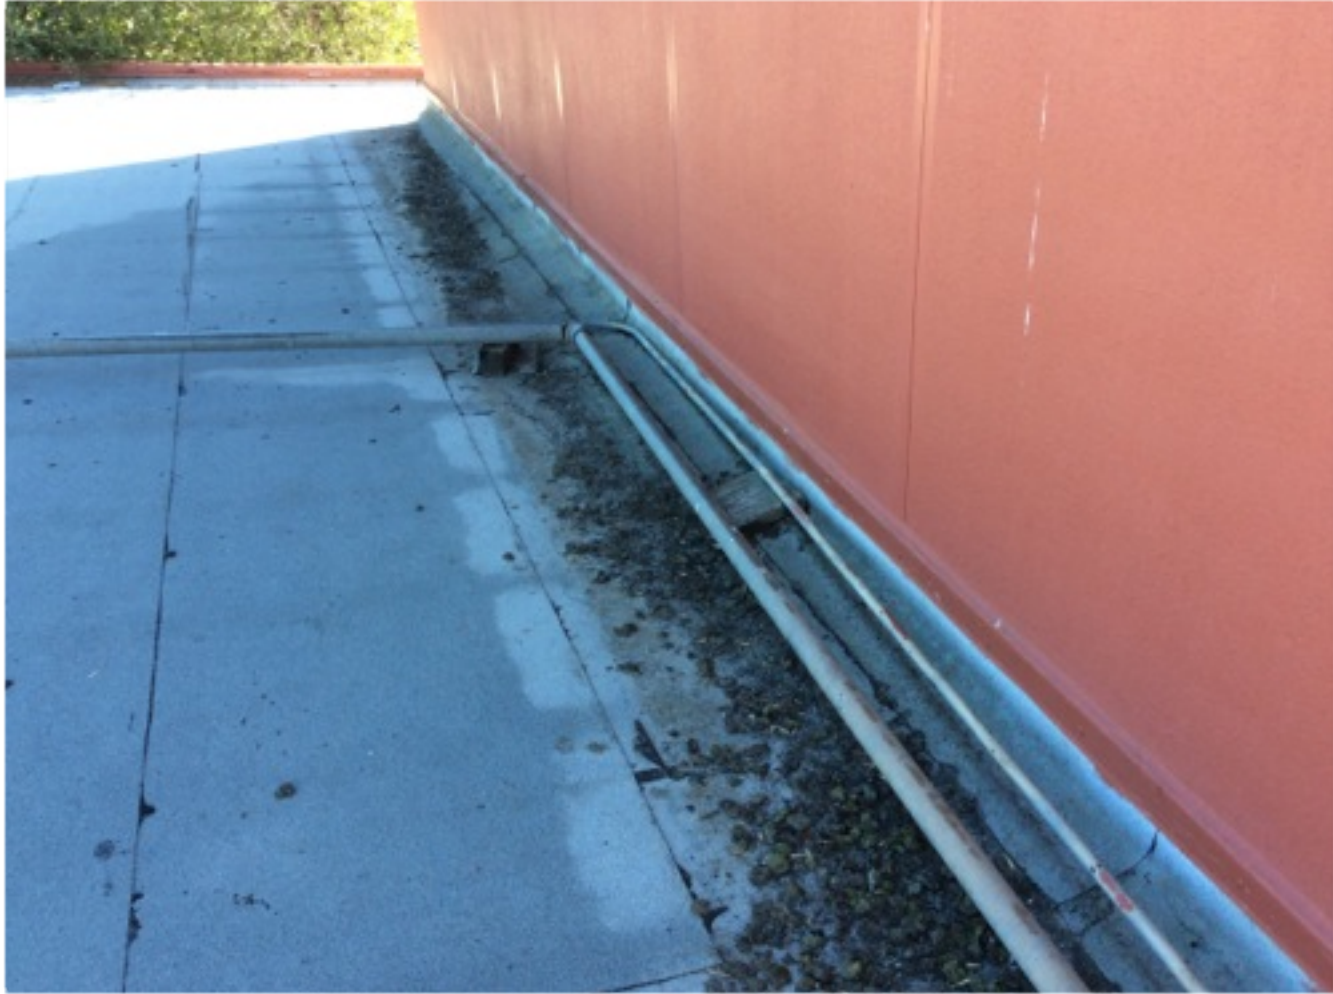
The photo below shows excessive ponding.

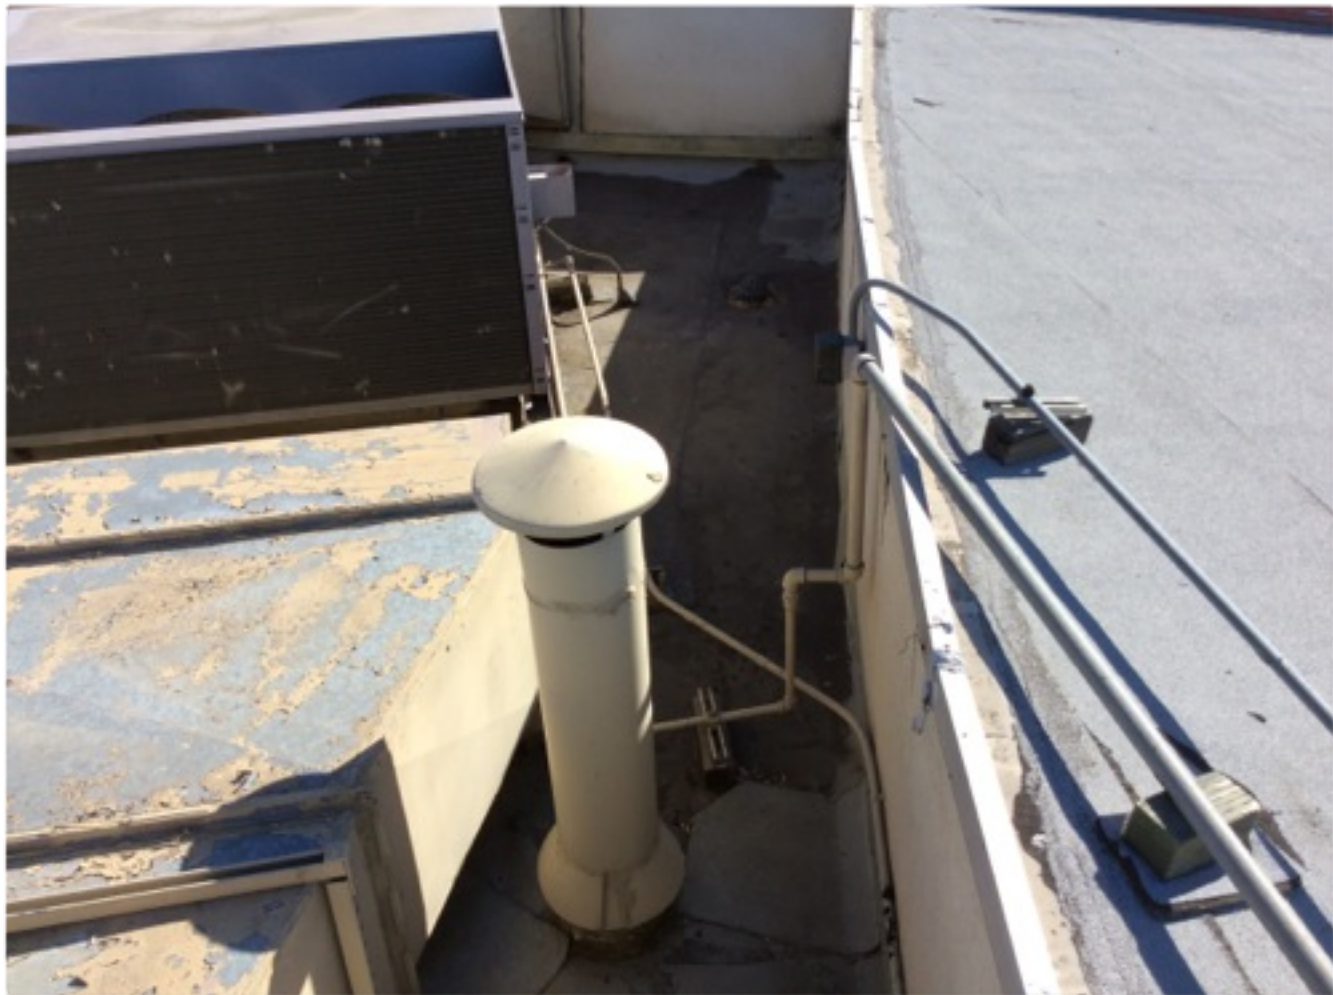
More signs of excessive ponding and repairs which point to leaks.

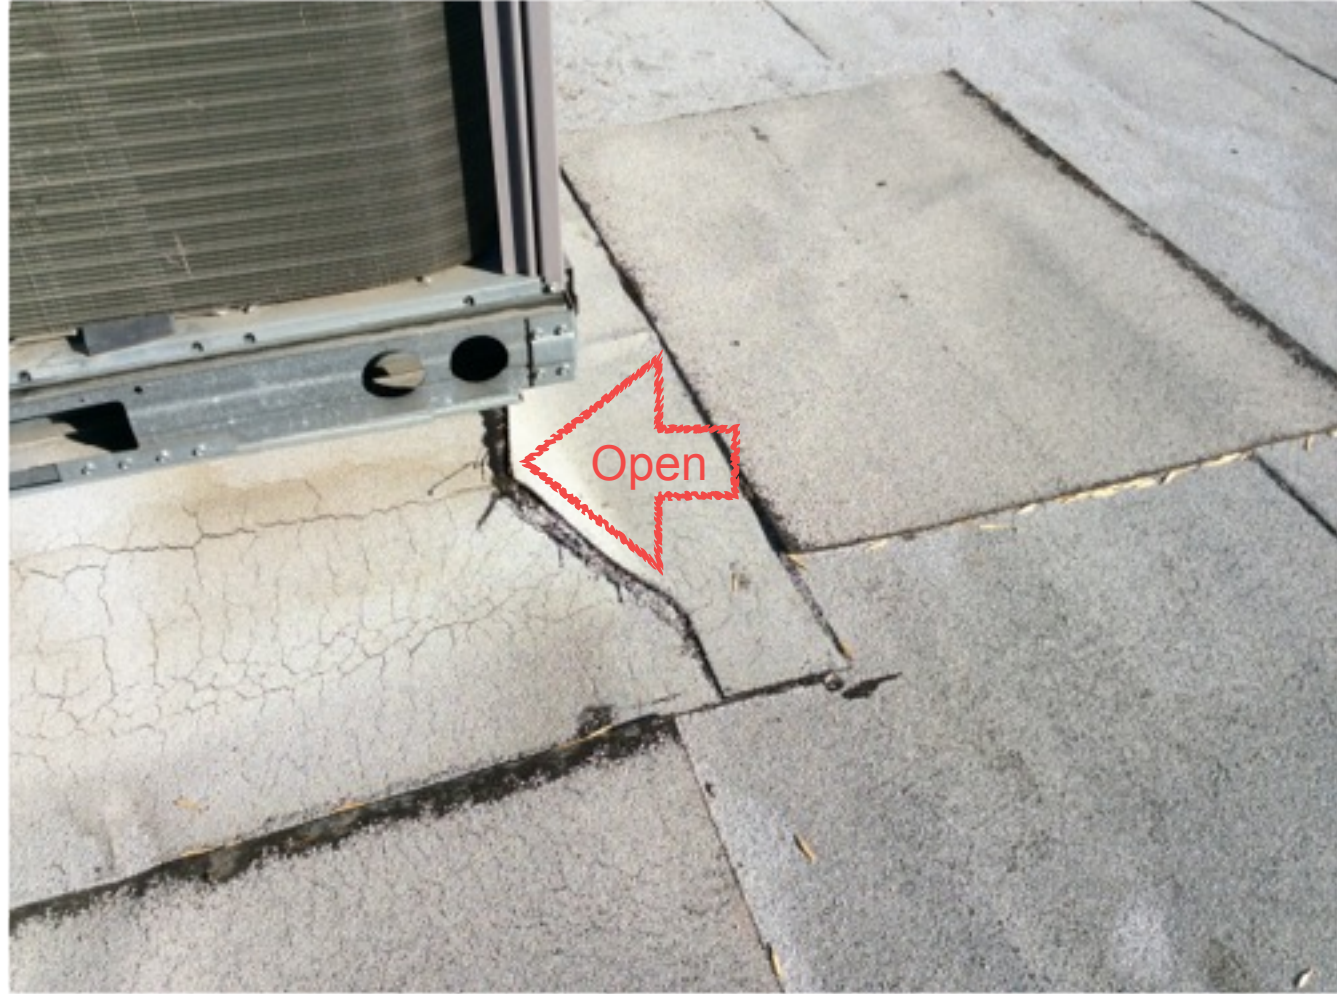
The photo below shows aging with craze cracking - the penetration corners need repair.

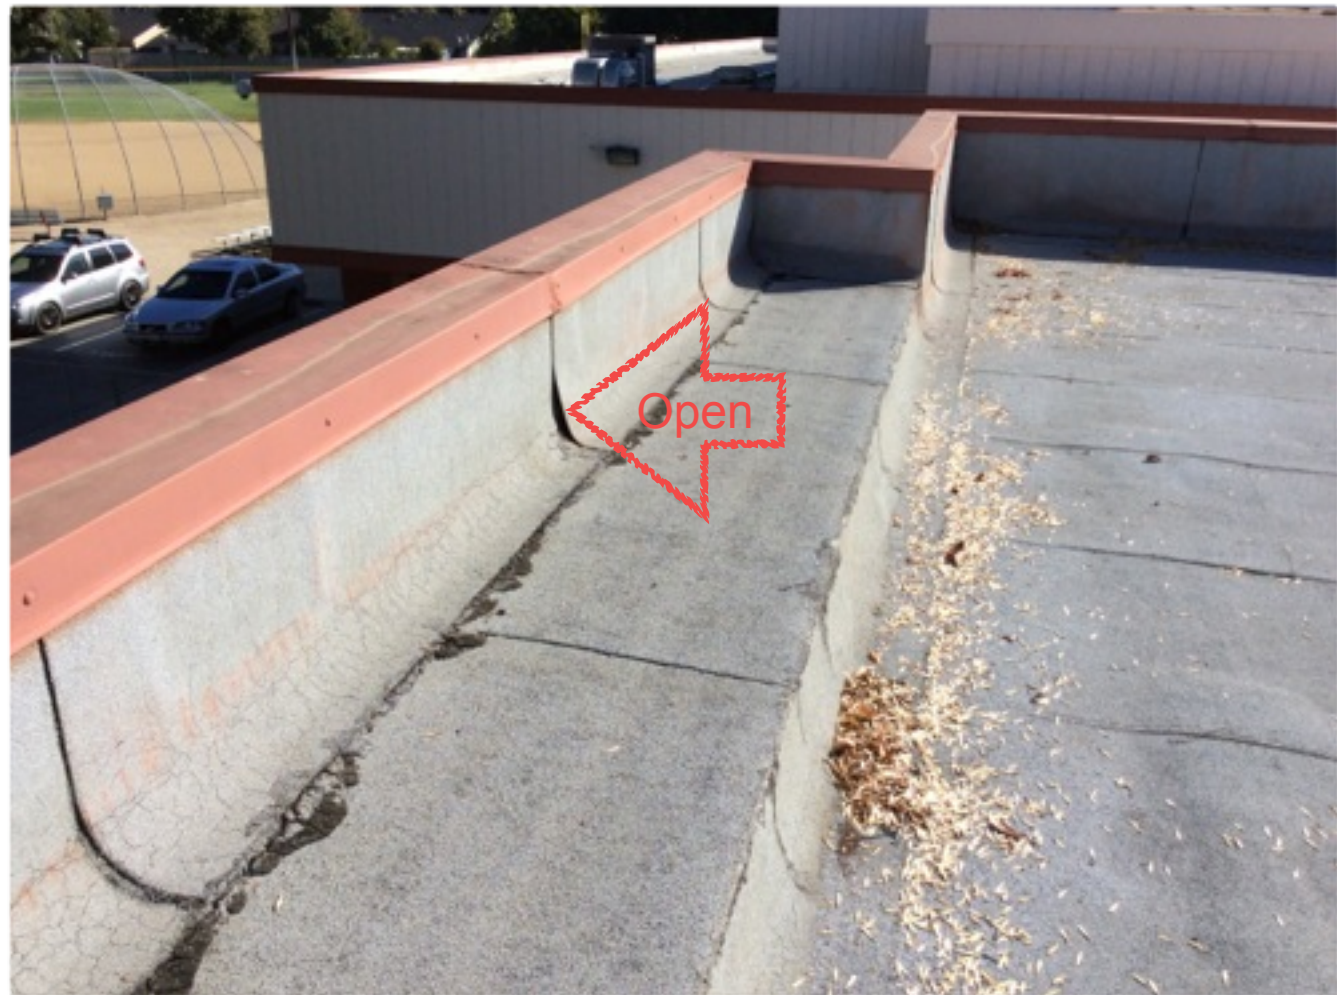
The photo below shows that some wall laps need to be sealed.

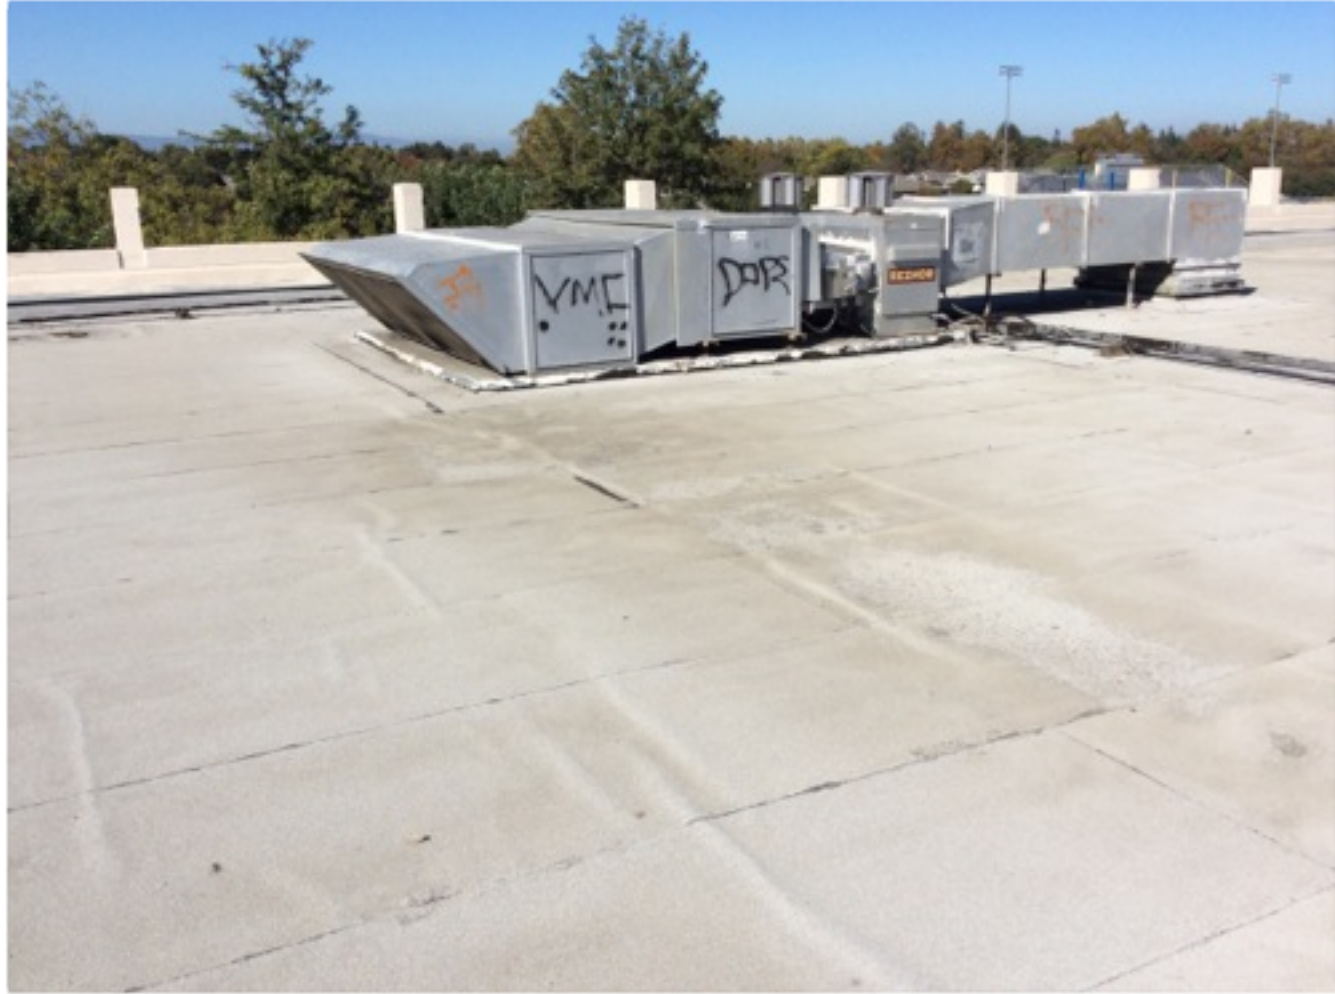
The photo below shows ridging and evidence of excessive ponding.

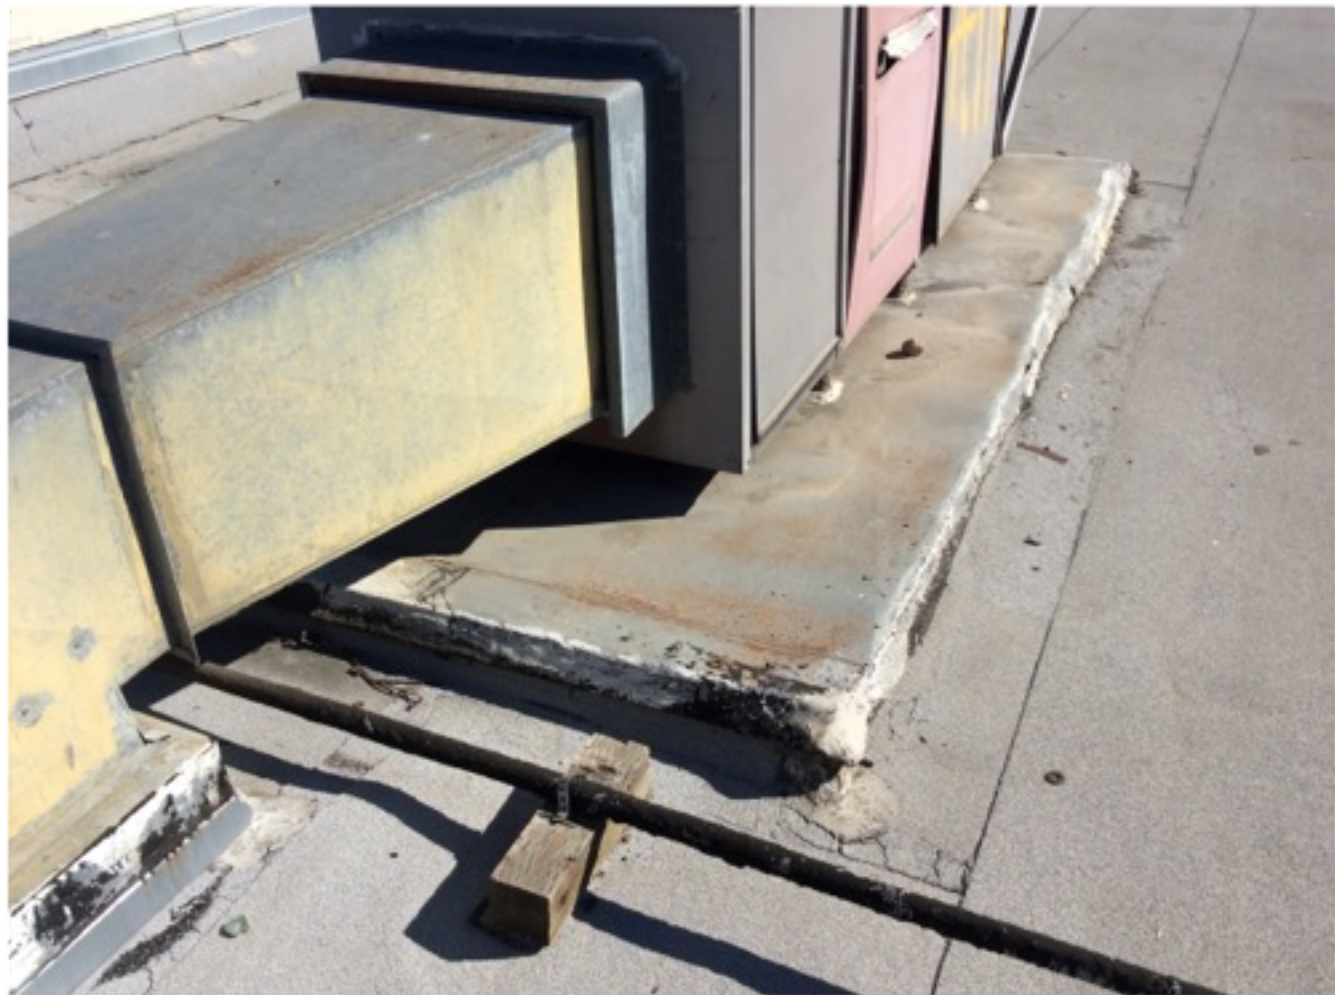
Many of the flashings are in really poor condition and need to be redesigned.

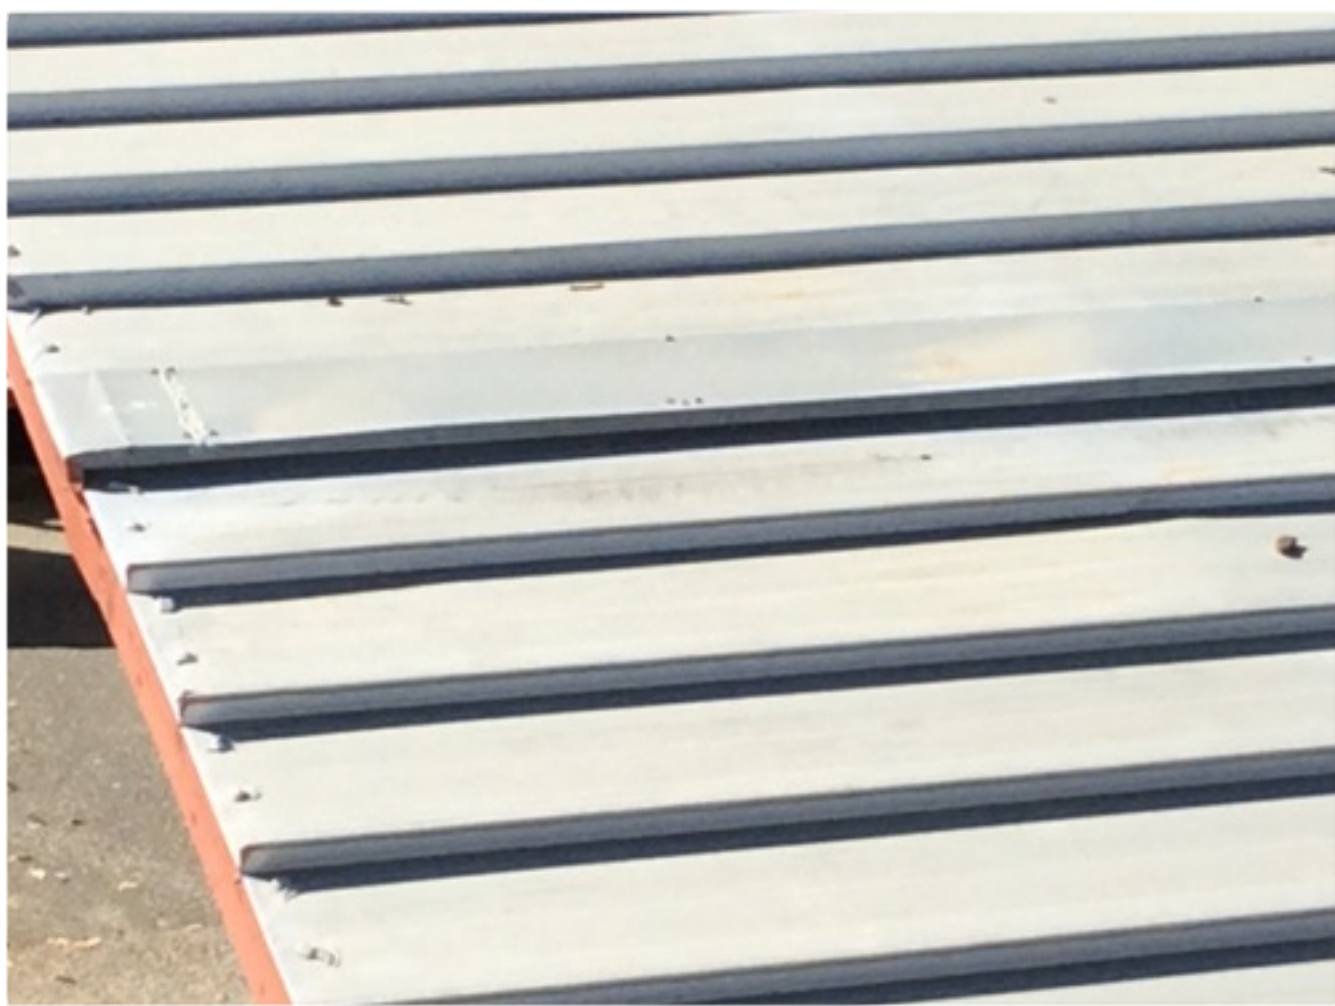
The photo below shows the roofs in good shape - no signs of rust.
