BUILDING INFORMATION	
FACILITY	Oak Grove HS
DATE	October 23, 2014
BUILDING	A Admin, H1, H2
ROOF SQ FT	25,000

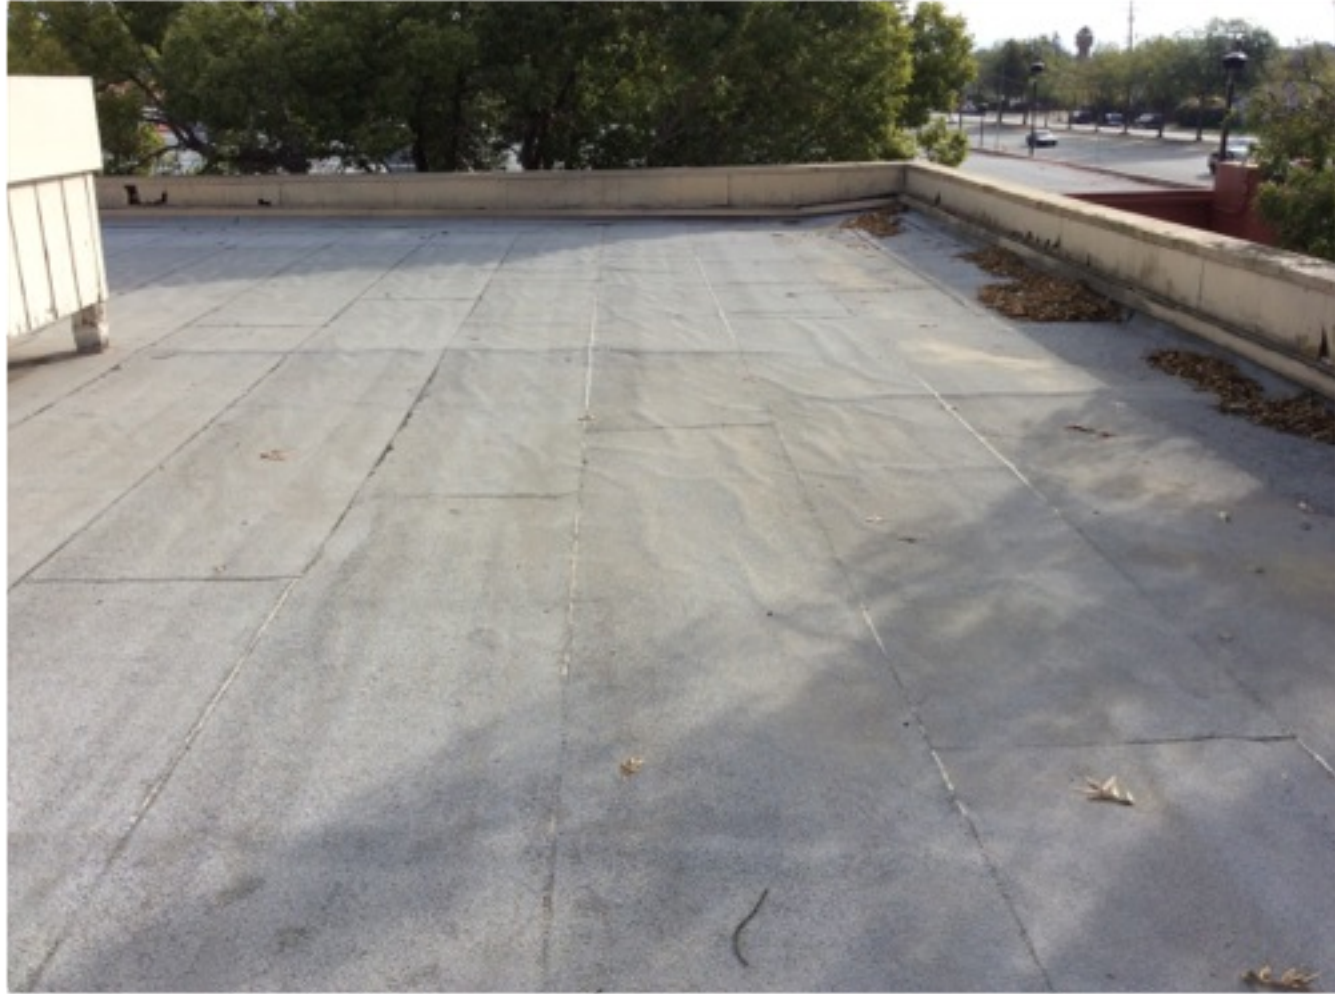
The photo below shows excessive ridging.

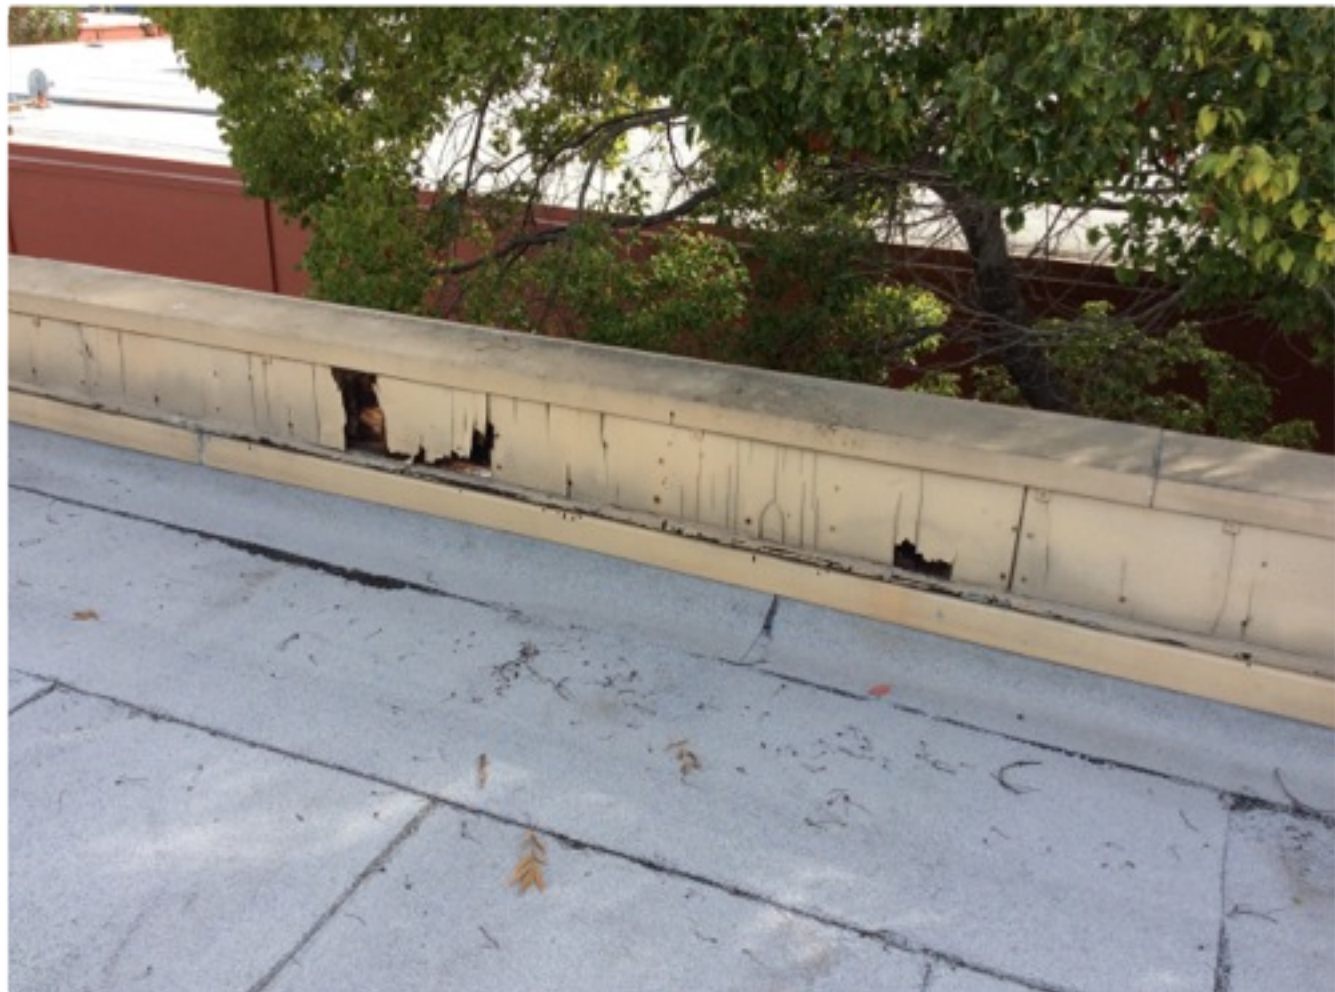
The photo below shows open holes in the walls - water is entering the system.

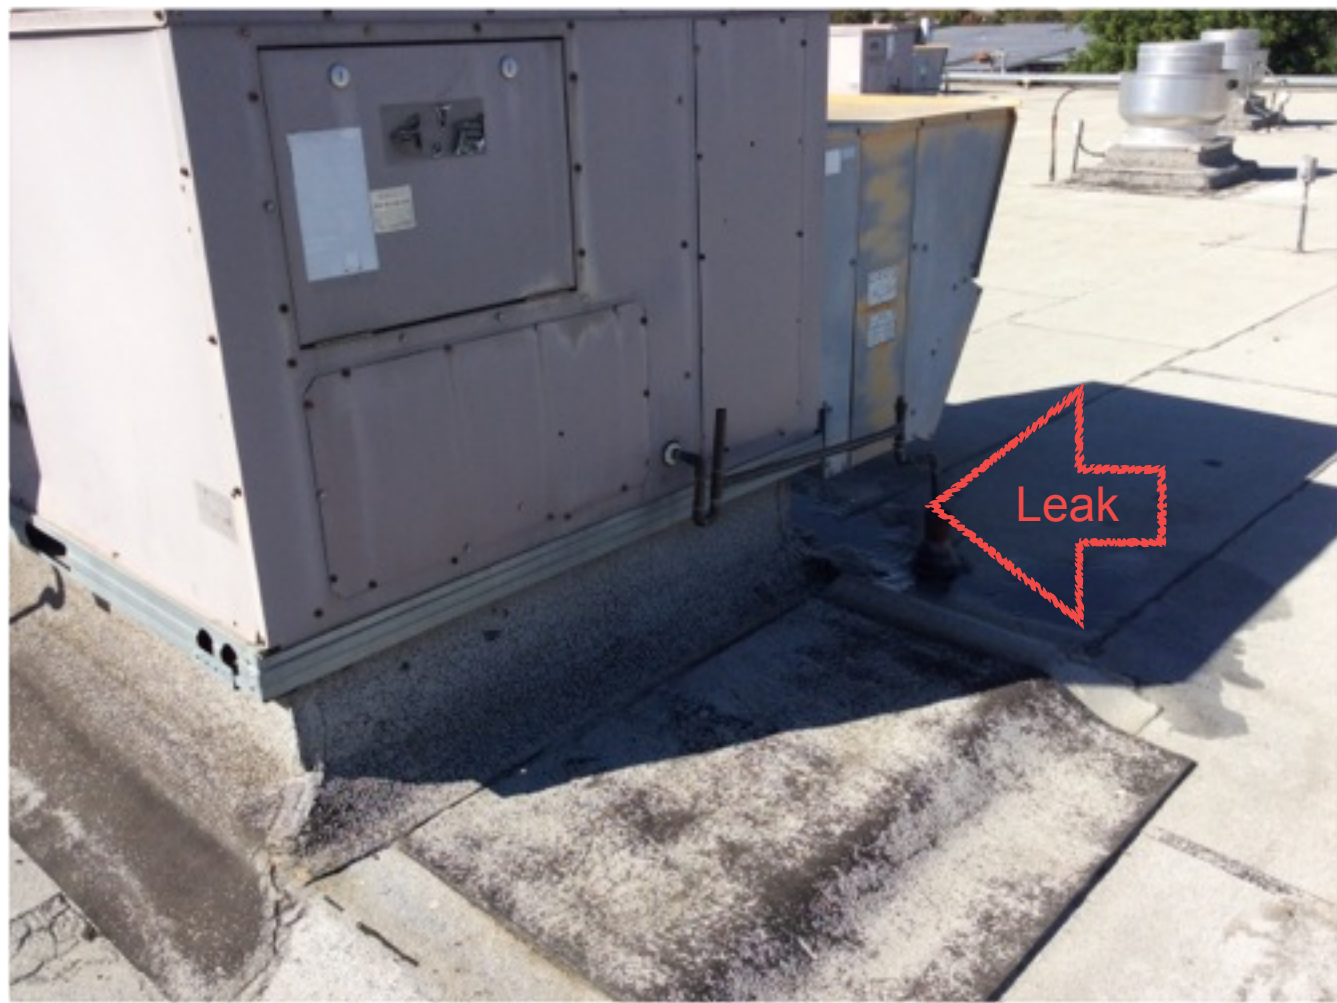
The photo below shows the failing and wear of all the penetration base flashings.

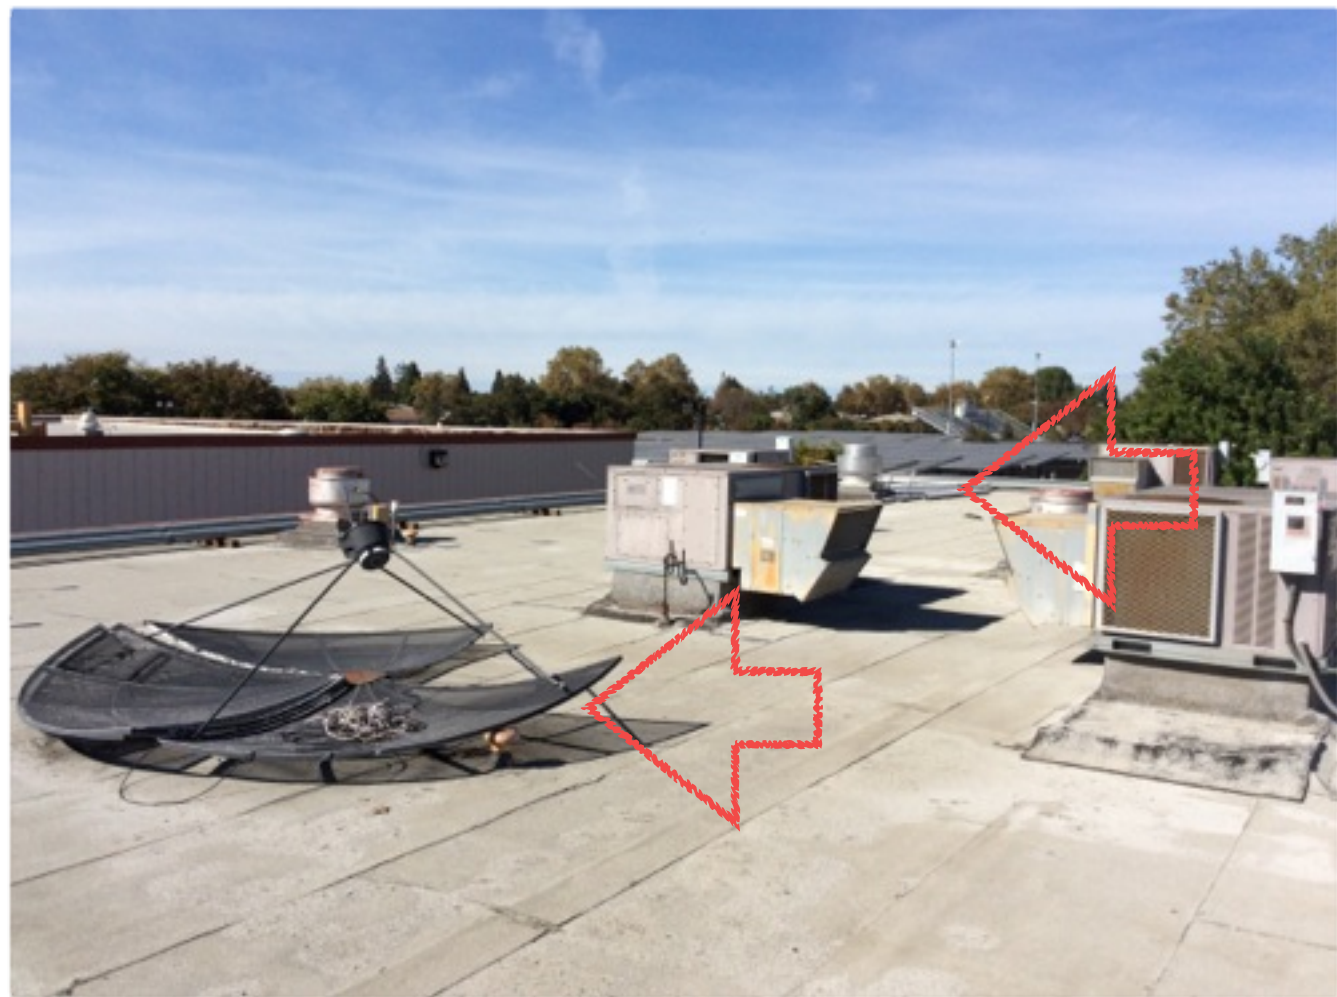
The photo below shows a fair amount of dead equipment that should be removed.

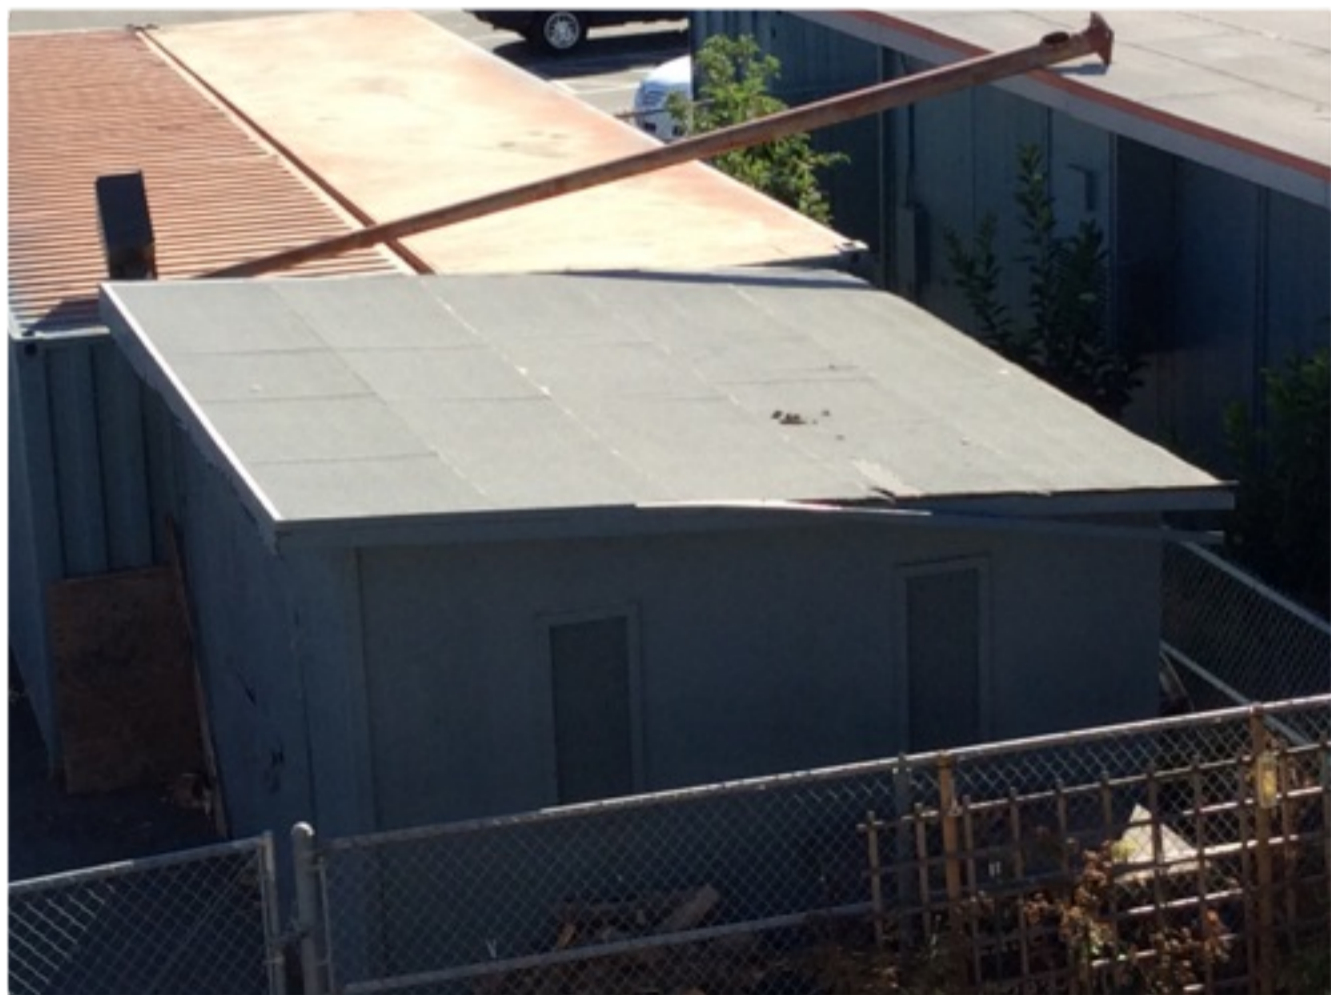
An overview photo from the roof level - damage to the edge flashing can be seen.

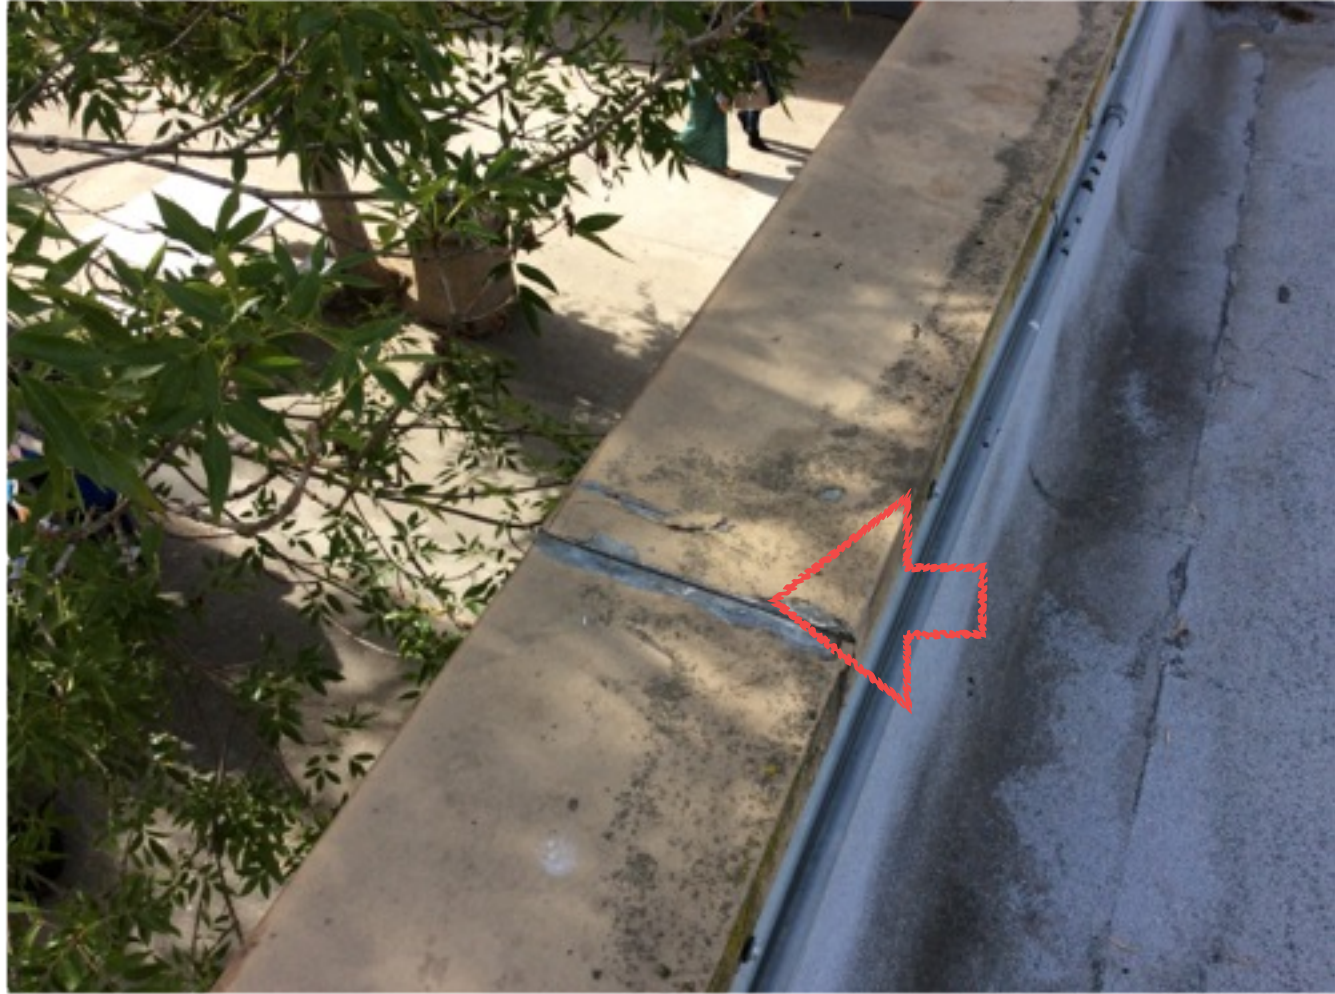
The photo below shows the wall cap flashing seams failing.

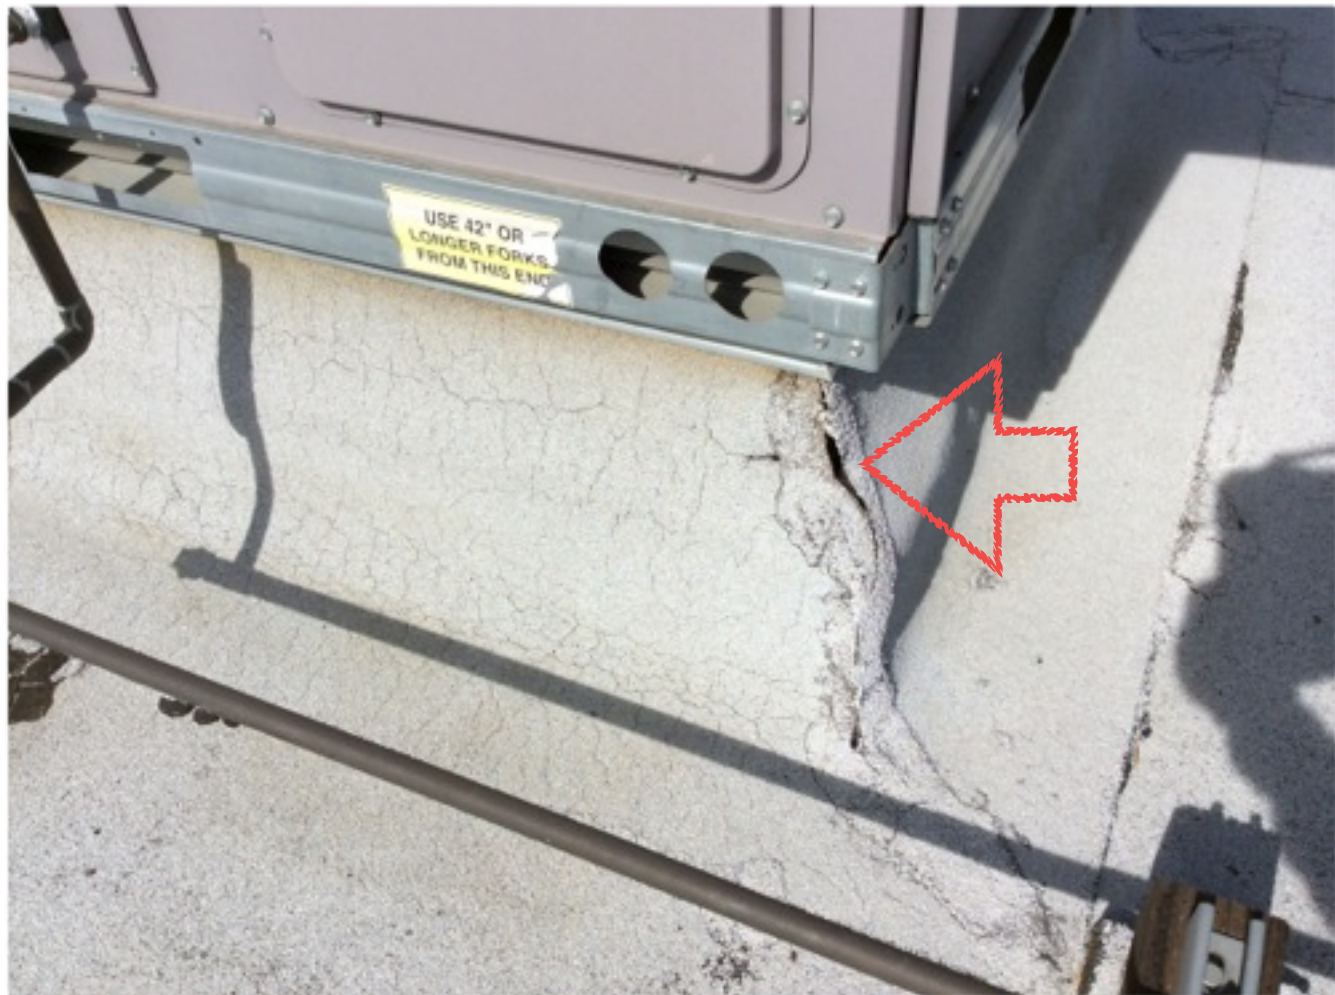
The photo below shows an open hole in the penetration corner.

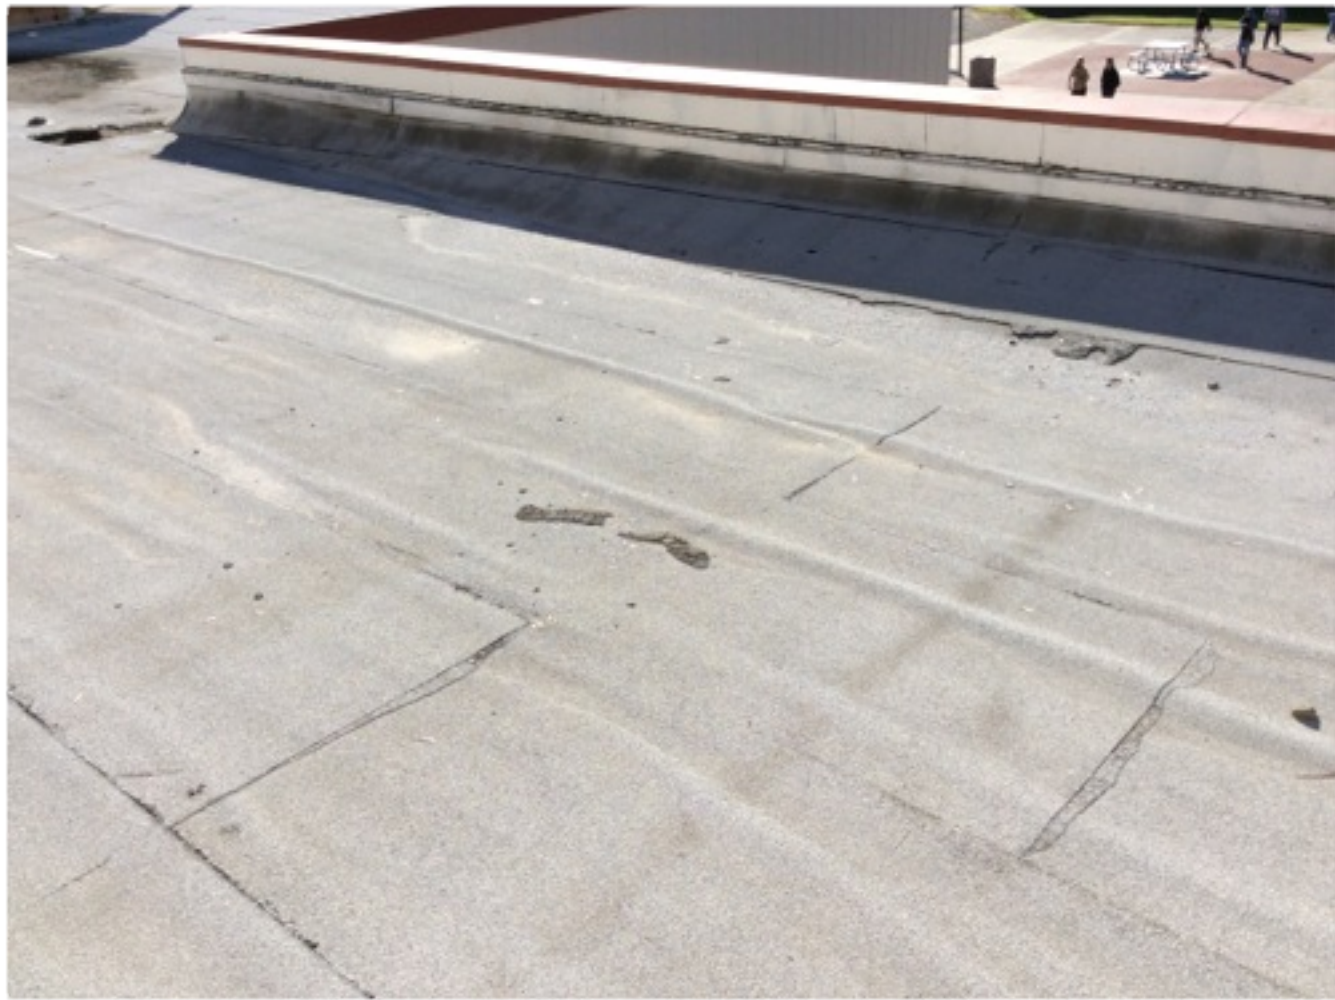
The photo below shows reaching in the field.

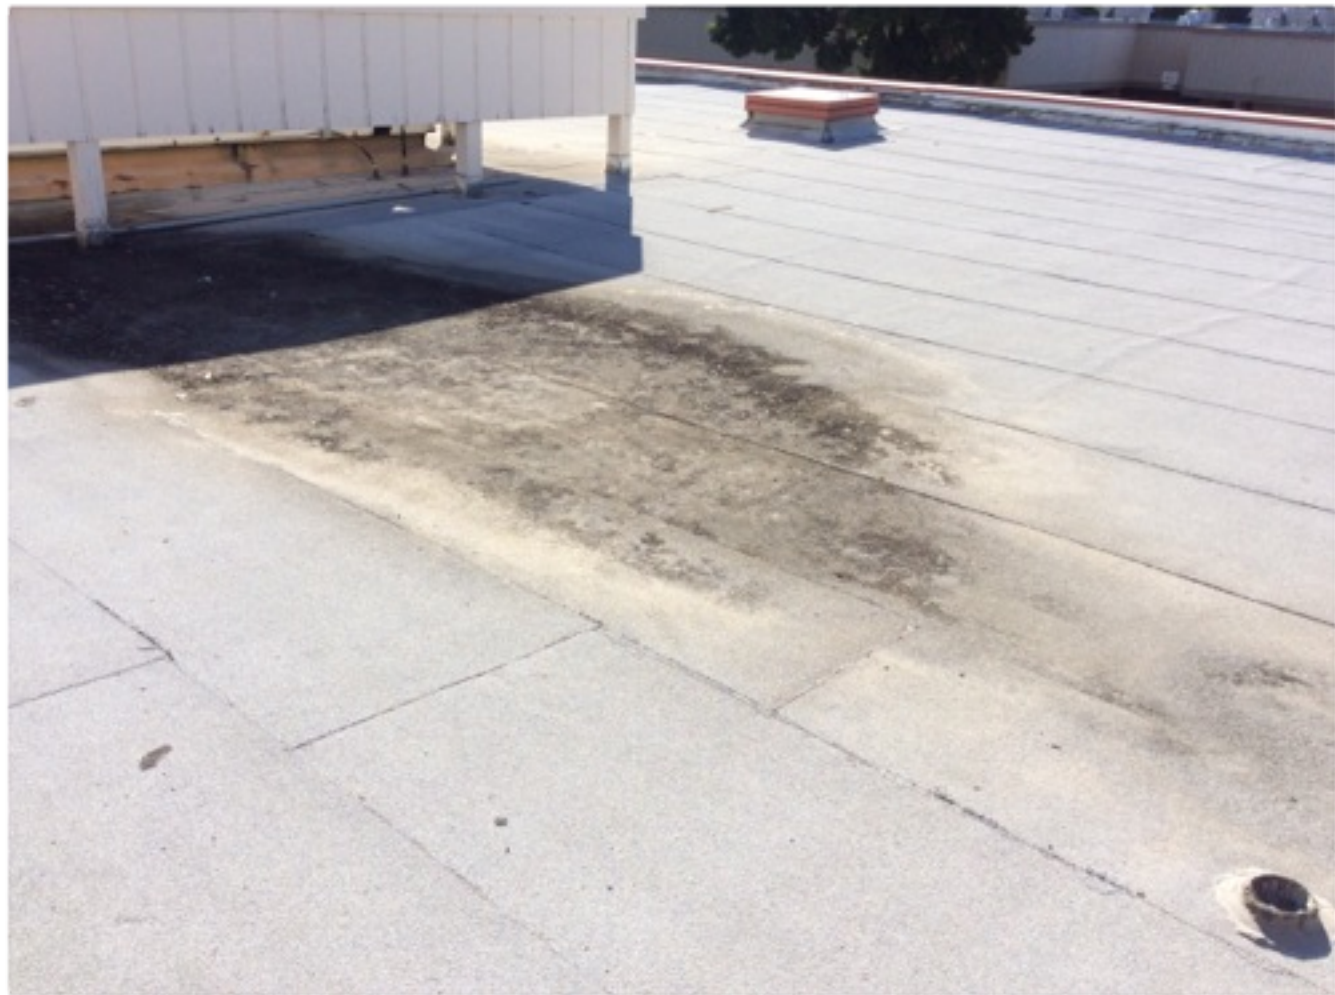
The photo below shows excessive ponding.
