BUILDING INFORMATION	
FACILITY	Education Center
DATE	November 6, 2014
BUILDING	Barn
ROOF SQ FT	5,100

BUILDING INFORMATION	
FACILITY	Education Center
DATE	November 6, 2014
BUILDING	Central Office
ROOF SQ FT	40,400

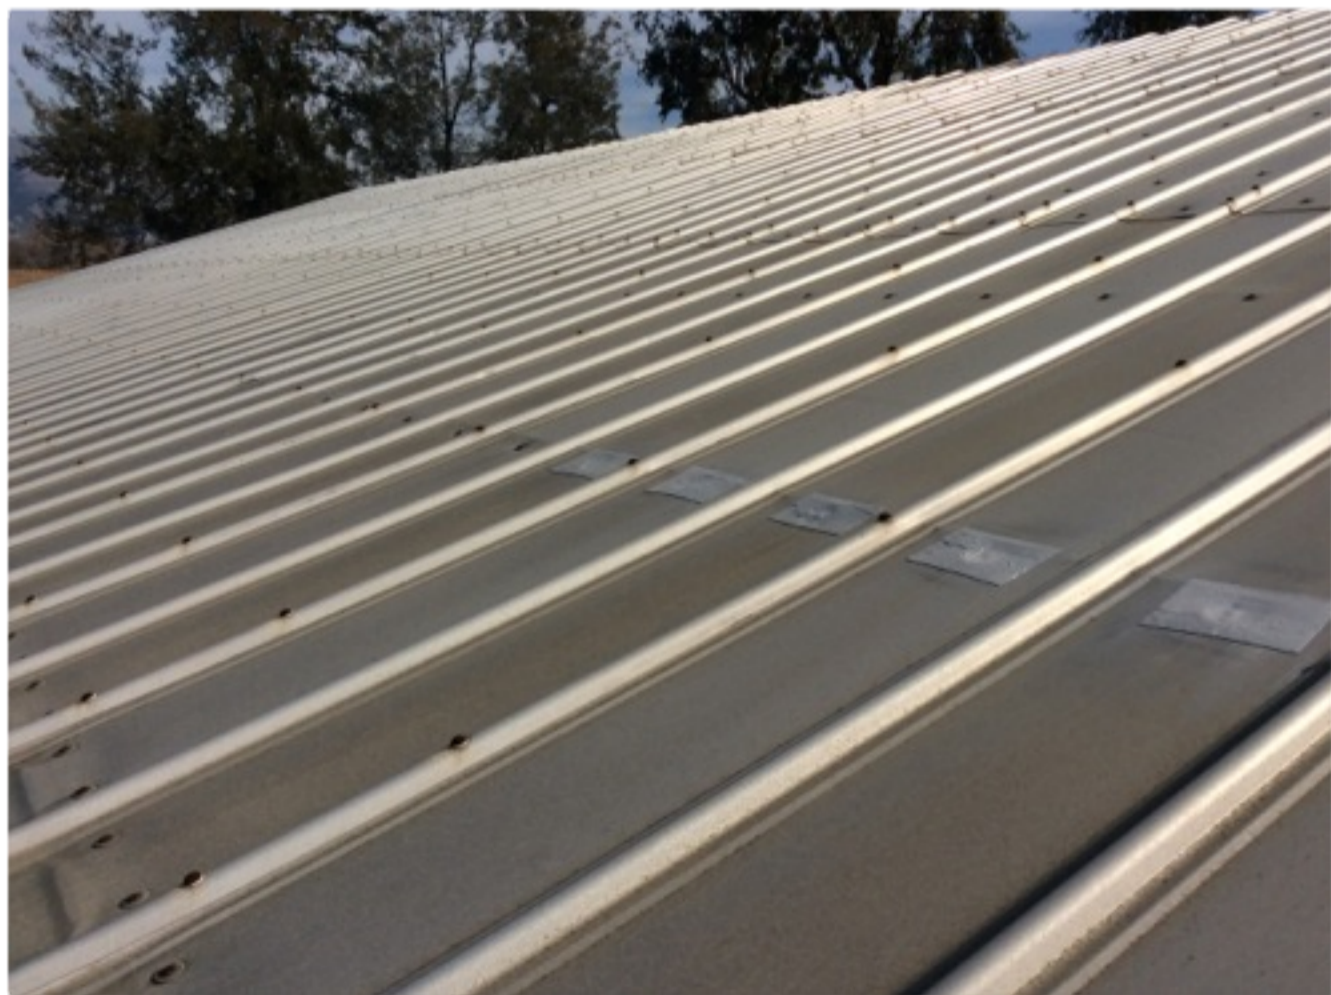
ADDITIONAL NOTES
 THE ROOF LOOKS GOOD. THE FASTENERS ARE RUSTING - RESEAL THEM ONLY IF THE BUILDING HAS BEEN REPORTED AS LEAKING.

An overview photo from the roof level.

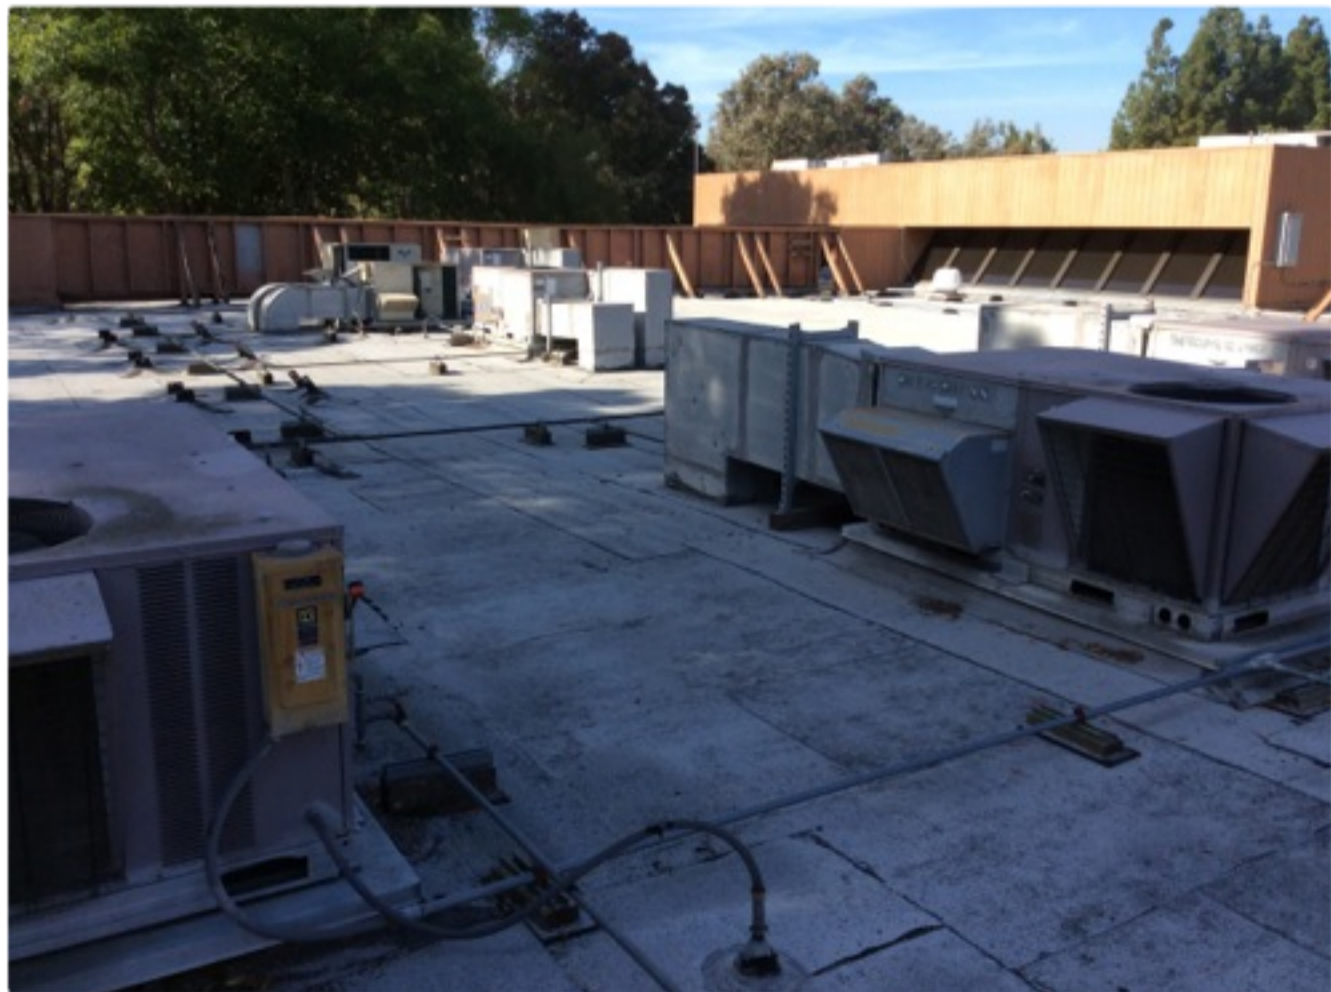
ADDITIONAL NOTES
 ROOF IS OVER DUE FOR REPLACEMENT.

An overview photo from the roof level.

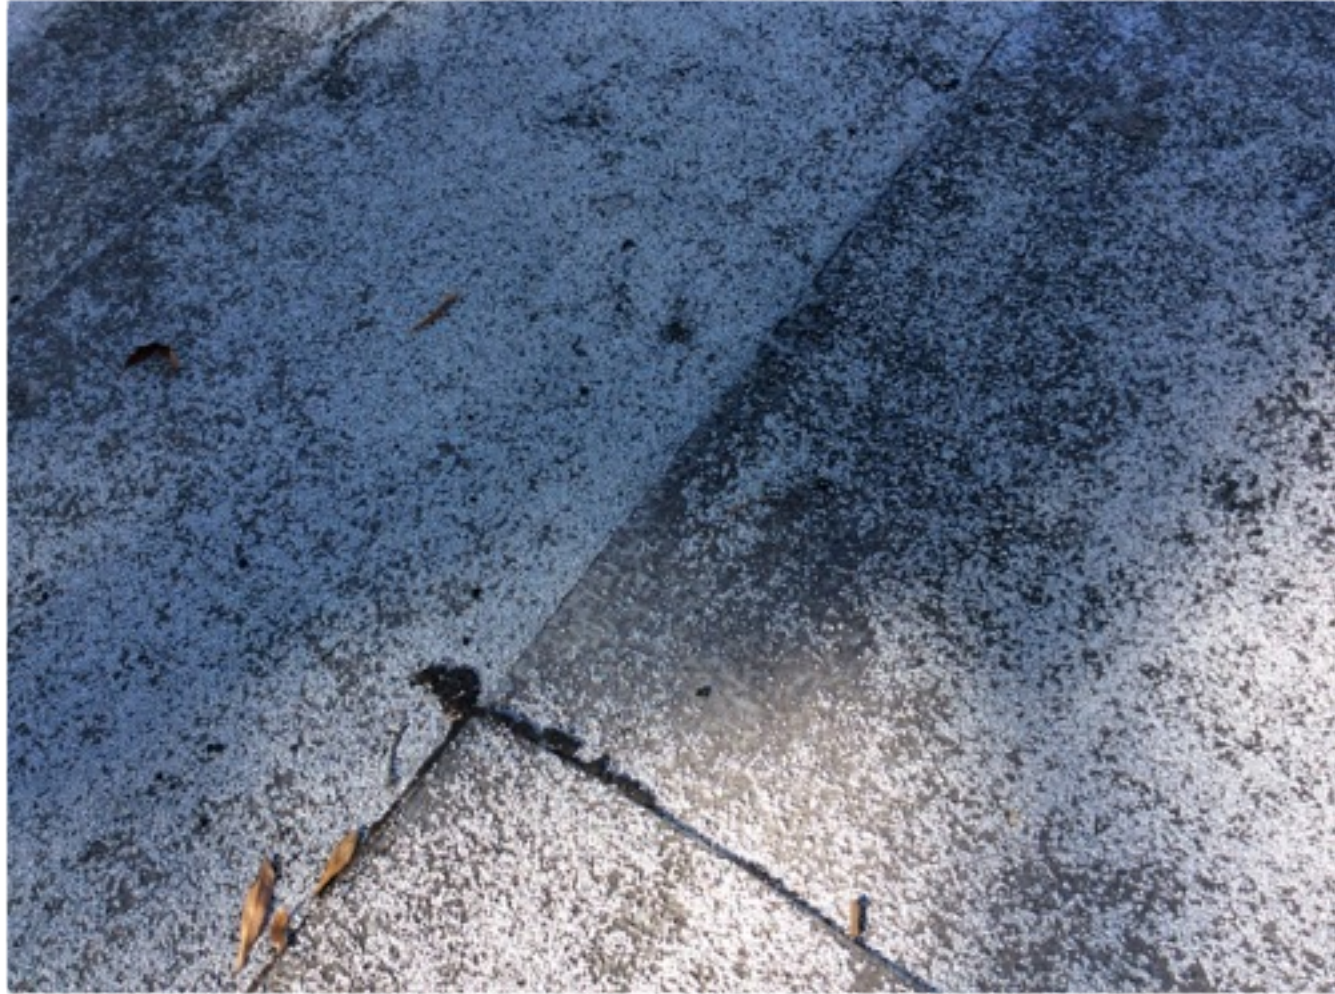
The photo below shows excessive wear to the membrane exposing the fibers.

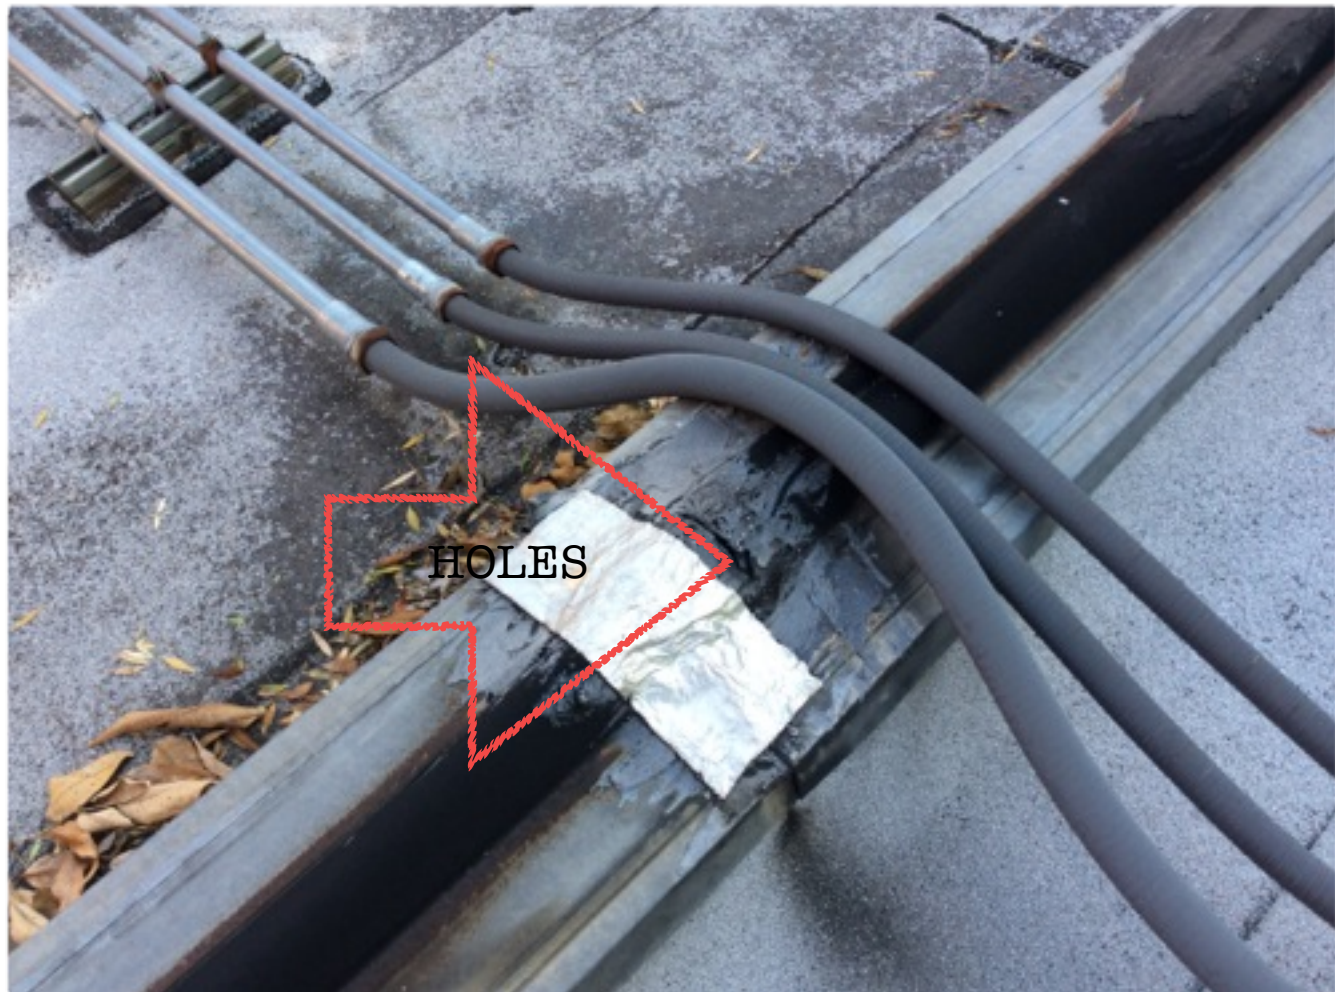
The photo below shows holes in the building expansion joints.

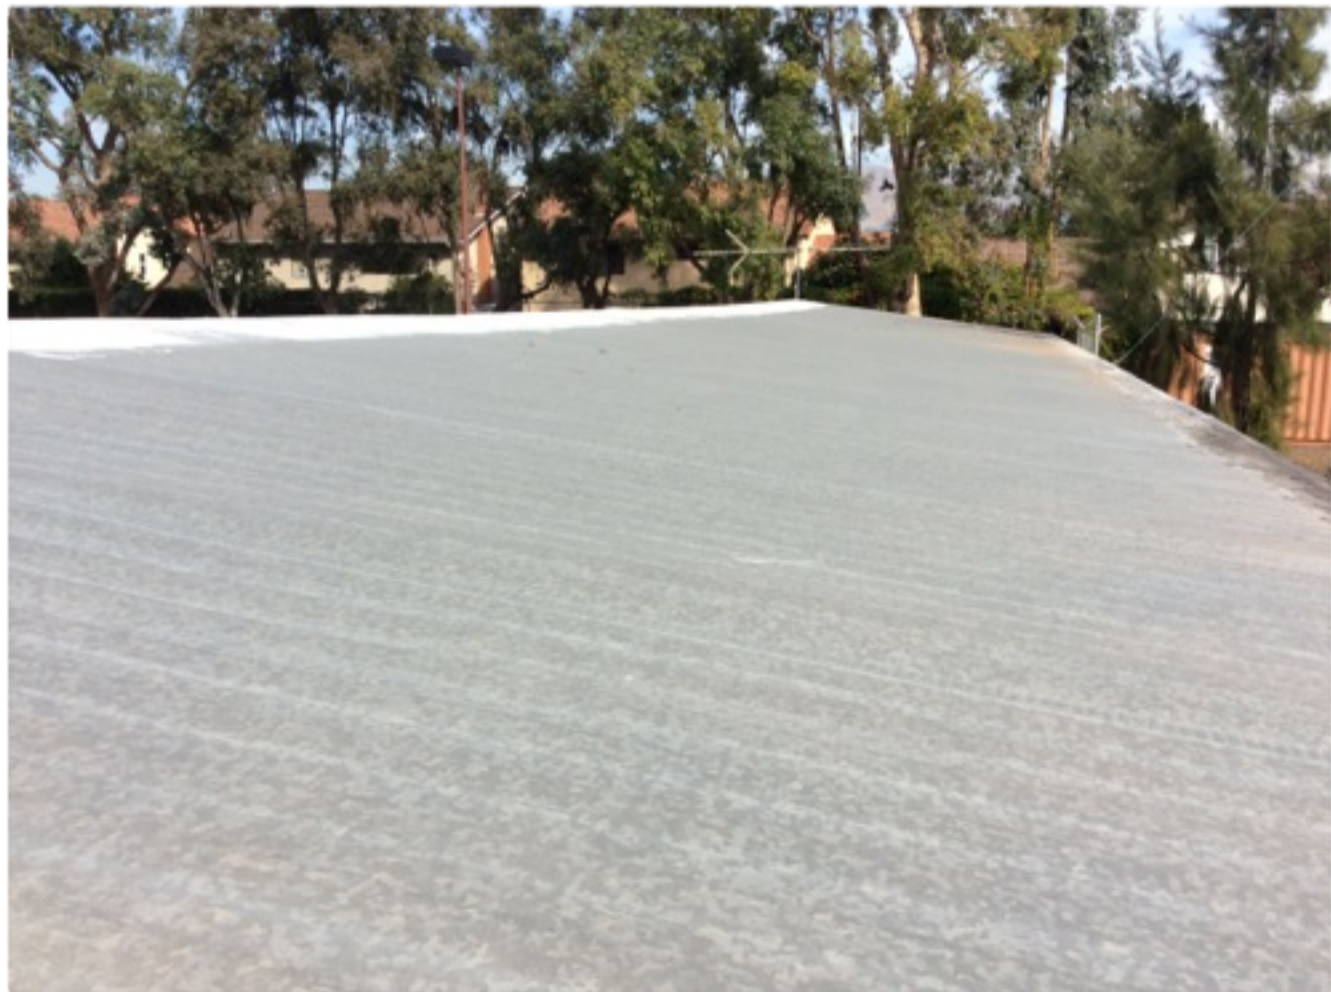
ADDITIONAL NOTES
 THE ROOF IS IN NEED OF REPAIRS. BUDGET TO RECOAT IN THE NEXT FIVE YEARS.

An overview photo from the roof level.

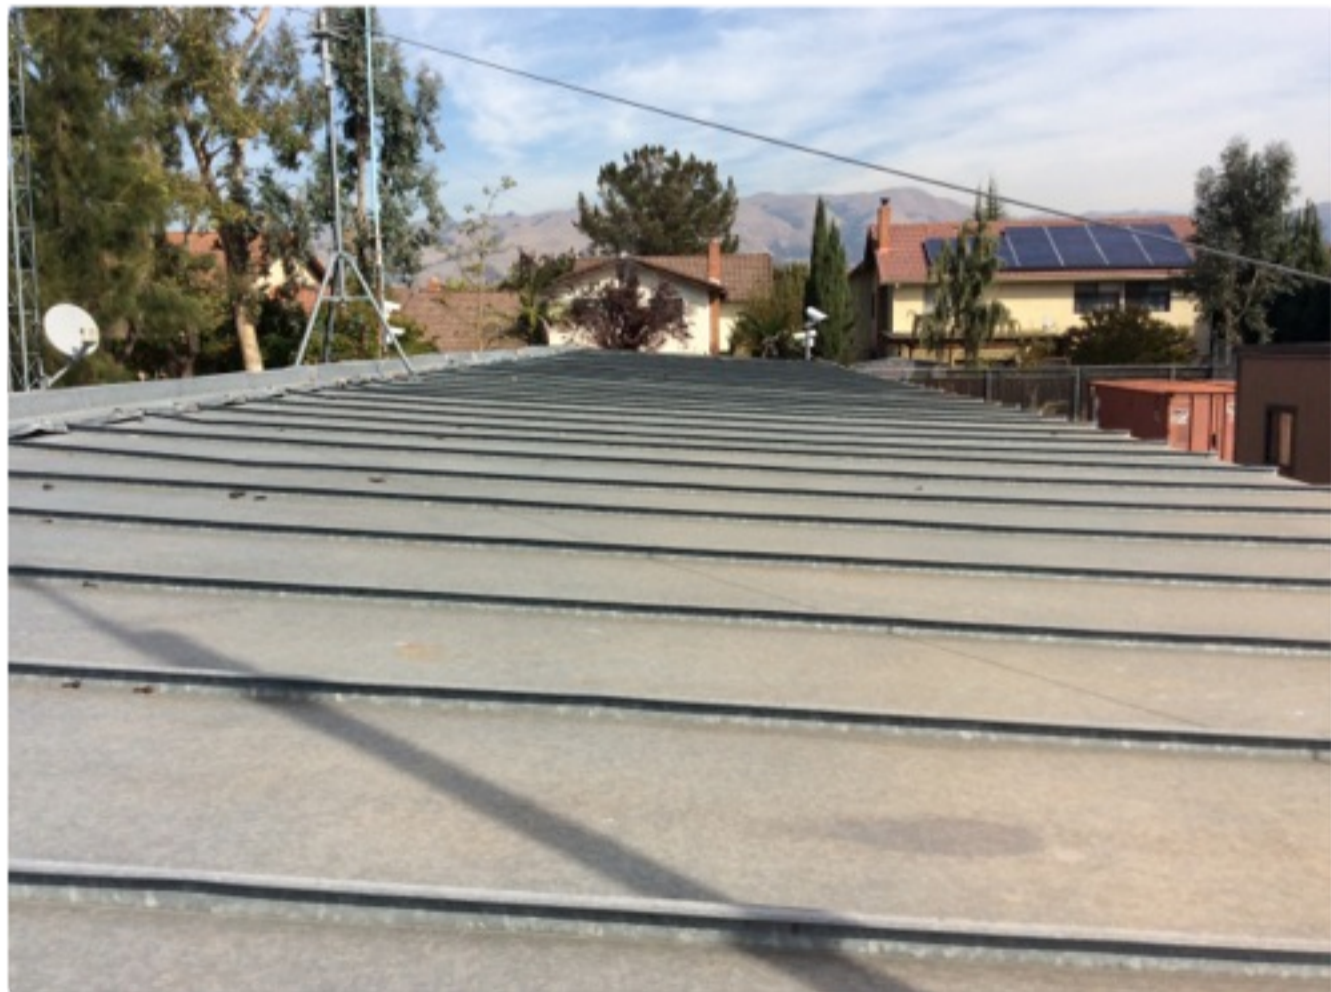
ADDITIONAL NOTES
 THE ROOF IS IN NEED OF REPAIRS. BUDGET TO RECOAT IN THE NEXT FIVE YEARS.

An overview photo from the roof level.

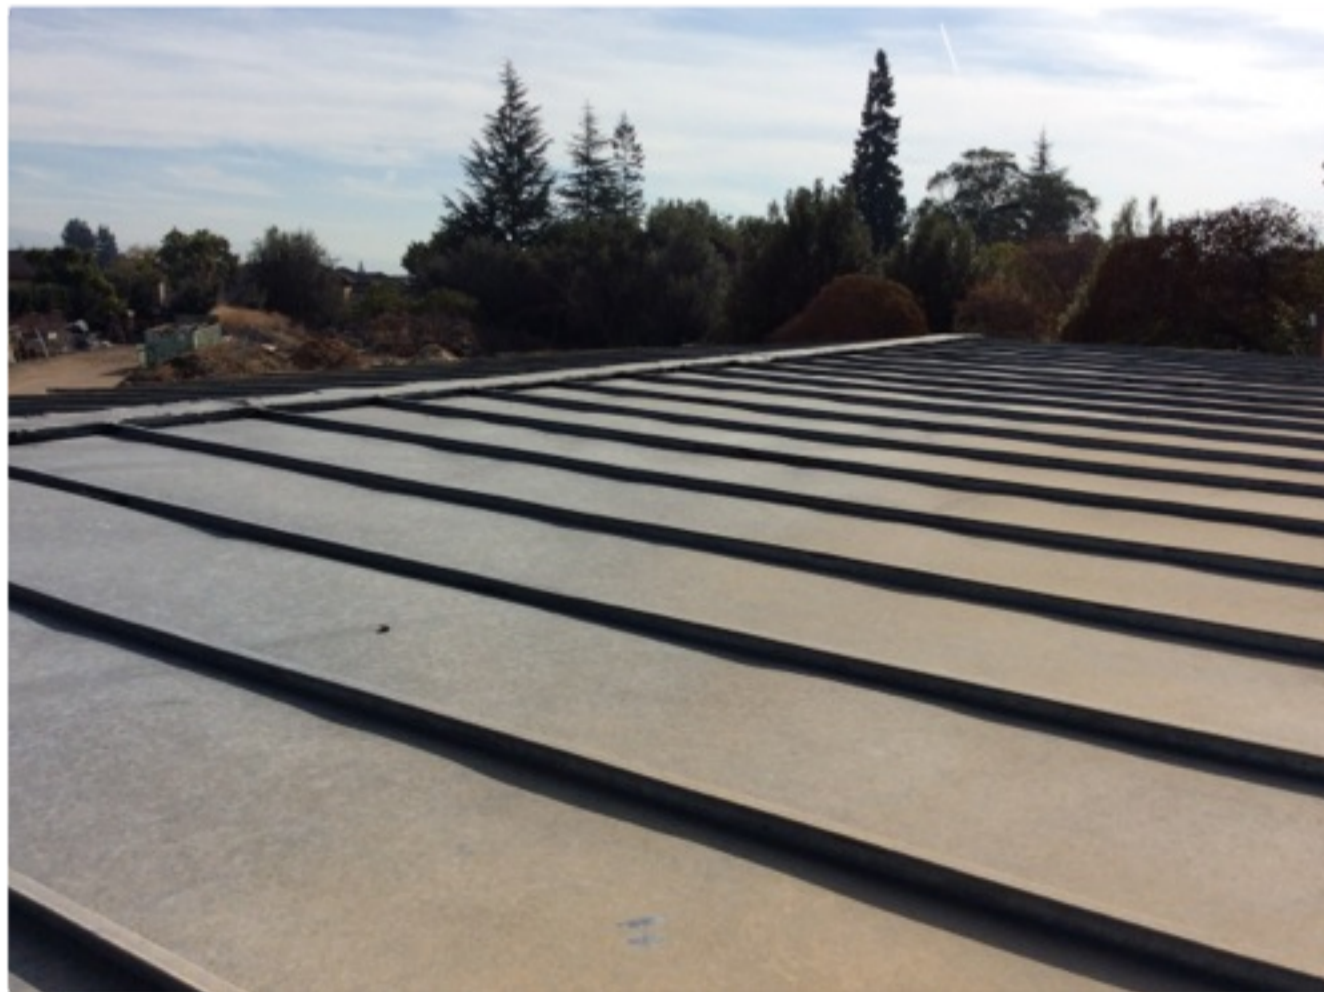
ADDITIONAL NOTES
 THE ROOF IS NOT RUSTING BUT IT IS VERY OLD. SUGGEST BUDGETING FOR A FULL TREAT, REPAIR, AND COATING WITHIN THE NEXT YEAR OR TWO.

An overview photo from the roof level.

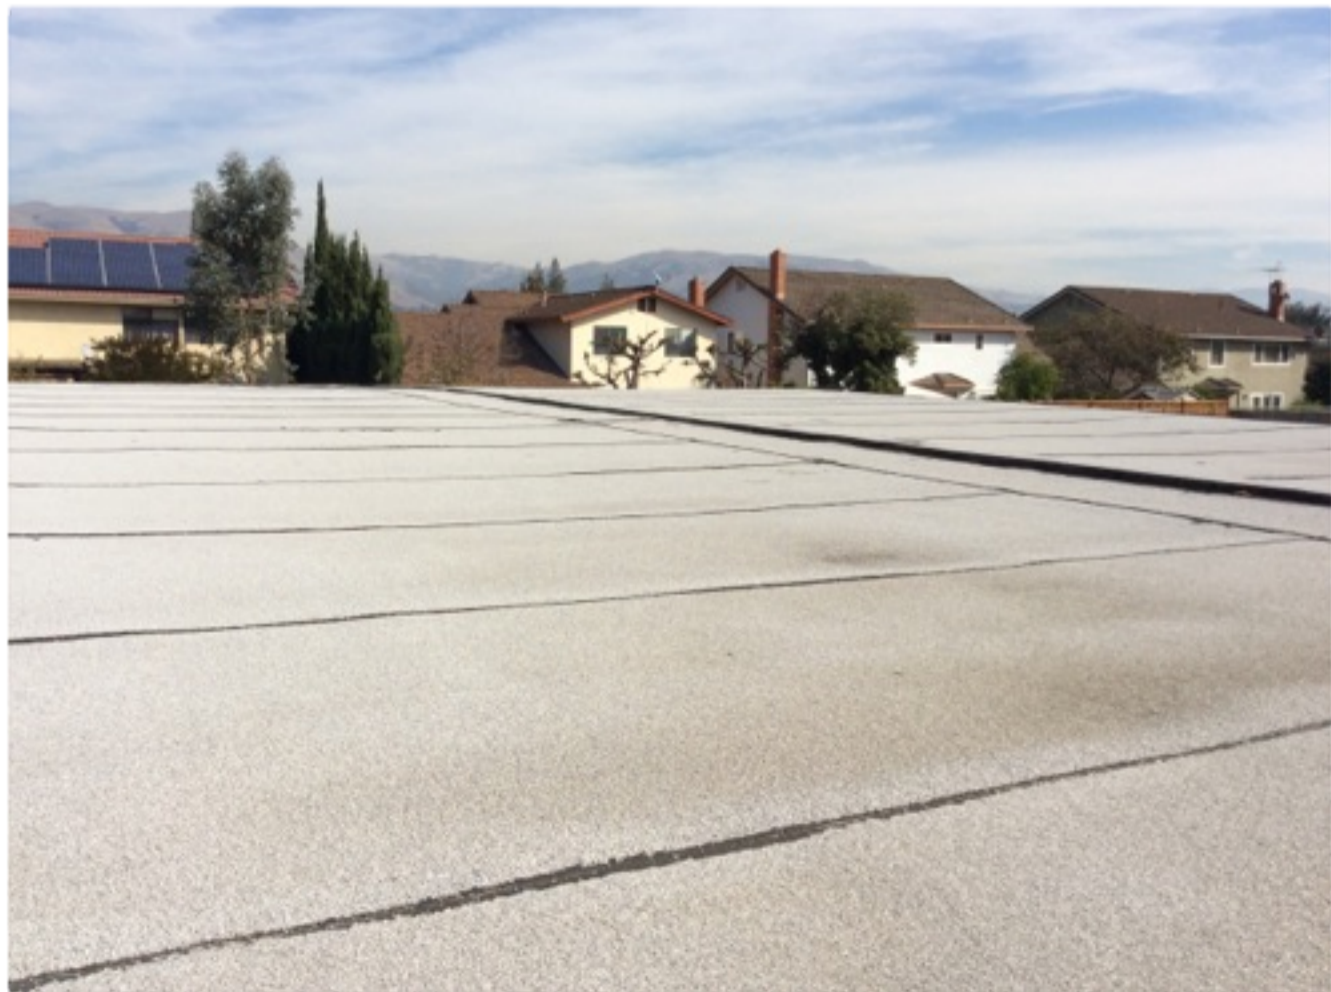
ADDITIONAL NOTES
 THE ROOF LOOKS GOOD. THE PERIMETER FLASHING REPAIRS ARE AGING AND WILL SOON NEED TO BE REDONE.

An overview photo from the roof level.

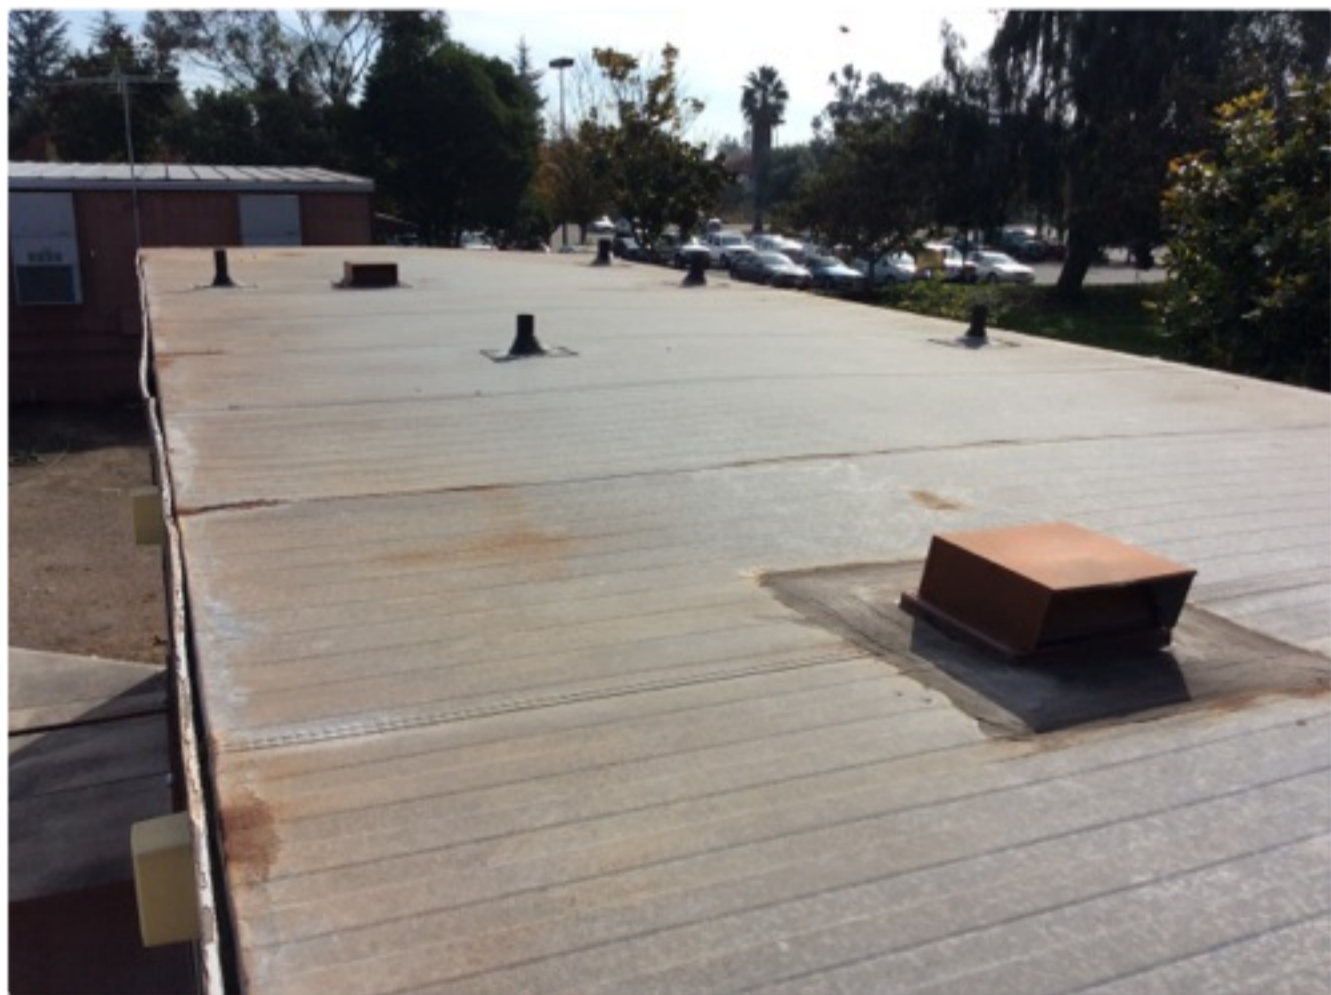
ADDITIONAL NOTES
THE ROOF IS RUSTING. TREAT, REPAIR, AND COAT.

An overview photo from the roof level.

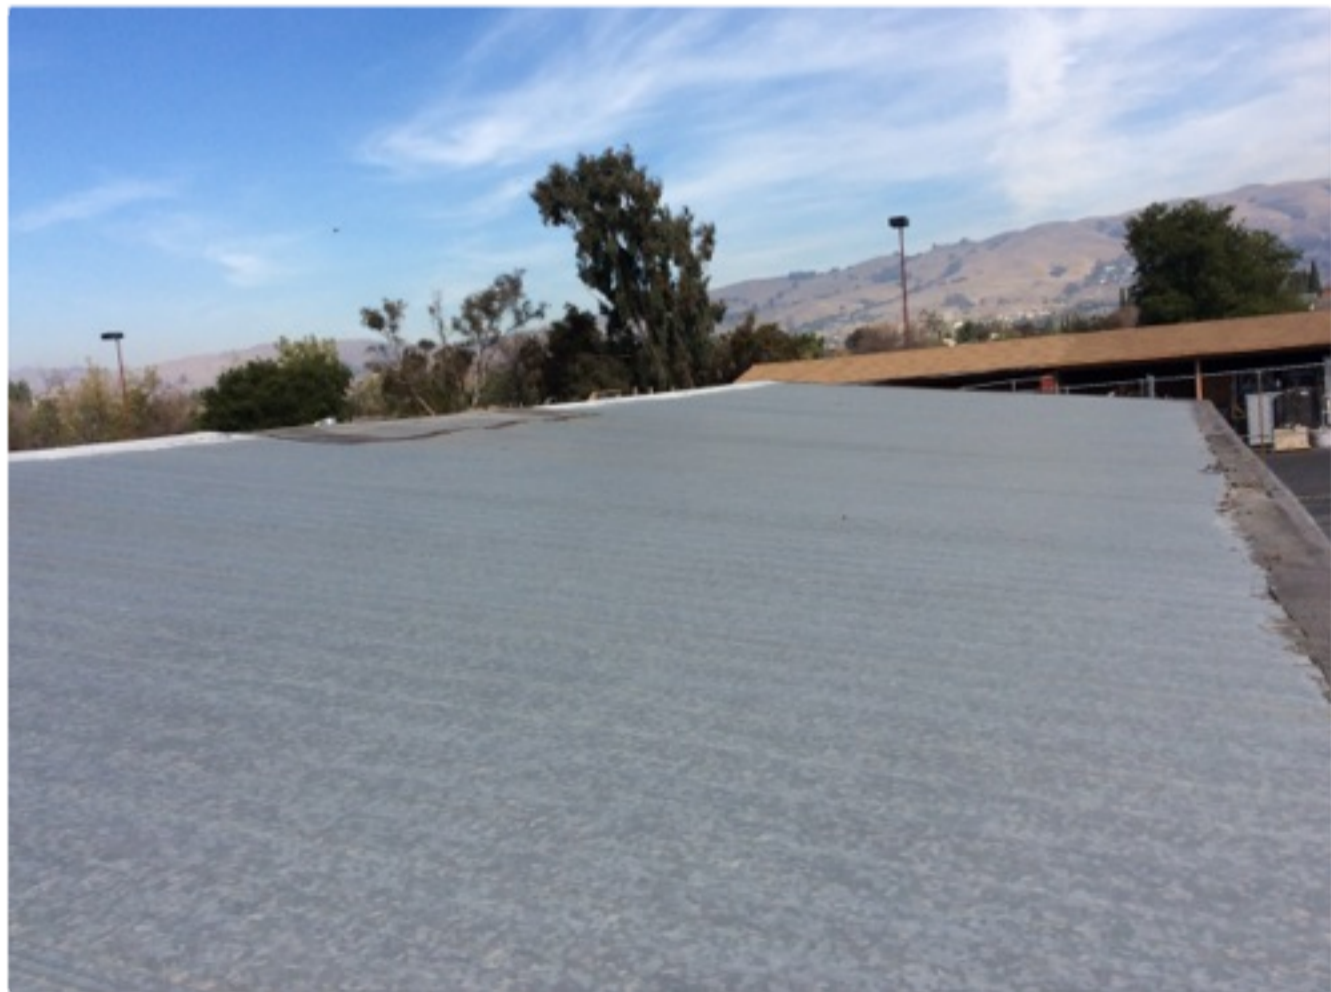
ADDITIONAL NOTES
 THE ROOF IS NOT RUSTING BUT IT IS VERY OLD. SUGGEST BUDGETING FOR A FULL TREAT, REPAIR, AND COATING WITHIN THE NEXT YEAR OR TWO.

An overview photo from the roof level.

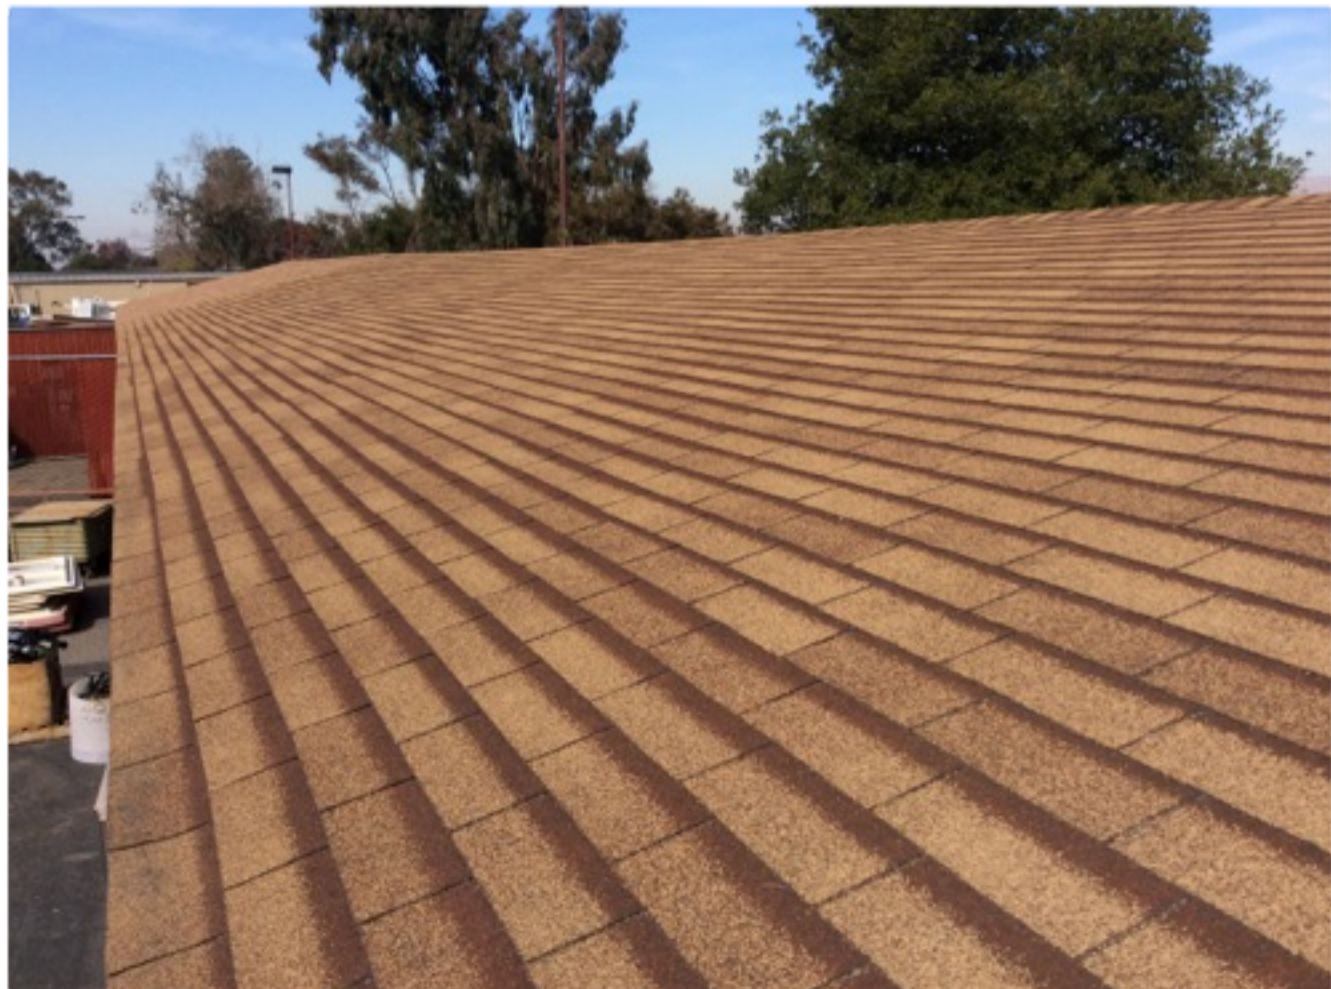
ADDITIONAL NOTES
 THE ROOF LOOKS GOOD WITH ONLY THE VERY FIRST SIGNS OF WEAR ON THE SHINGLES.

An overview photo from the roof level.

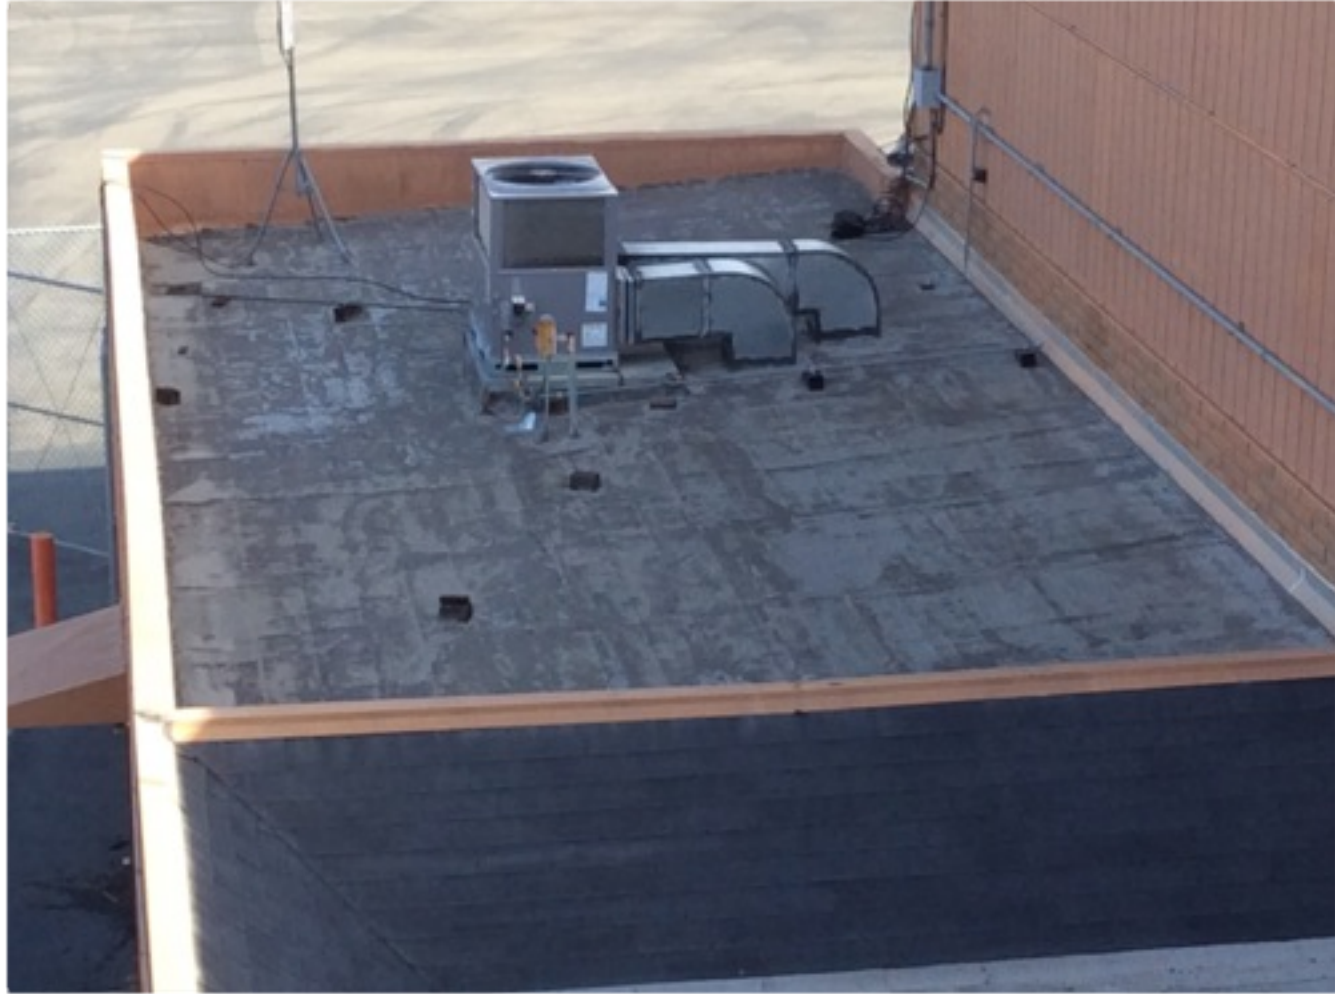
The photo below shows a small BUR roof that is in poor condition.

ADDITIONAL NOTES
 MAIN UPPER ROOFS ARE AGING VERY WELL. RESEAL PENETRATIONS ON THE UPPER ROOFS. LOWER ADJACENT ROOFS ARE AGING MORE NORMALLY. BUDGET TO REPLACE IN THE NEXT COUPLE YEARS.

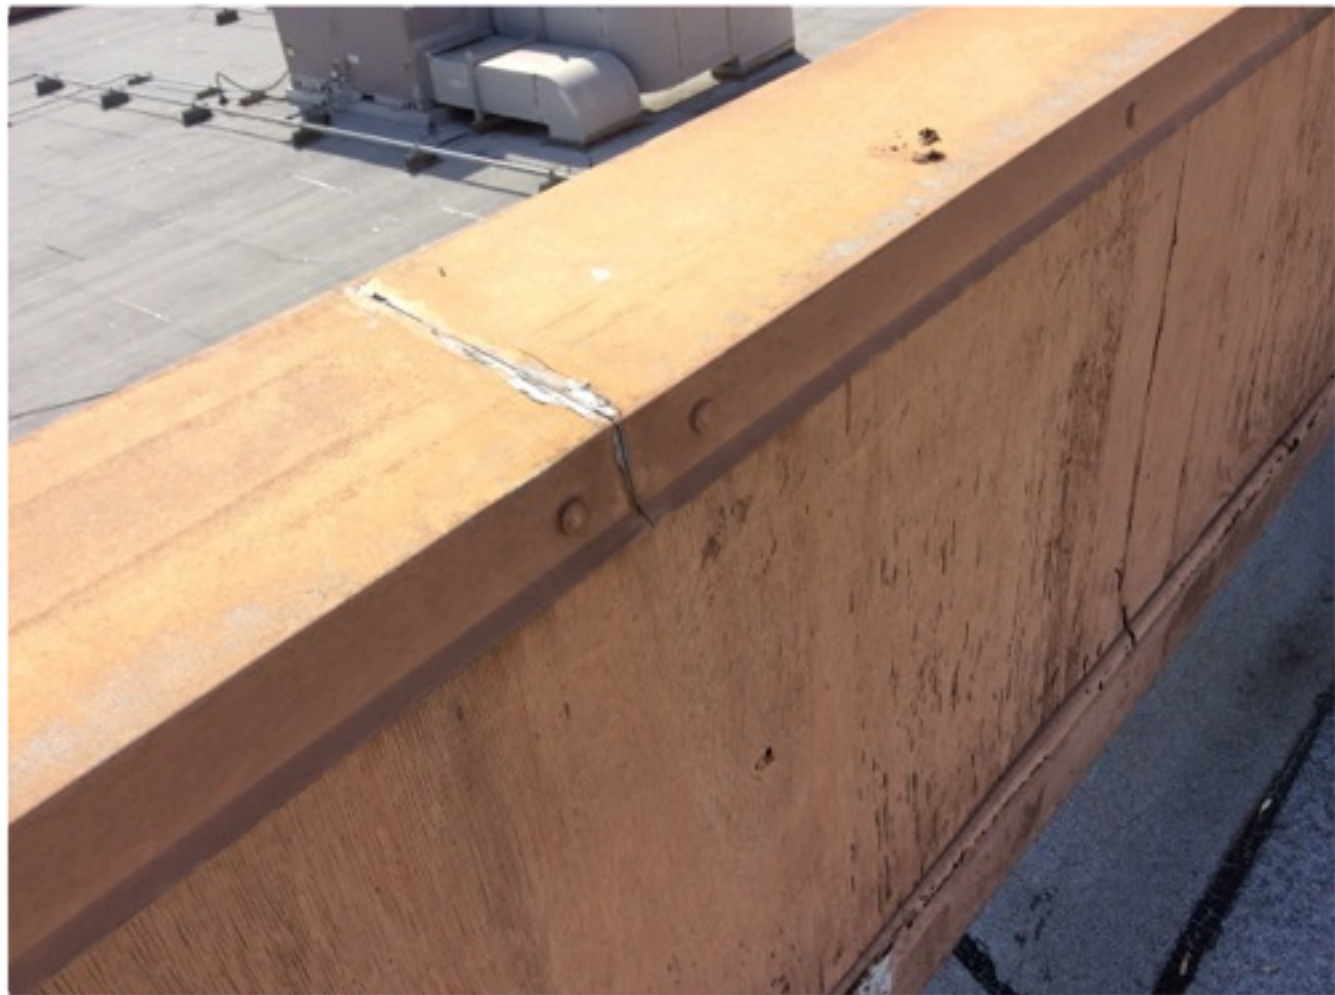
The photo below shows that wall and cap flashing need to be resealed and coated.
