BUILDING INFORMATION	
FACILITY	Foothill HS
DATE	August 18, 2014
BUILDING	Admin BUR
ROOF SQ FT	1,500

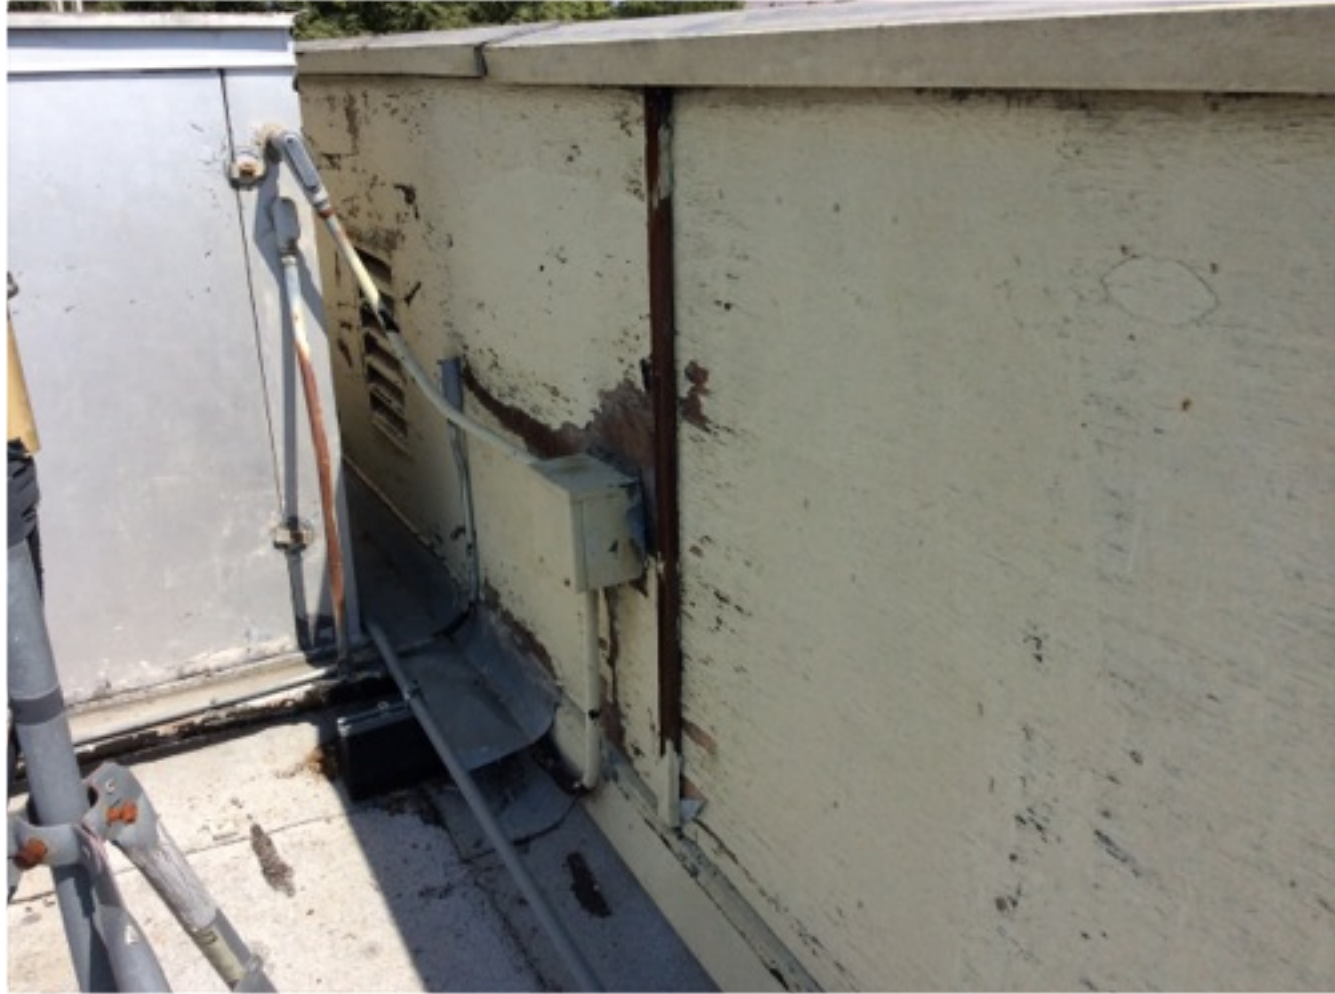
ADDITIONAL NOTES
 BUR SYSTEM IS IN POOR CONDITION AND MAY COMPROMISE SHINGLE SYTEM IF NOT REPLACED WITHIN A COUPLE OF YEARS.

The photo below shows the walls in bad shape.

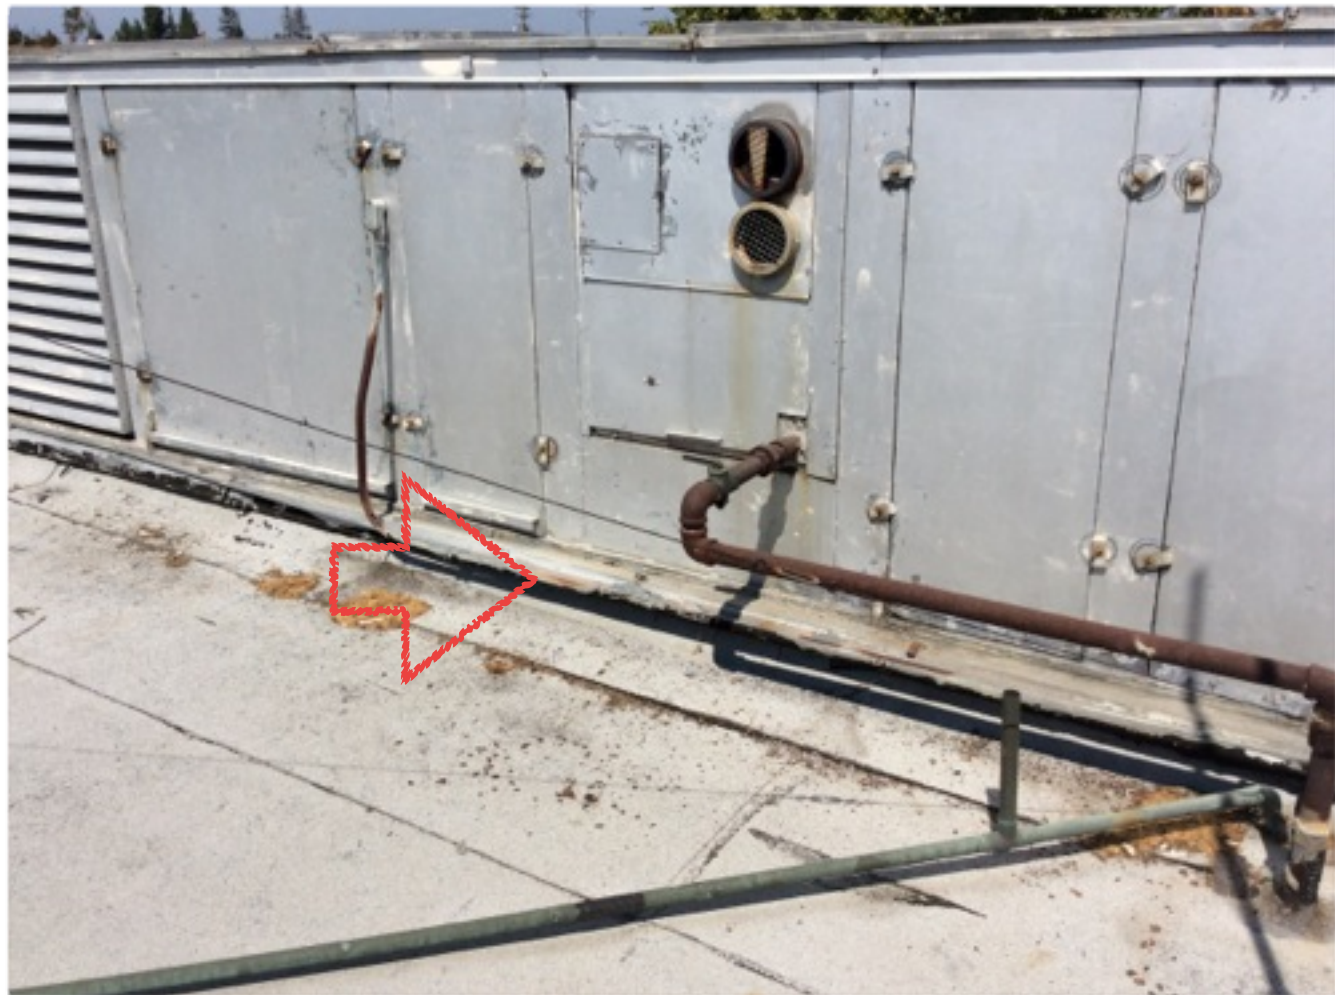
The photo below shows the penetration flashing in need of a new design.

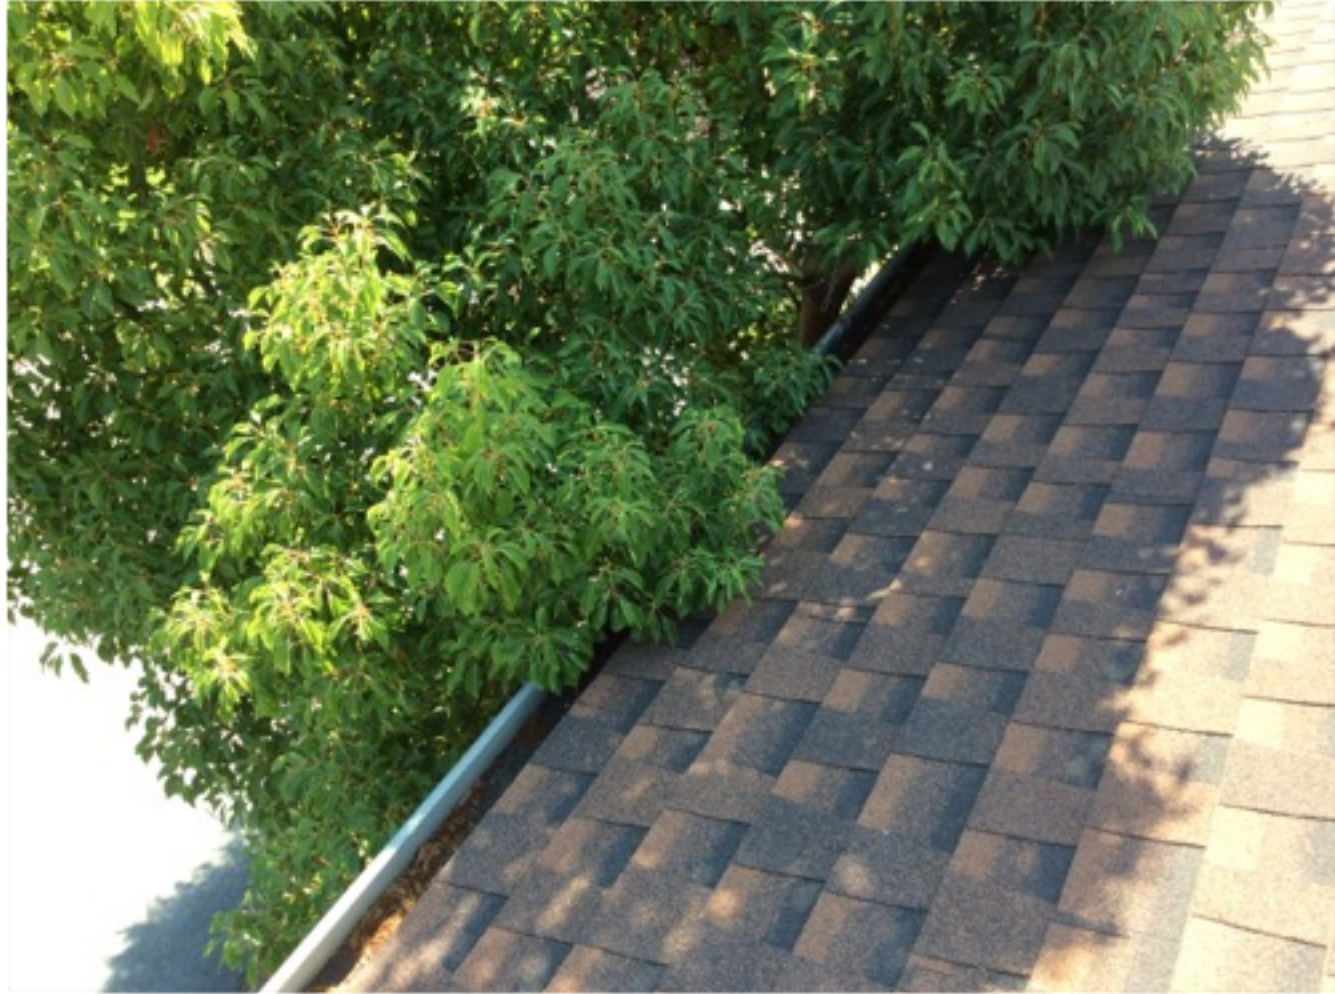
Keep gutters clean - trimming trees saves on maintenance and roof system aging.

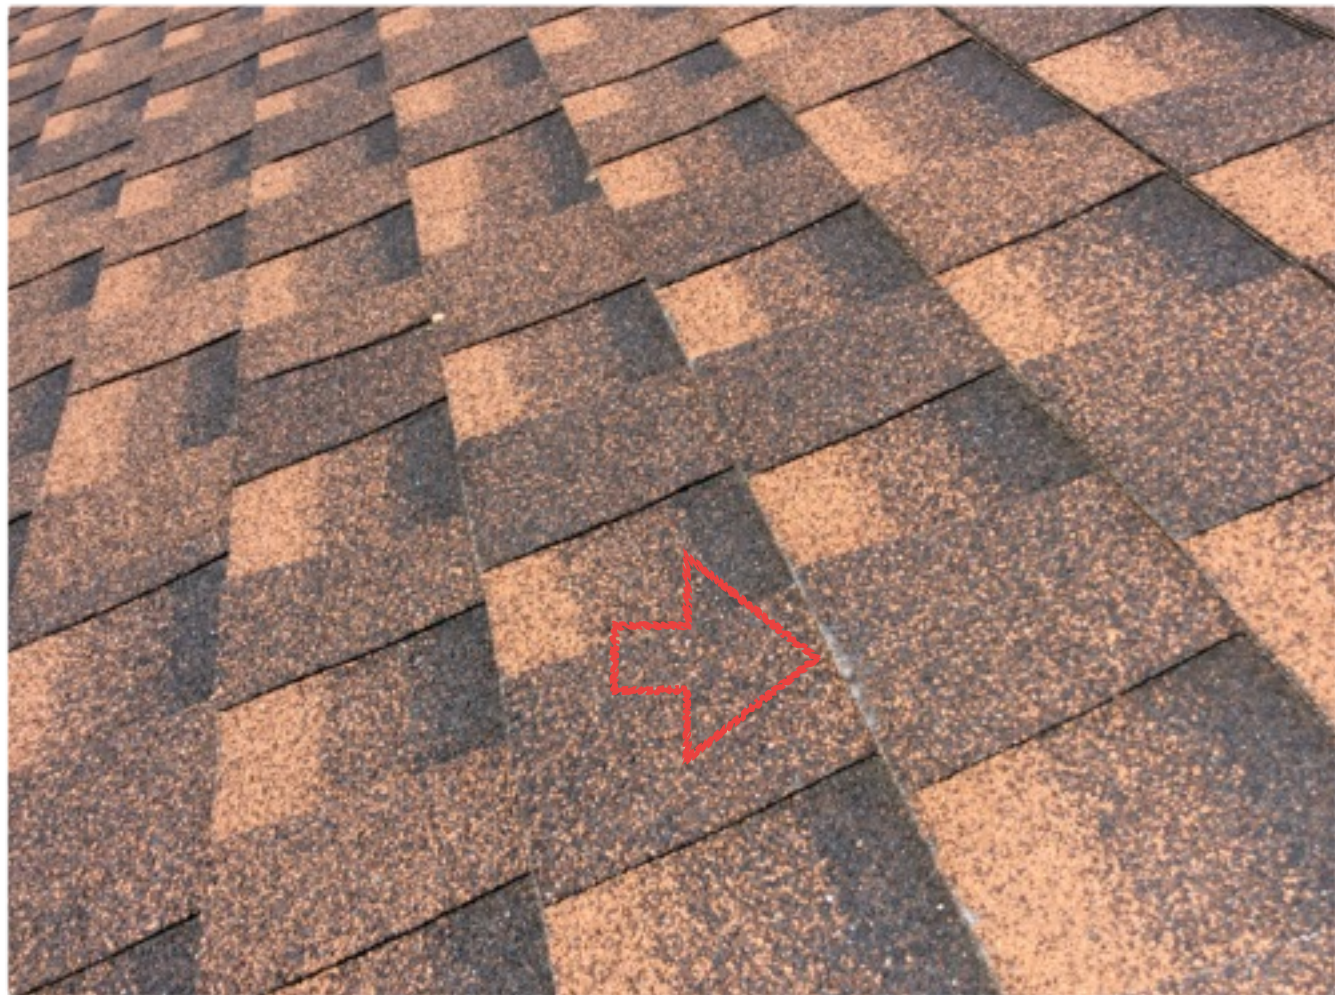
The photo below shows the shingles starting to wear.

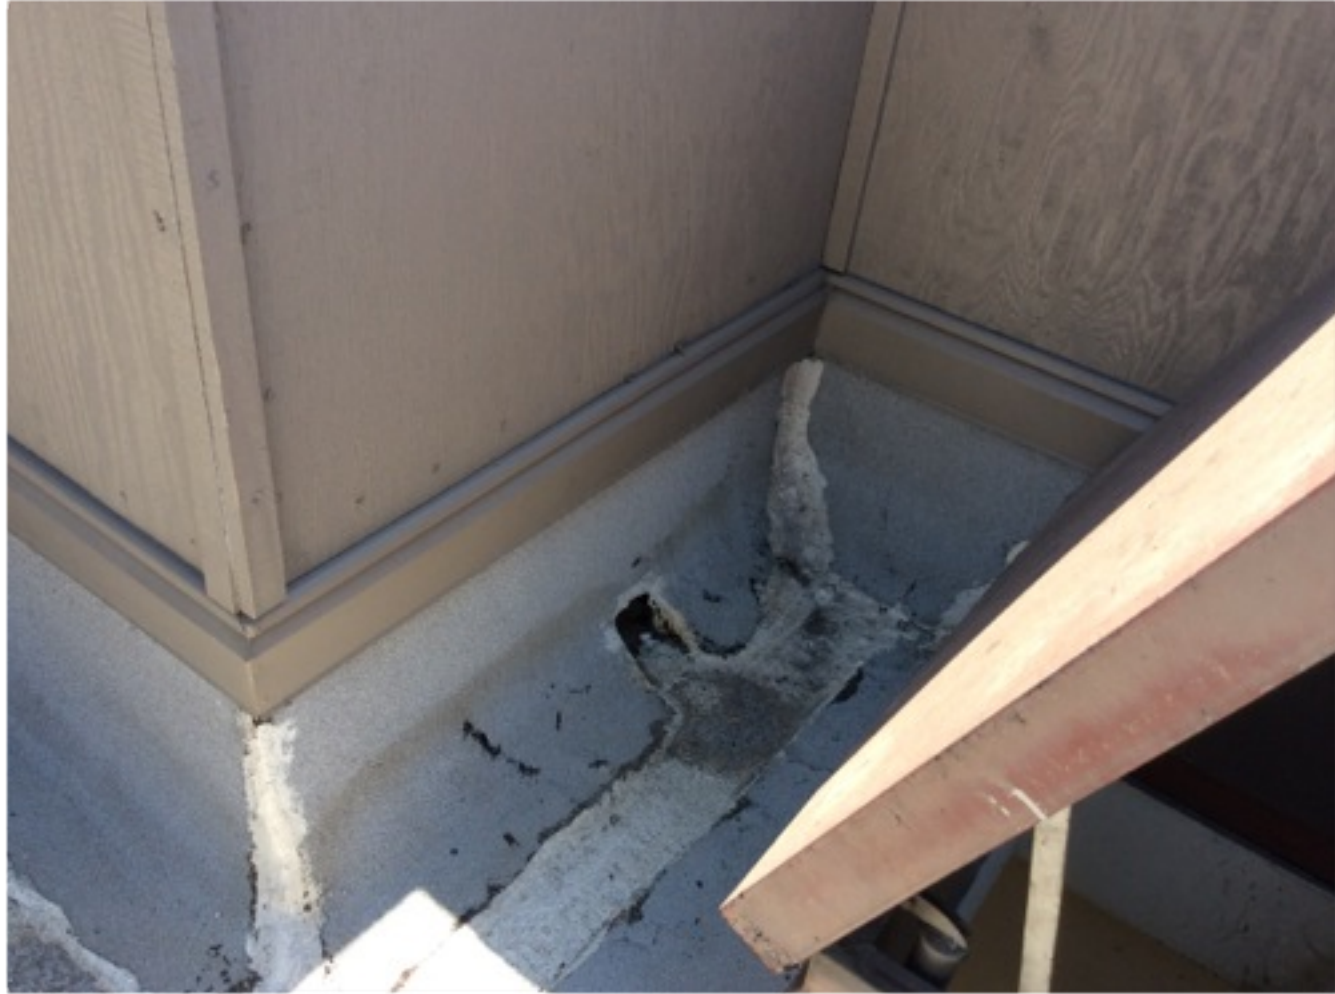
The photo below shows the drain area in good condition with no ponding.

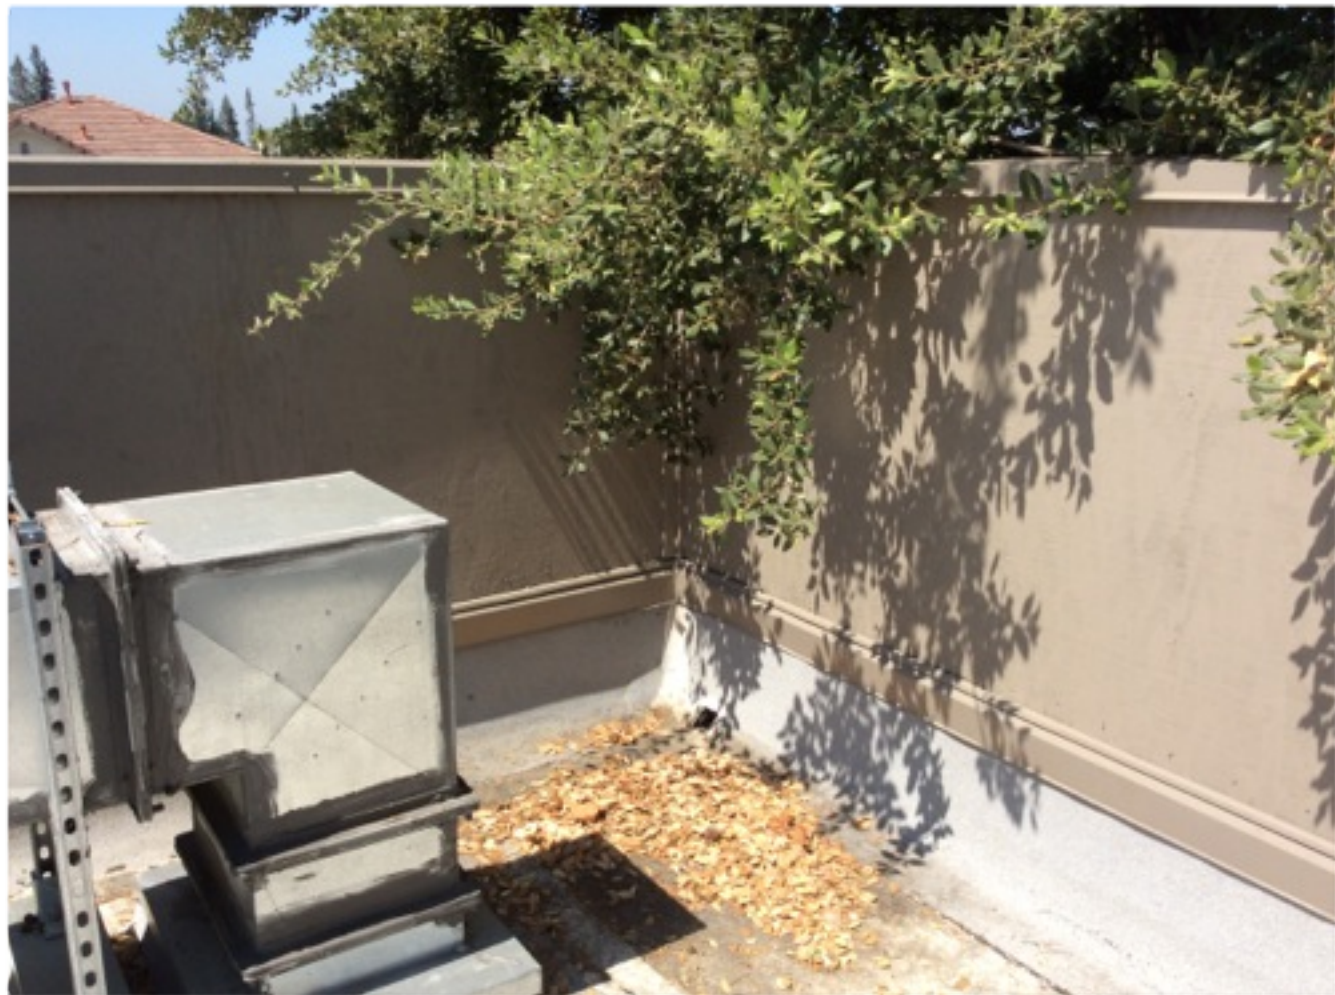
Trimming trees will prolong the life of the roof.

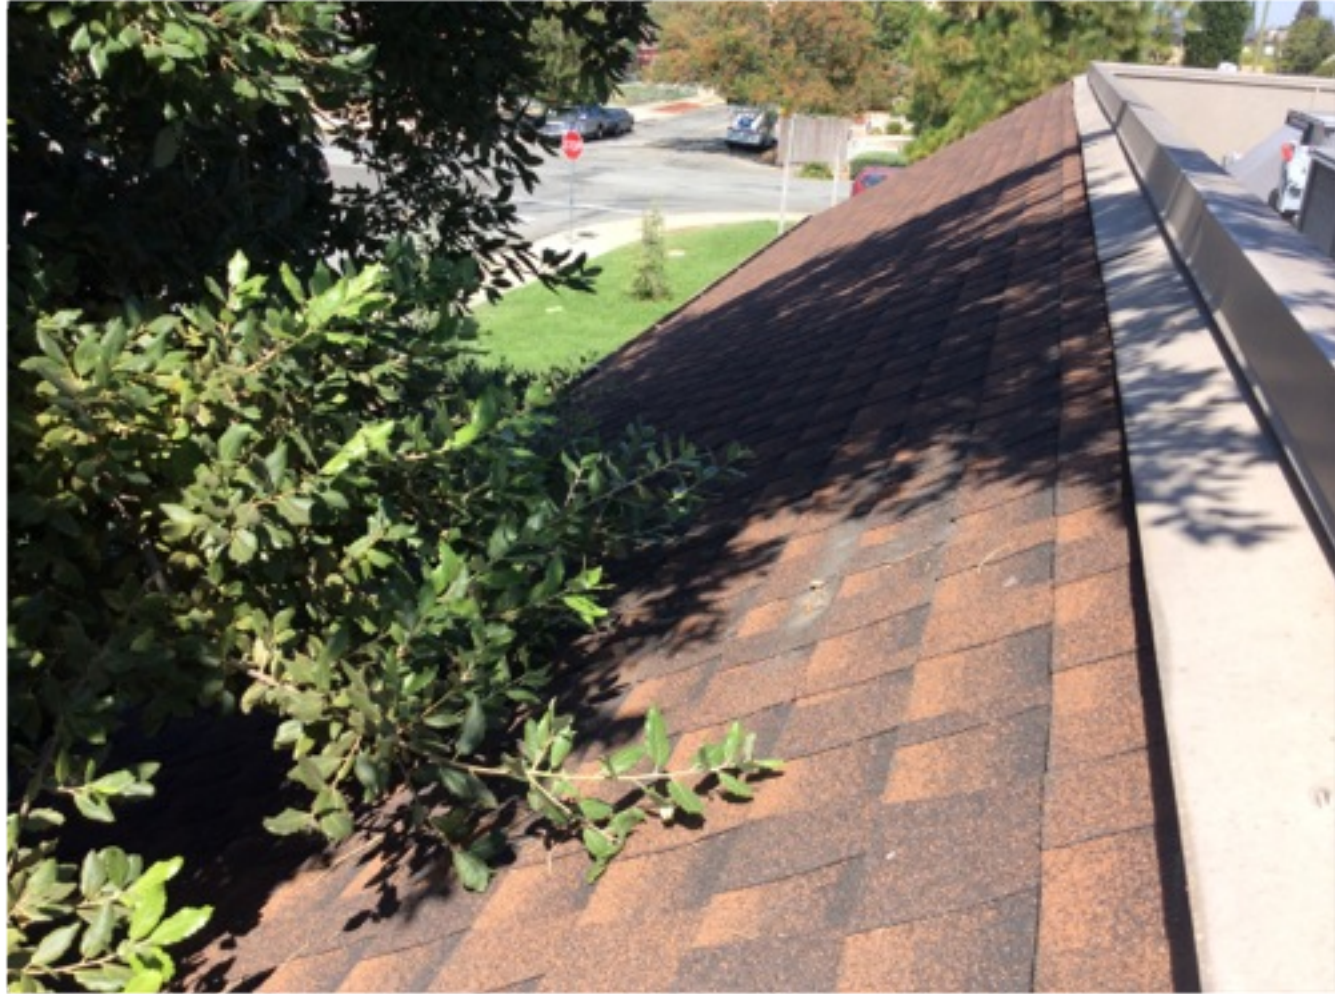
The photo below shows the shingles in great condition.

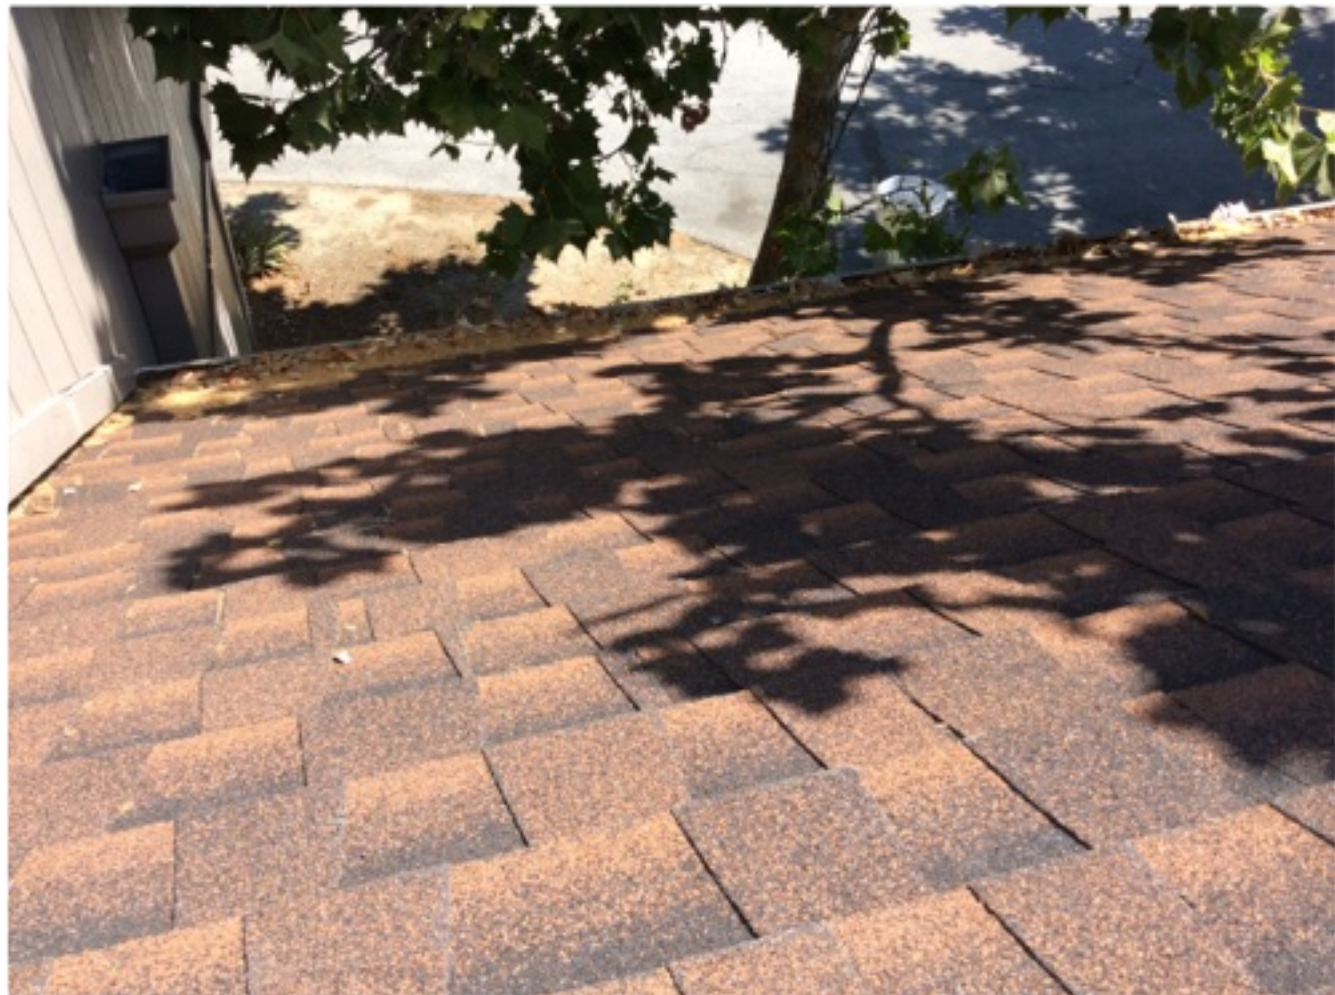
The photo below shows the gutters and drainage blocked.

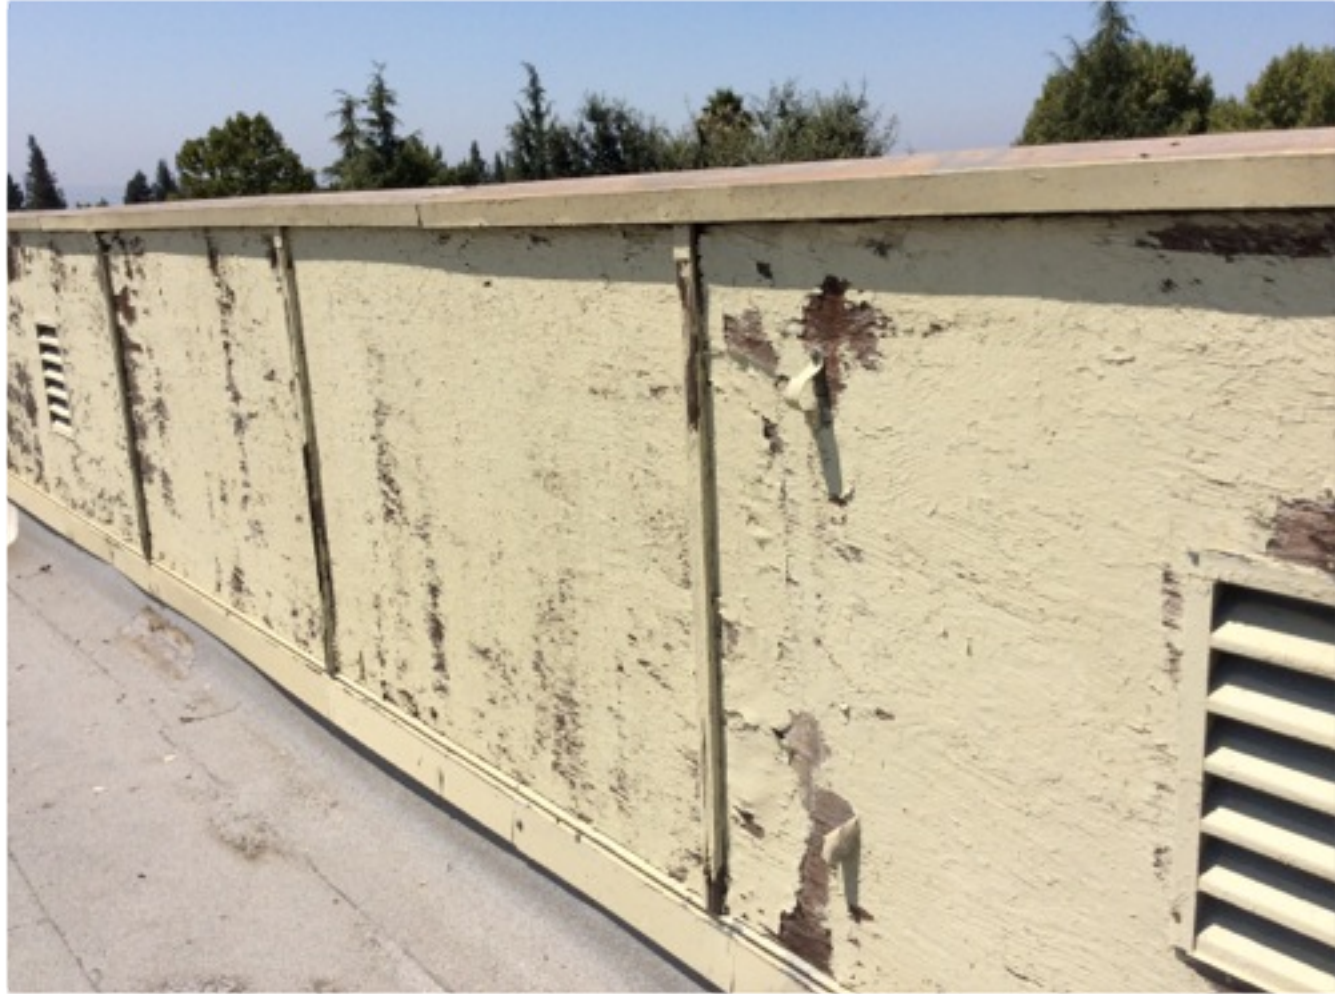
ADDITIONAL NOTES
 BUR SYSTEM IS IN POOR CONDITION AND MAY COMPROMISE SHINGLE SYTEM IF NOT REPLACED WITHIN A COUPLE OF YEARS.

The photo below shows the walls in bad shape.

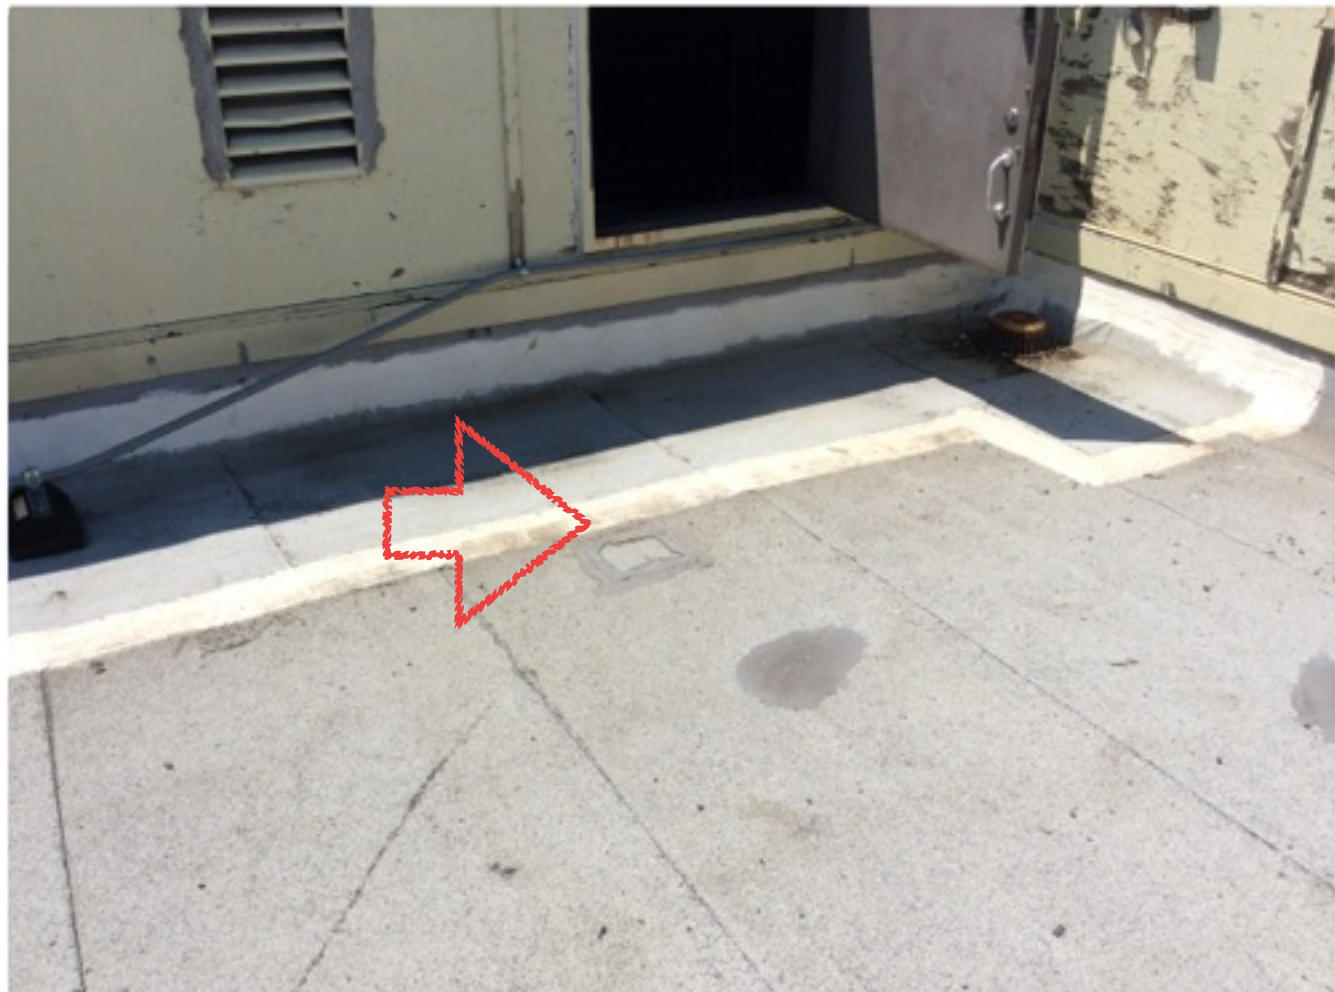
The photo below shows signs of leaking.

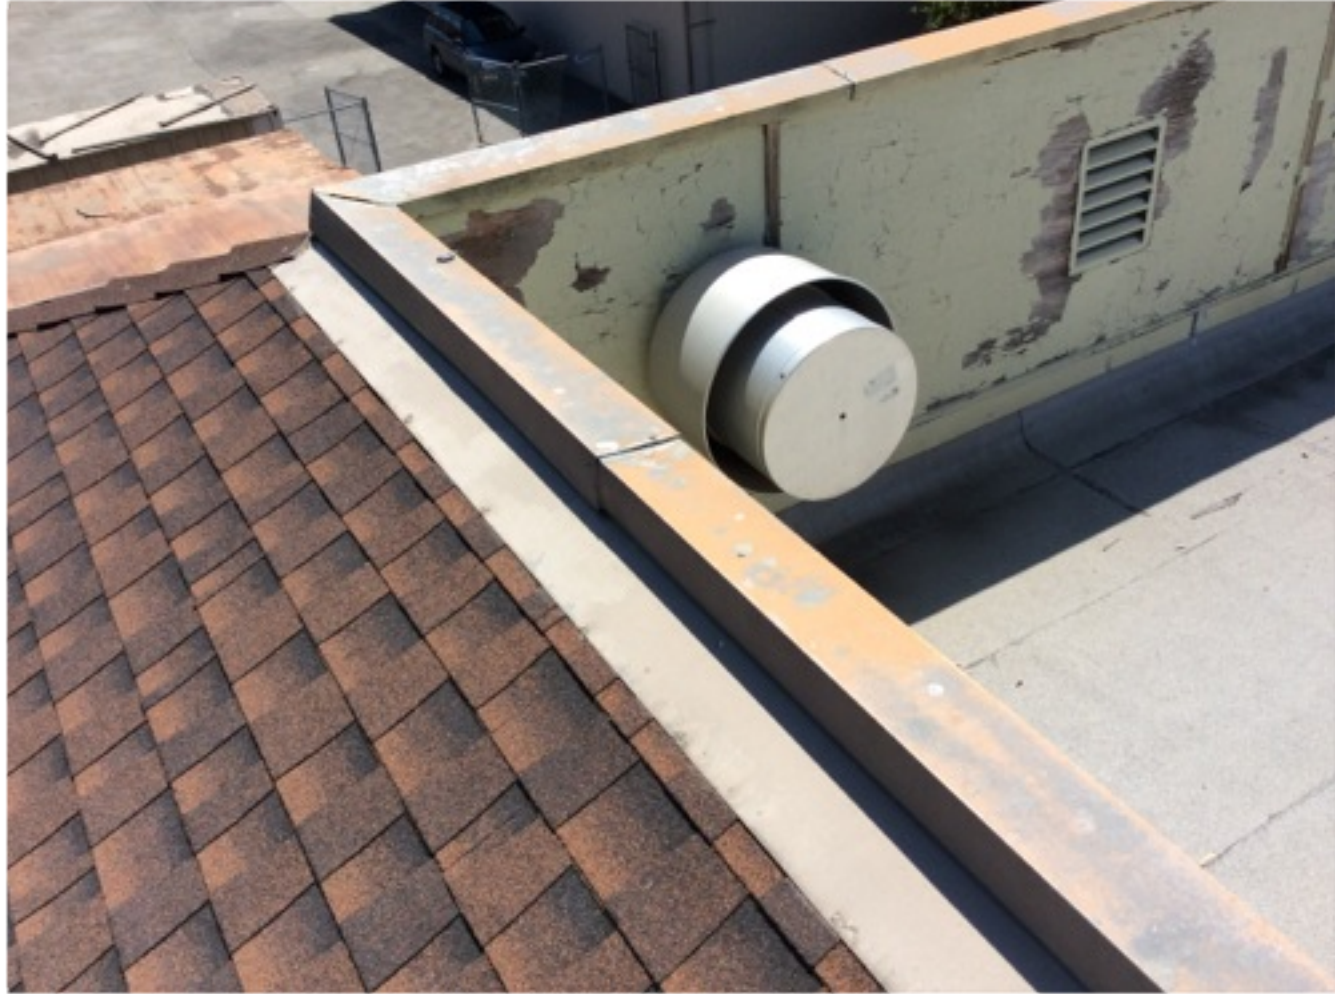
The cap flashing needs to be replaced with the reroof of the BUR system.

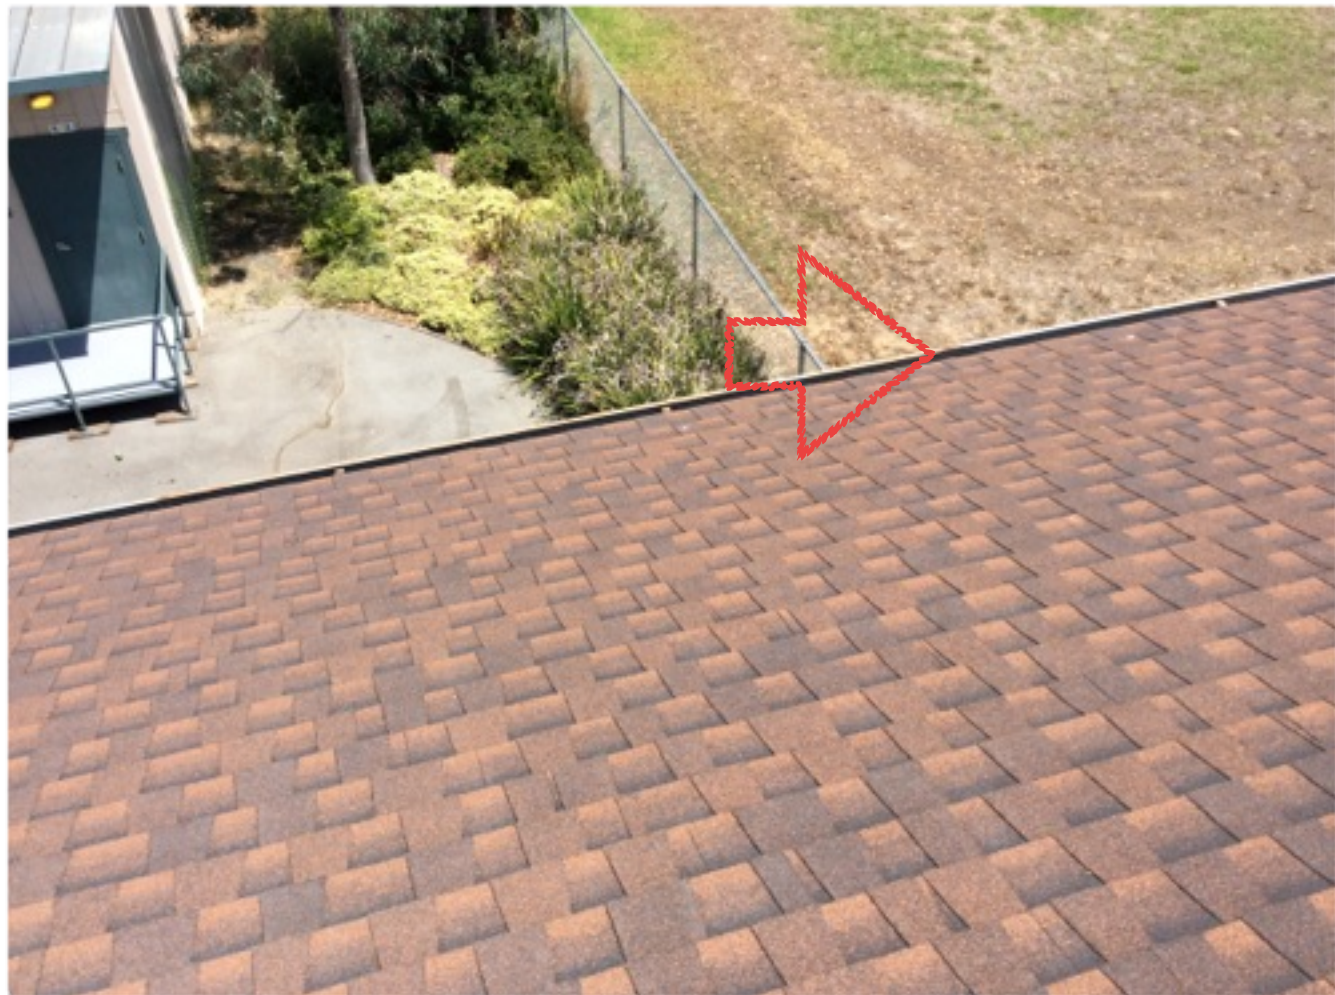
ADDITIONAL NOTES
 THE SHINGLE SYSTEM IS DOING WELL. THE GUTTERS ARE RUSTING AND NEED TO BE COATED. DO AT THE SAME TIME AS THE REROOF.

The photo below shows the gutters rusting.

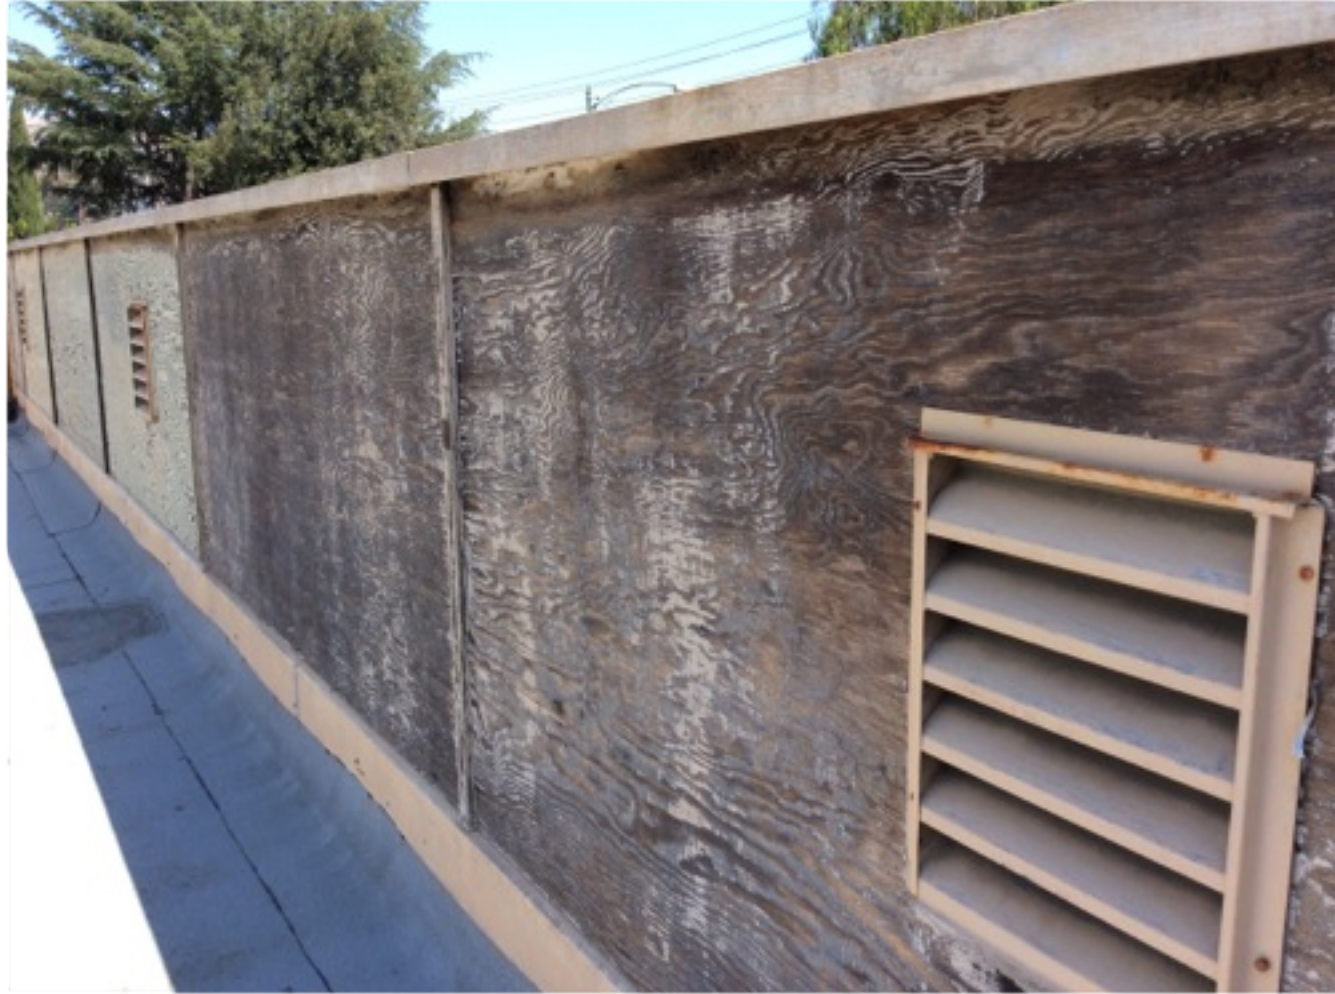
ADDITIONAL NOTES
 DUE TO THE CONDITION OF THE WALLS AND THE WALL FLASHING, AND THE AGE OF THE ROOF, IT WOULD BE OUR RECOMMENDATION TO REPLACE IT AT THE SAME TIME AS F AND G. HOWEVER WITH THE ABOVE REPAIRS IT COULD BE DELAYED FOR A FEW YEARS.

The photo below shows the walls in bad shape.

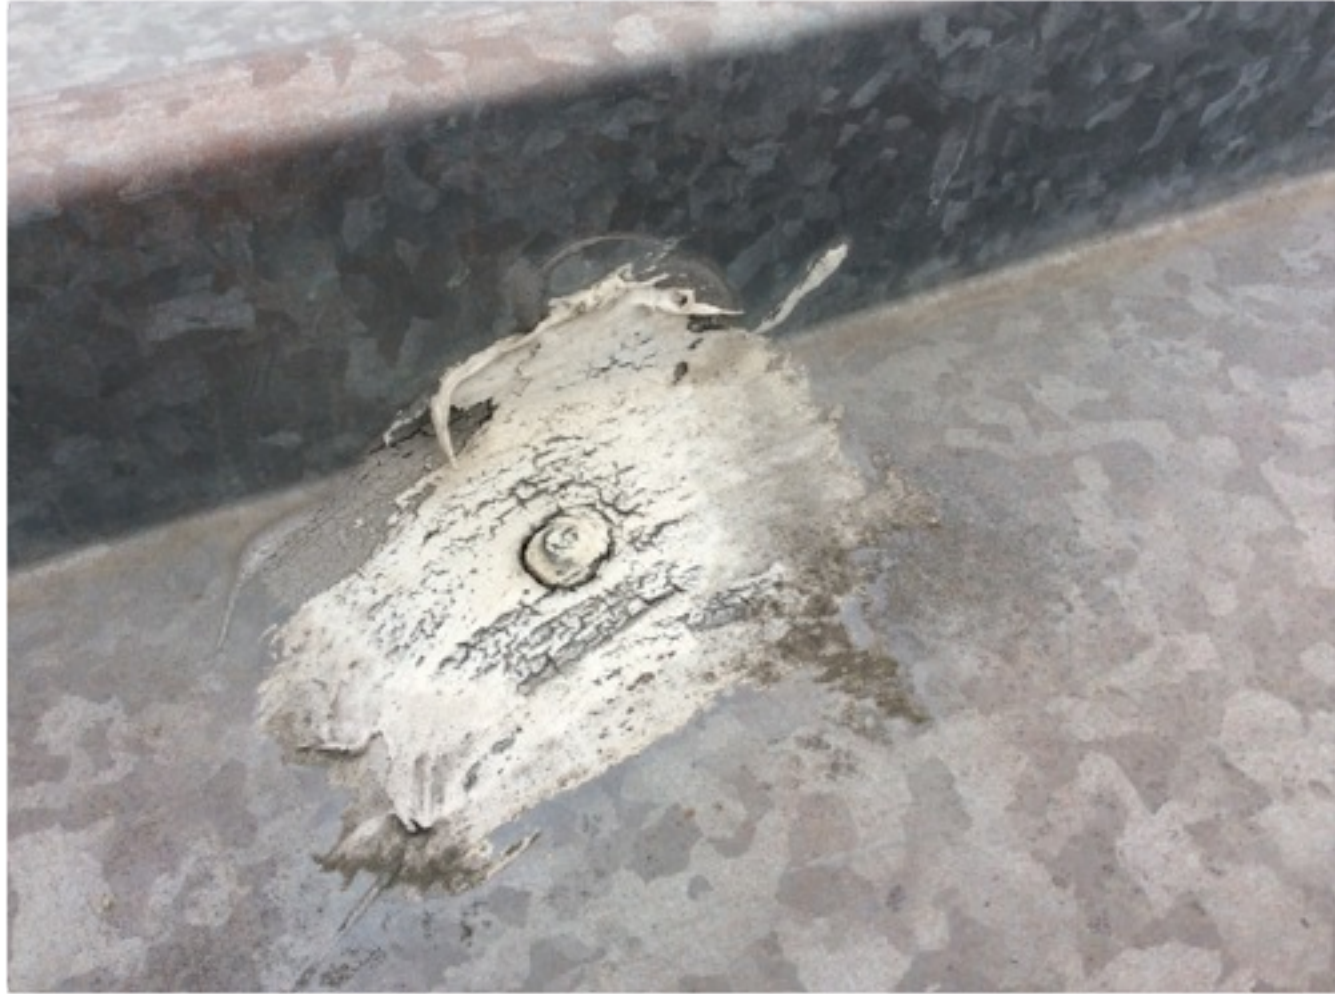
The photo below shows the fastener sealant failing on roof B.

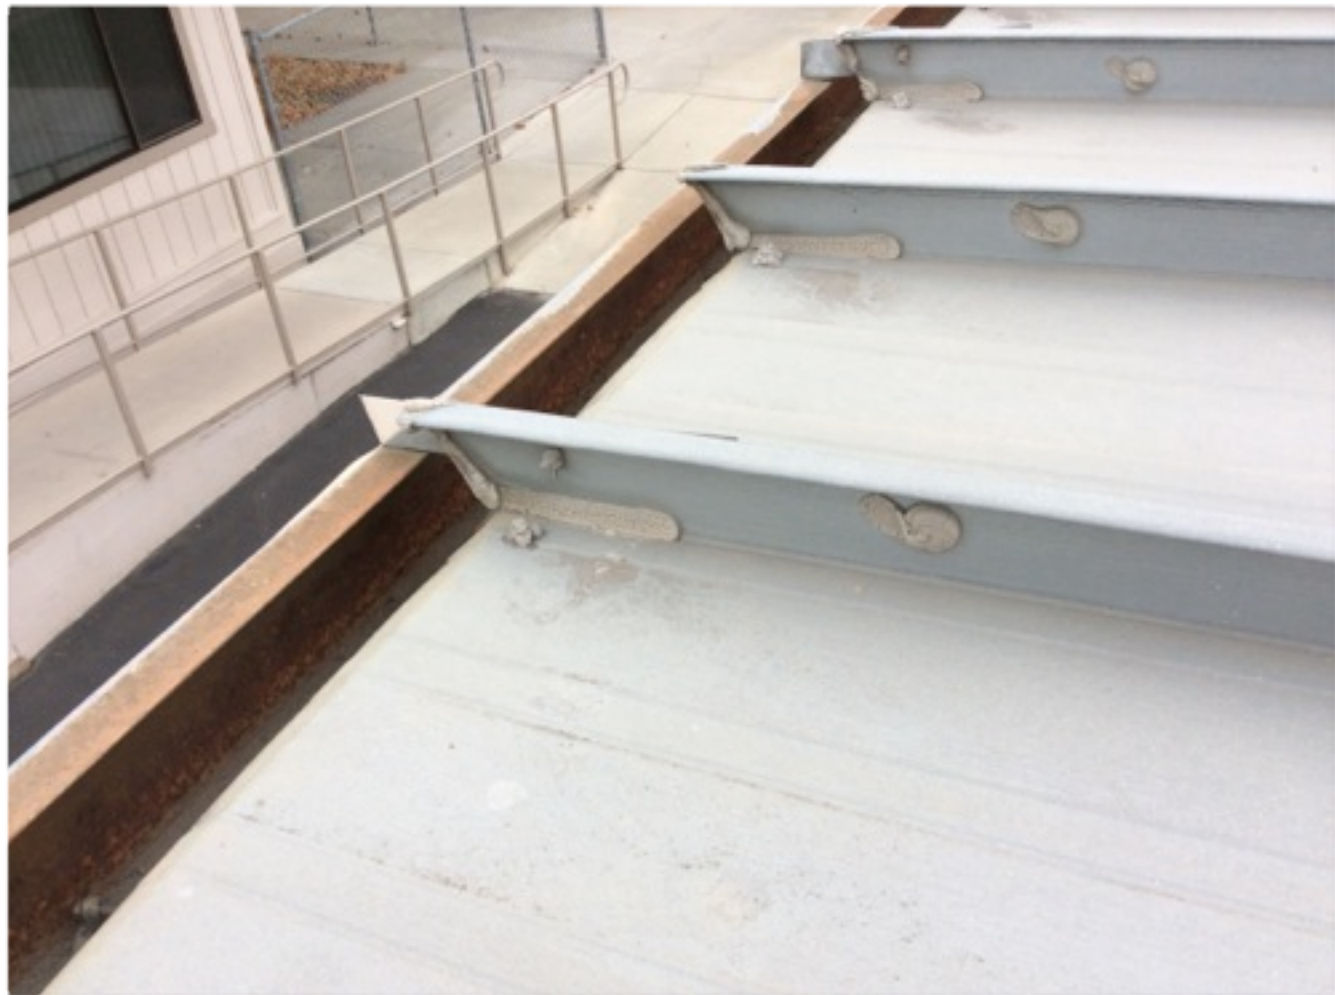
The photo below shows the gutter and edge detail rusting - treatment is needed.

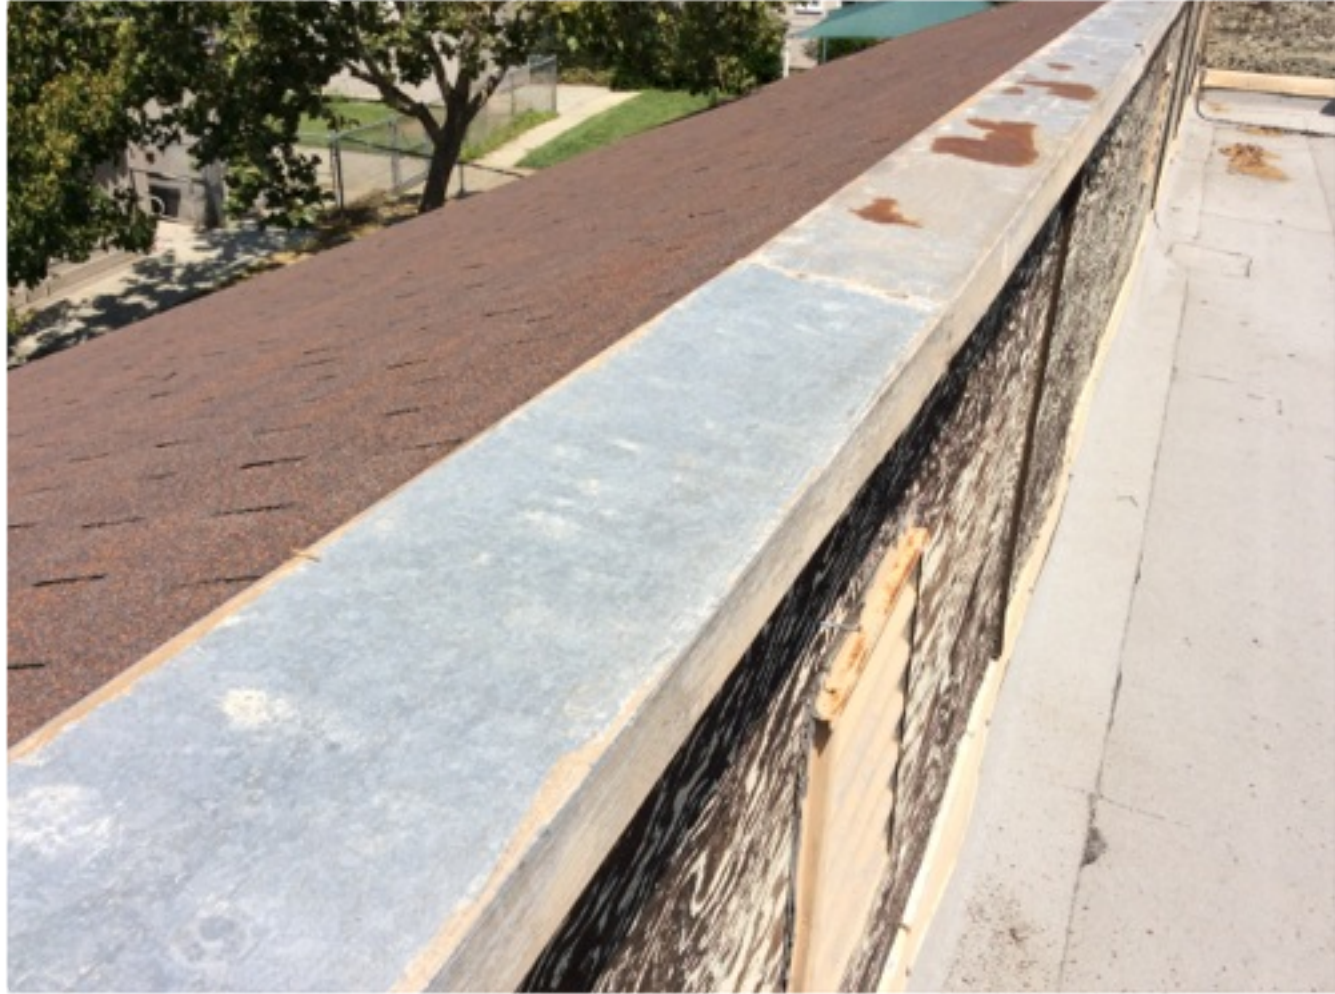
The cap flashing needs to be replaced with the reroof of the BUR system.

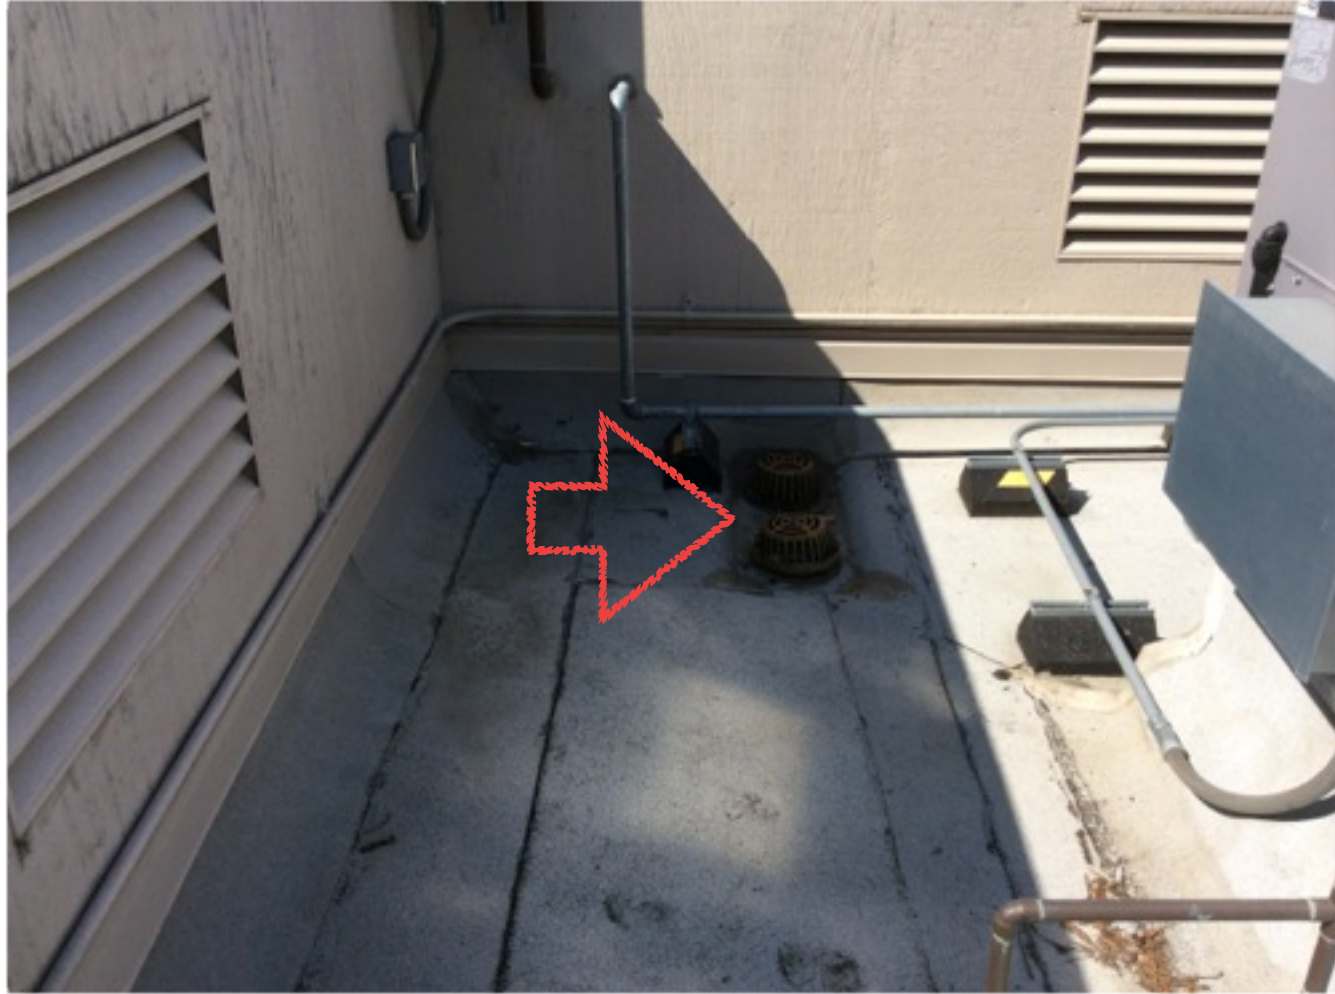
The photo below shows the drain area in good condition with no ponding.
