BUILDING INFORMATION	
FACILITY	Foothill HS
DATE	August 18, 2014
BUILDING	Admin BUR
ROOF SQ FT	1,500

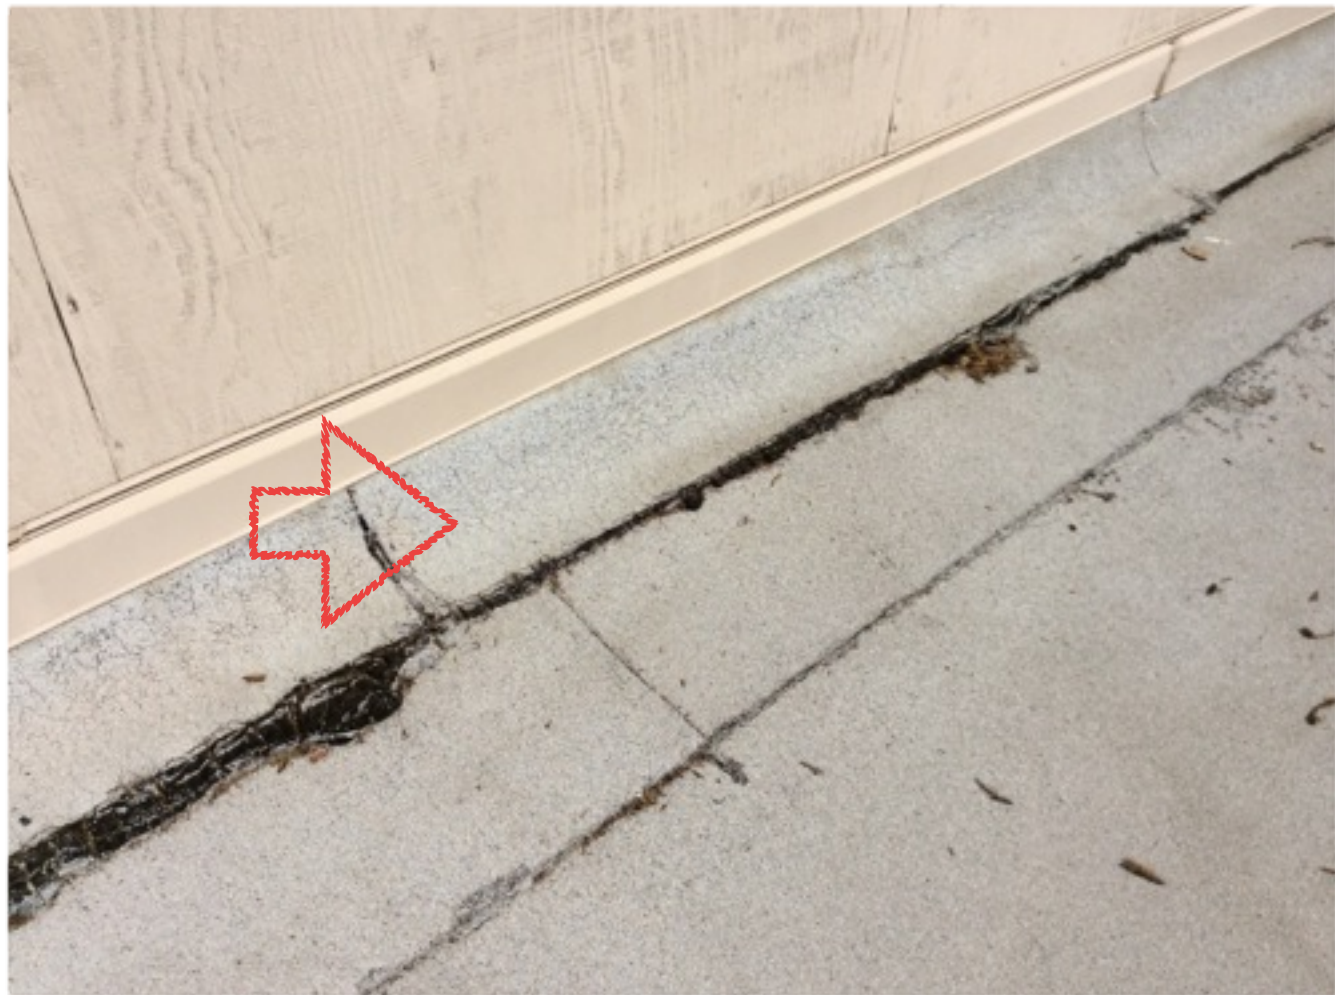
The photo below shows the beginning of some craze cracking - showing some age.

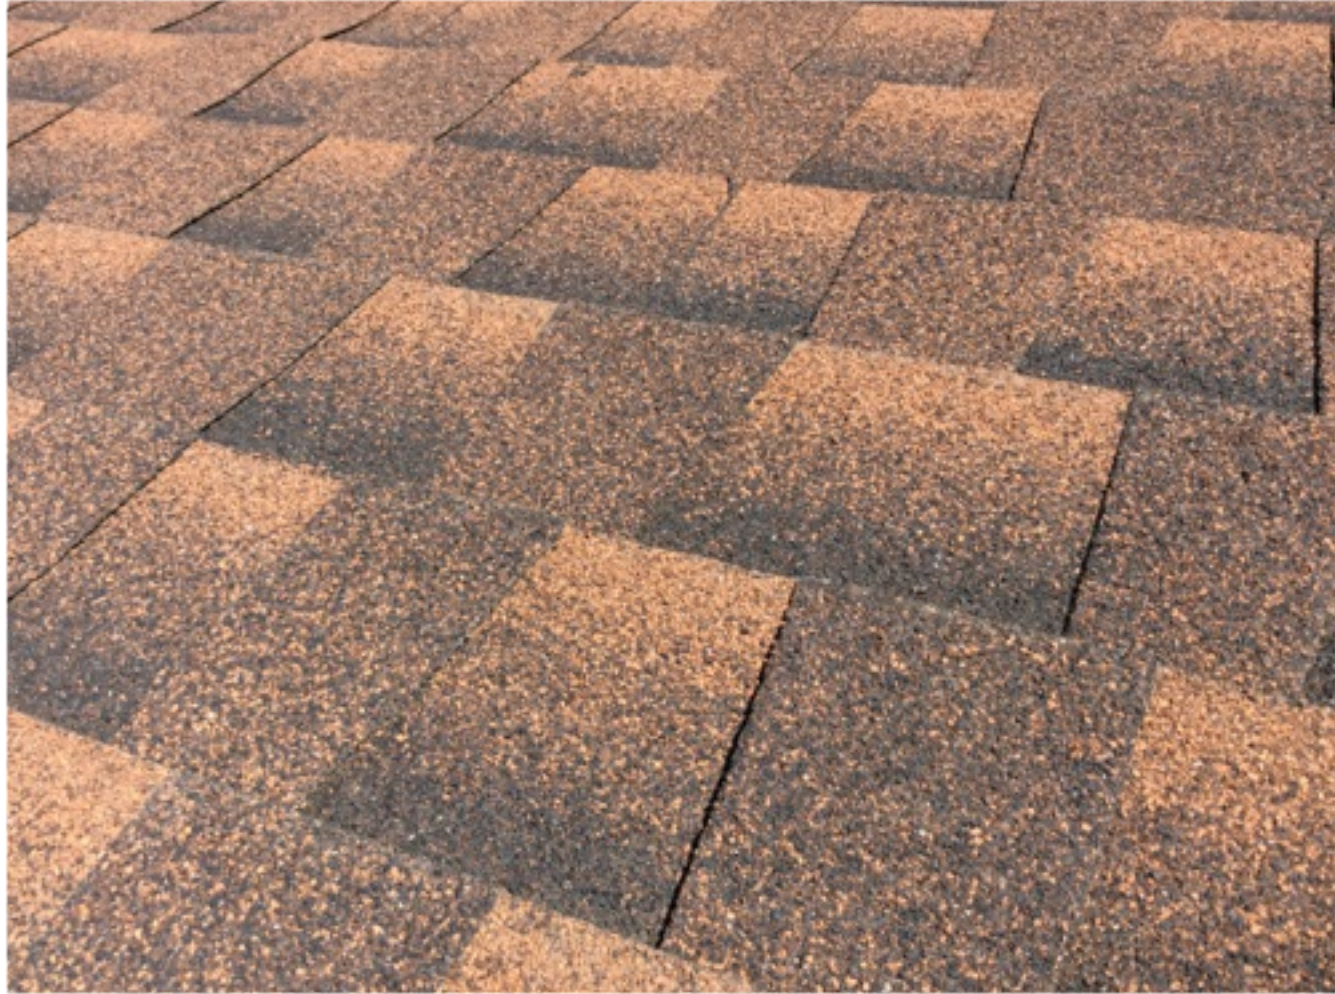
The photo below shows the shingles in great condition.

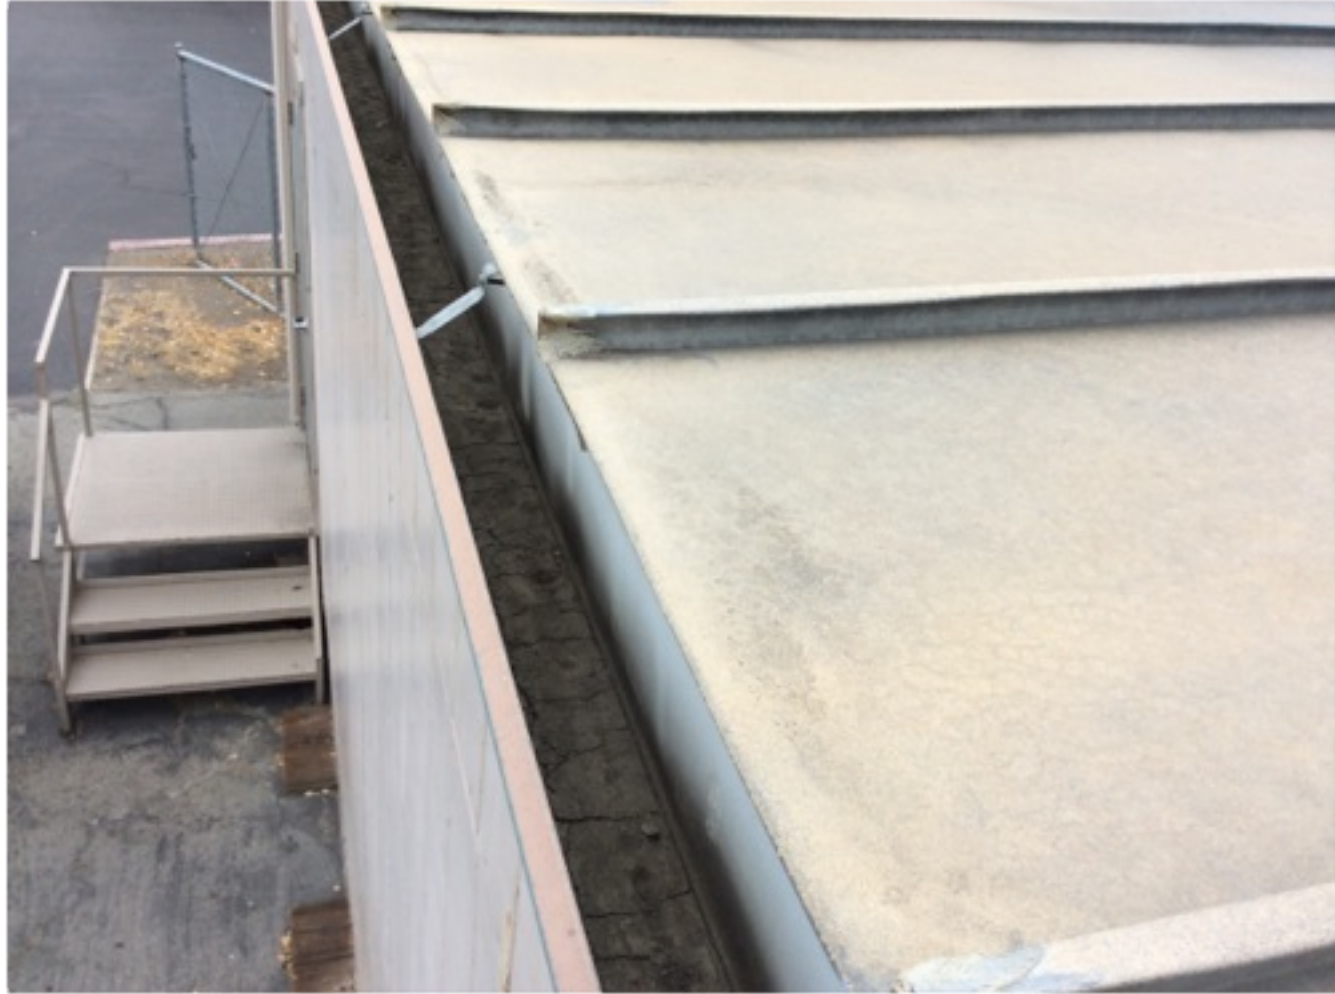
The photo below shows the gutter in fair condition.

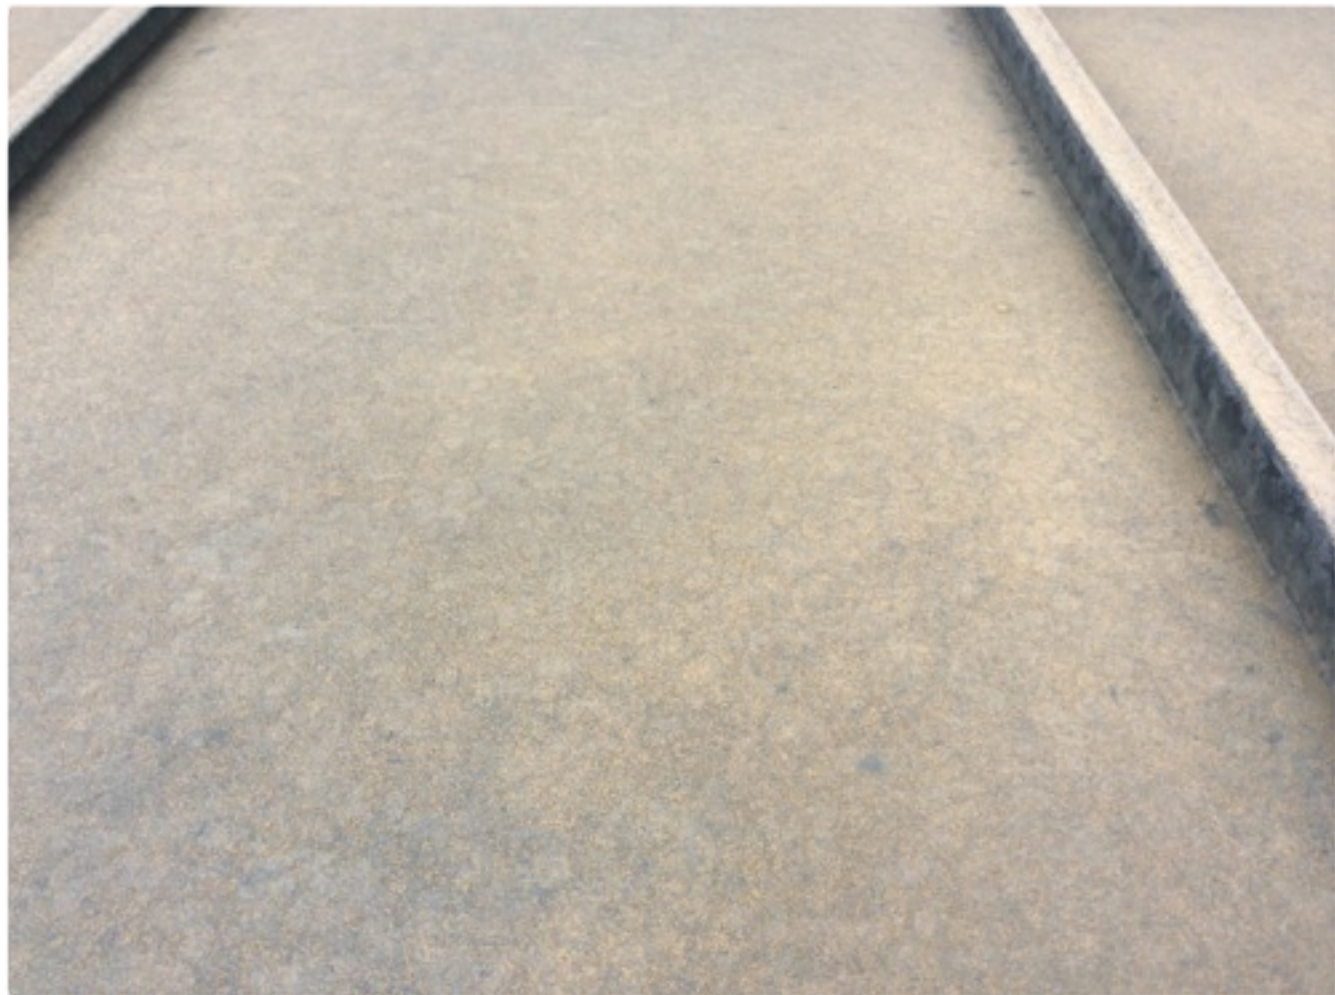
The photo below shows the roof coating as almost completely worn off.

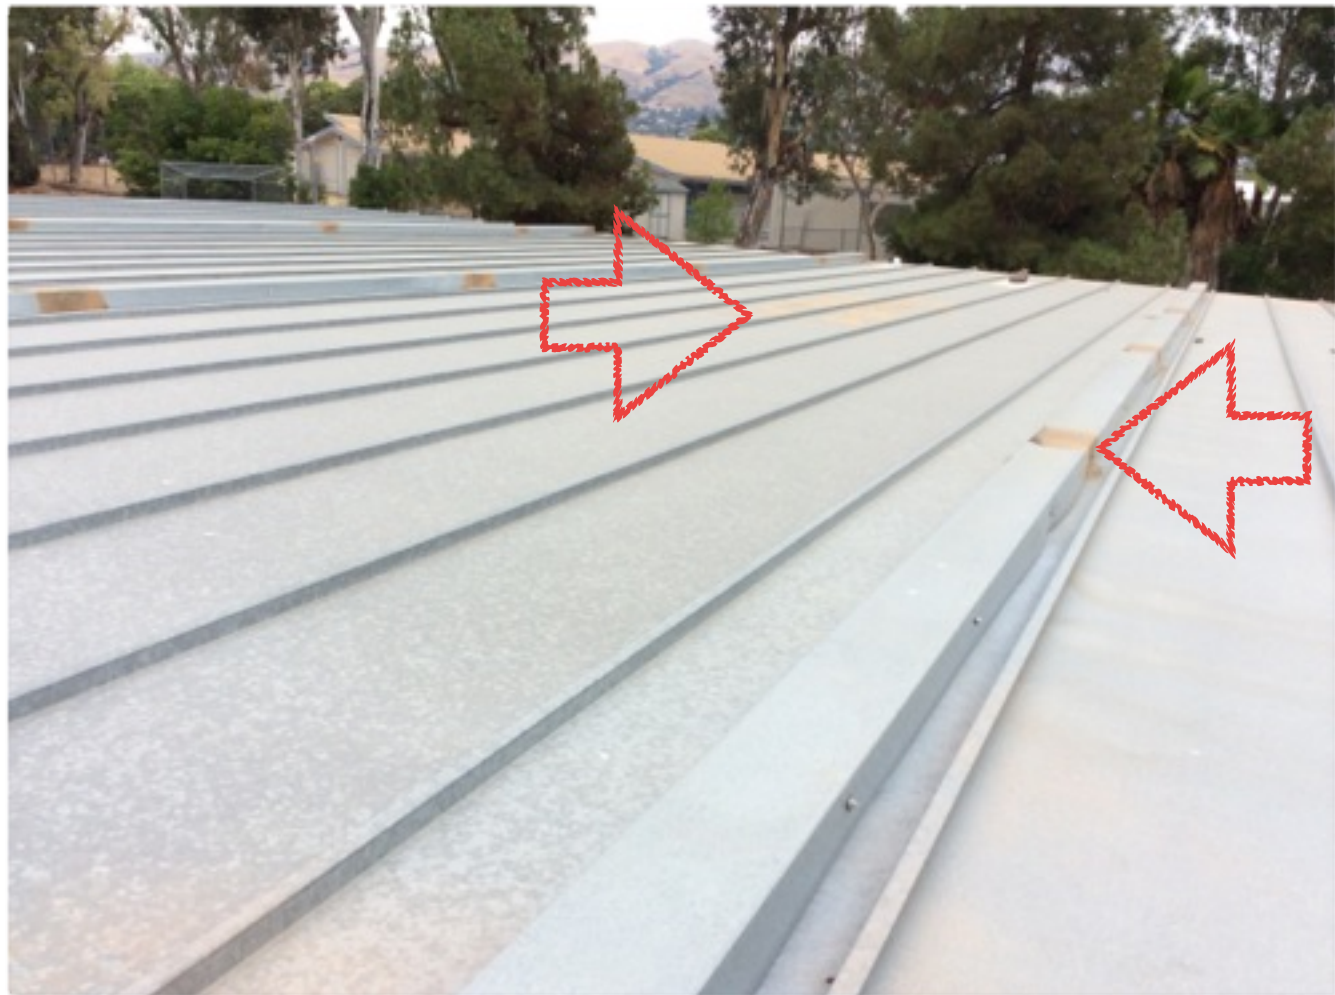
The photo below shows the panels rusting.

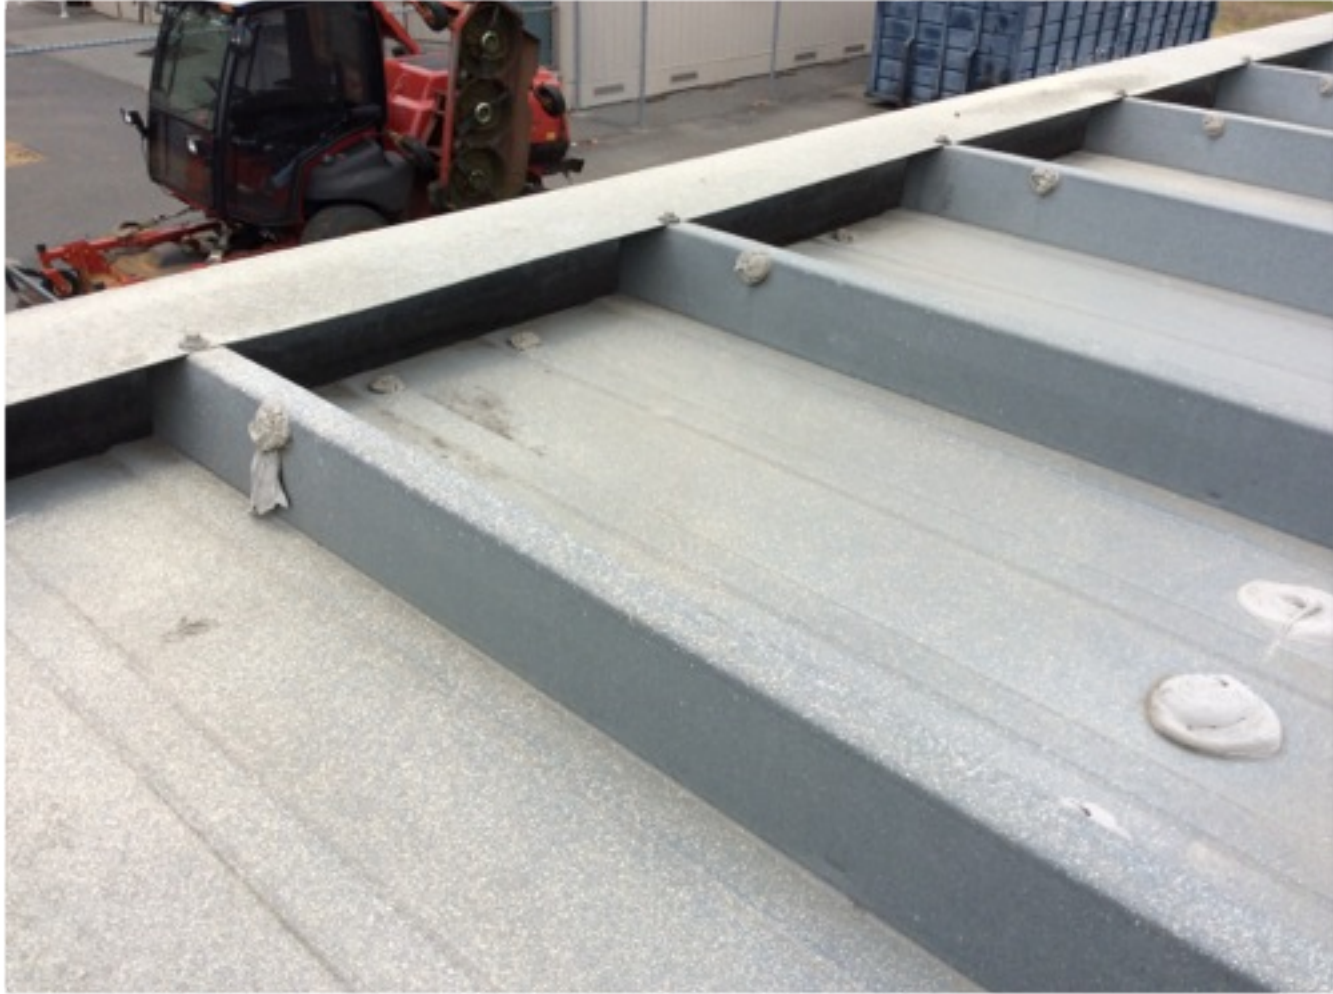
The photo below shows the fastener sealant in tact.

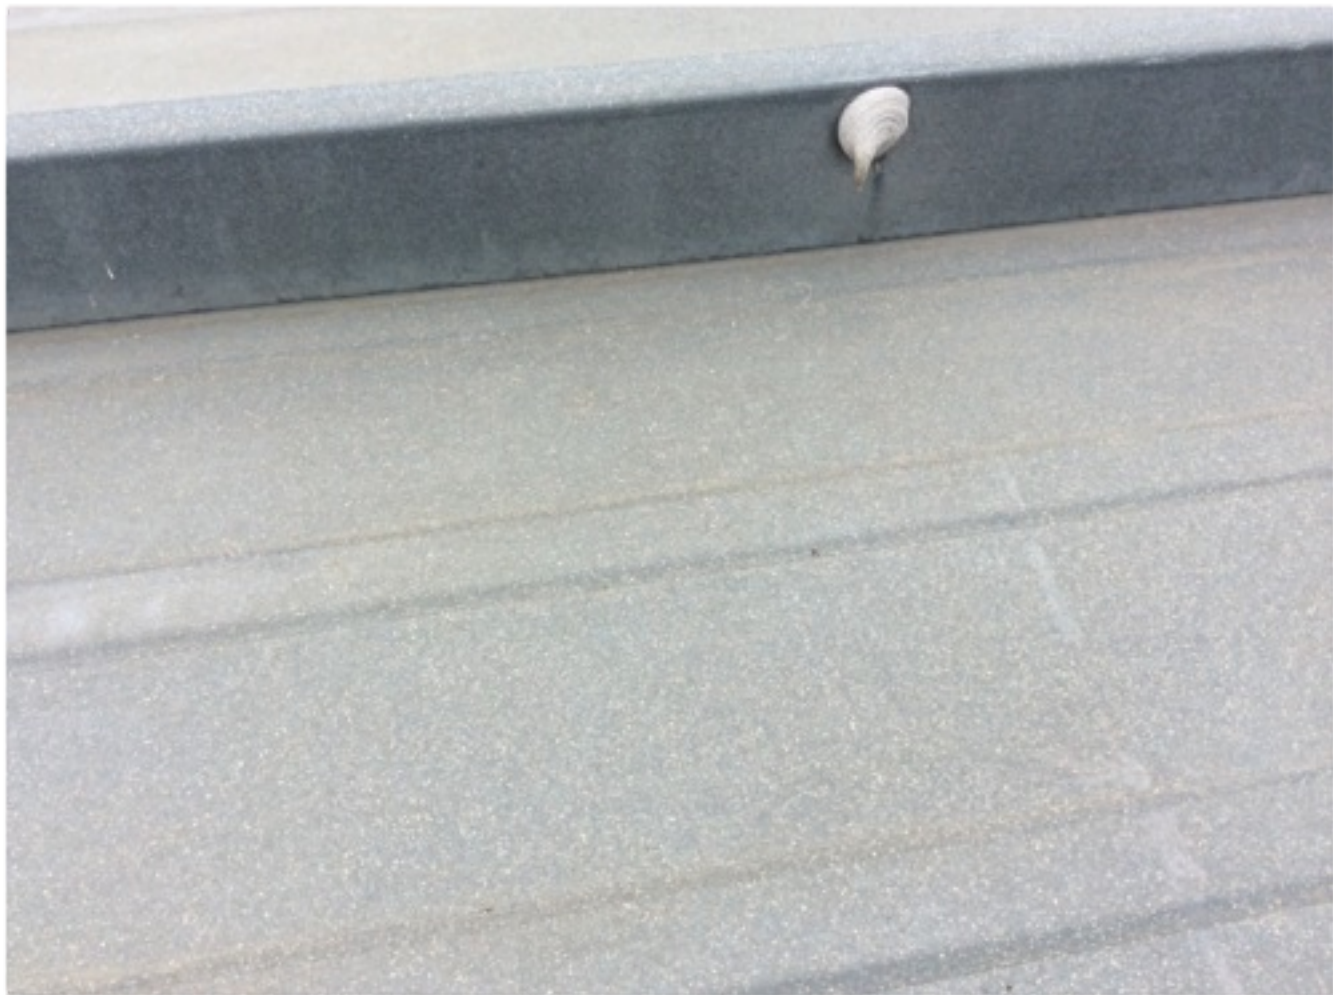
The photo below shows the panels in good shape with no rust.

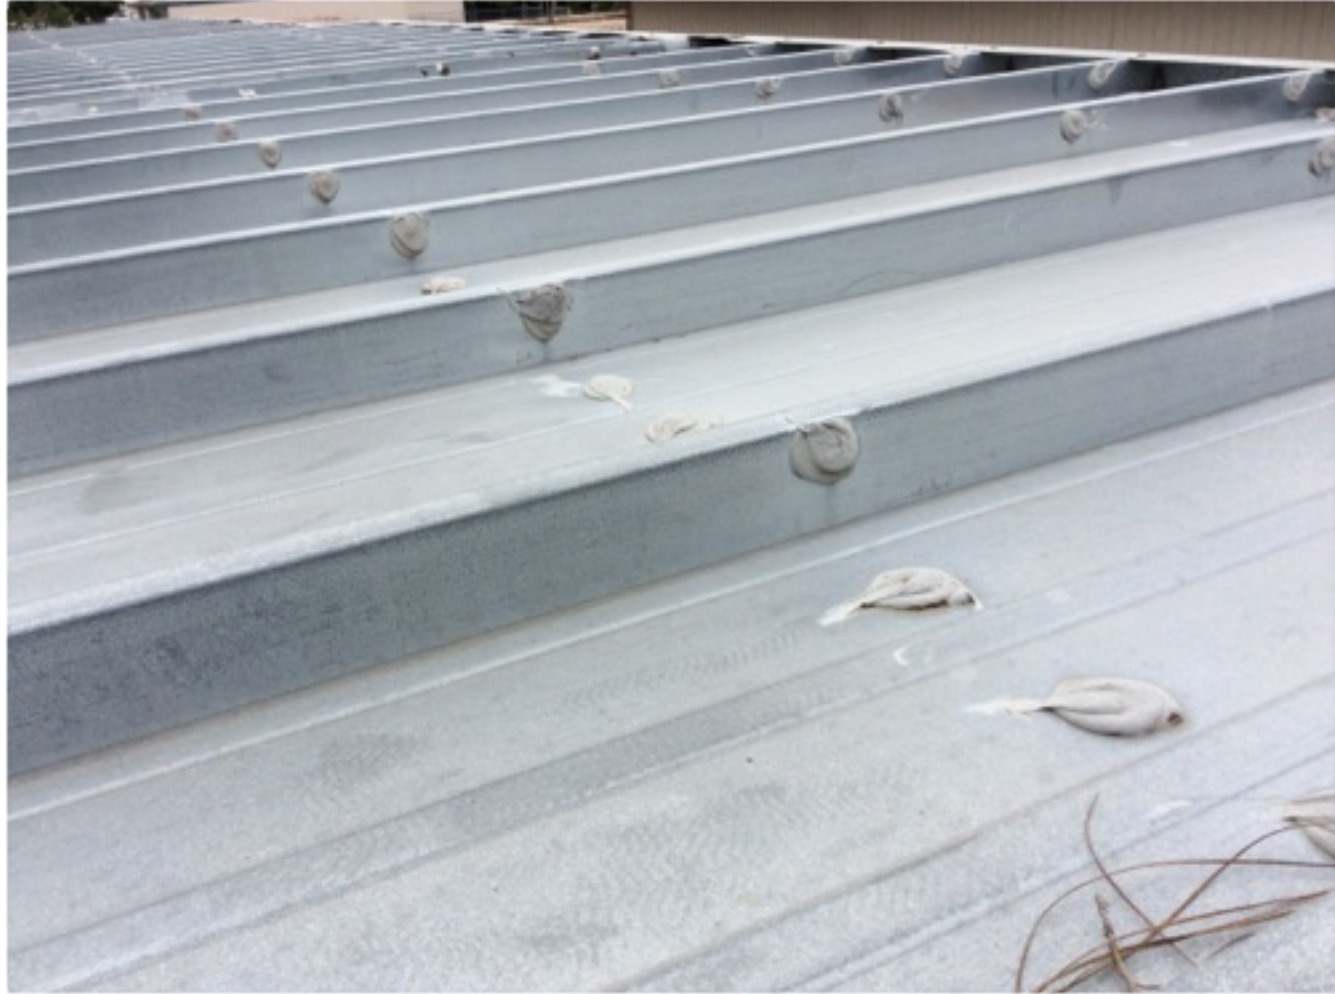
The photo below shows the fastener sealant in tact.

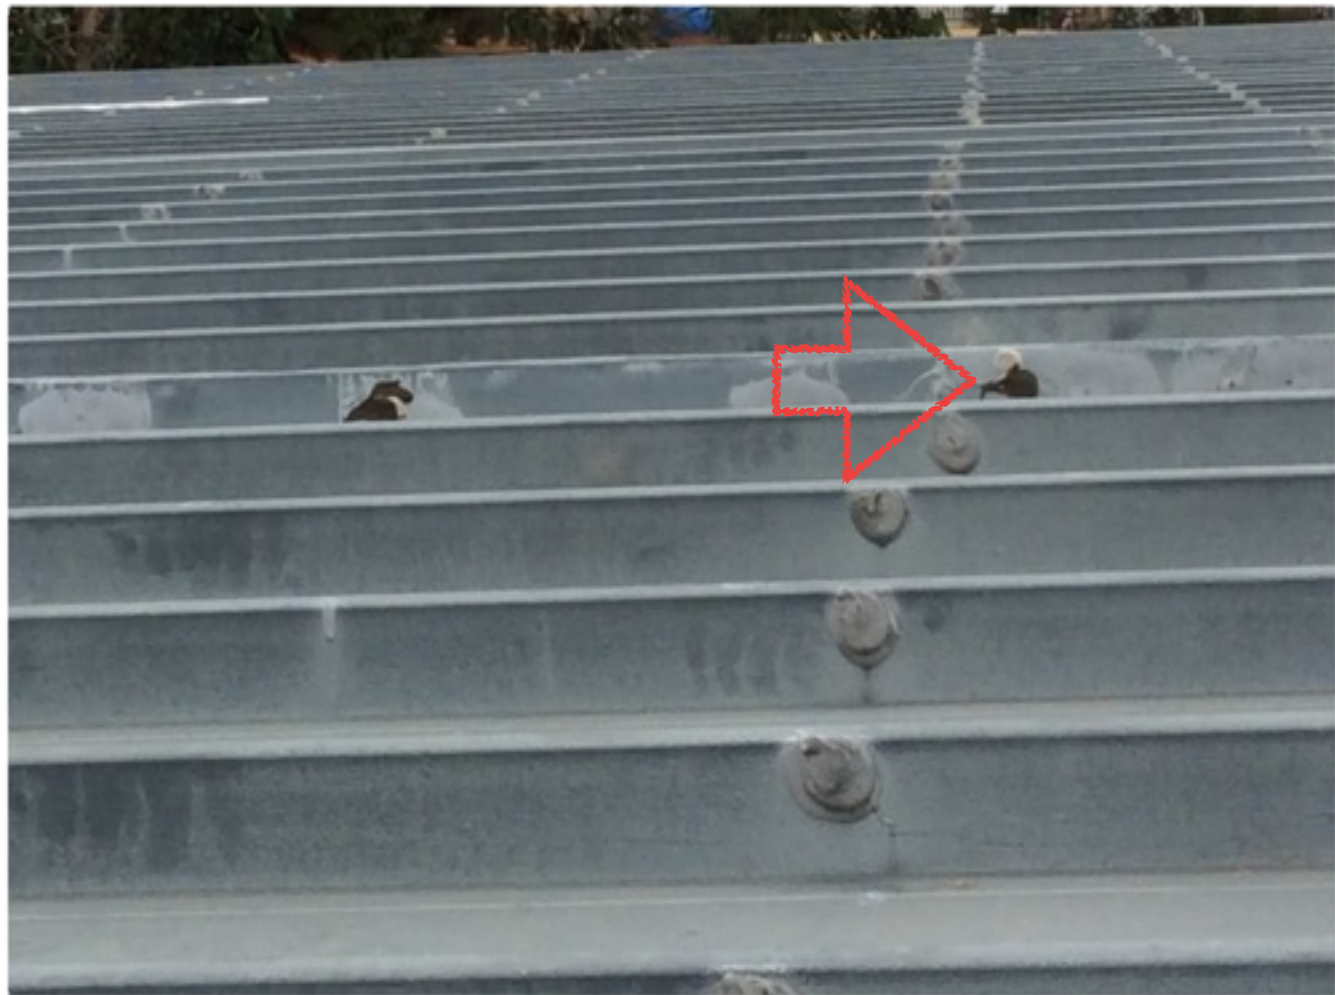
The photo below shows that there has been some problems at the building joints.

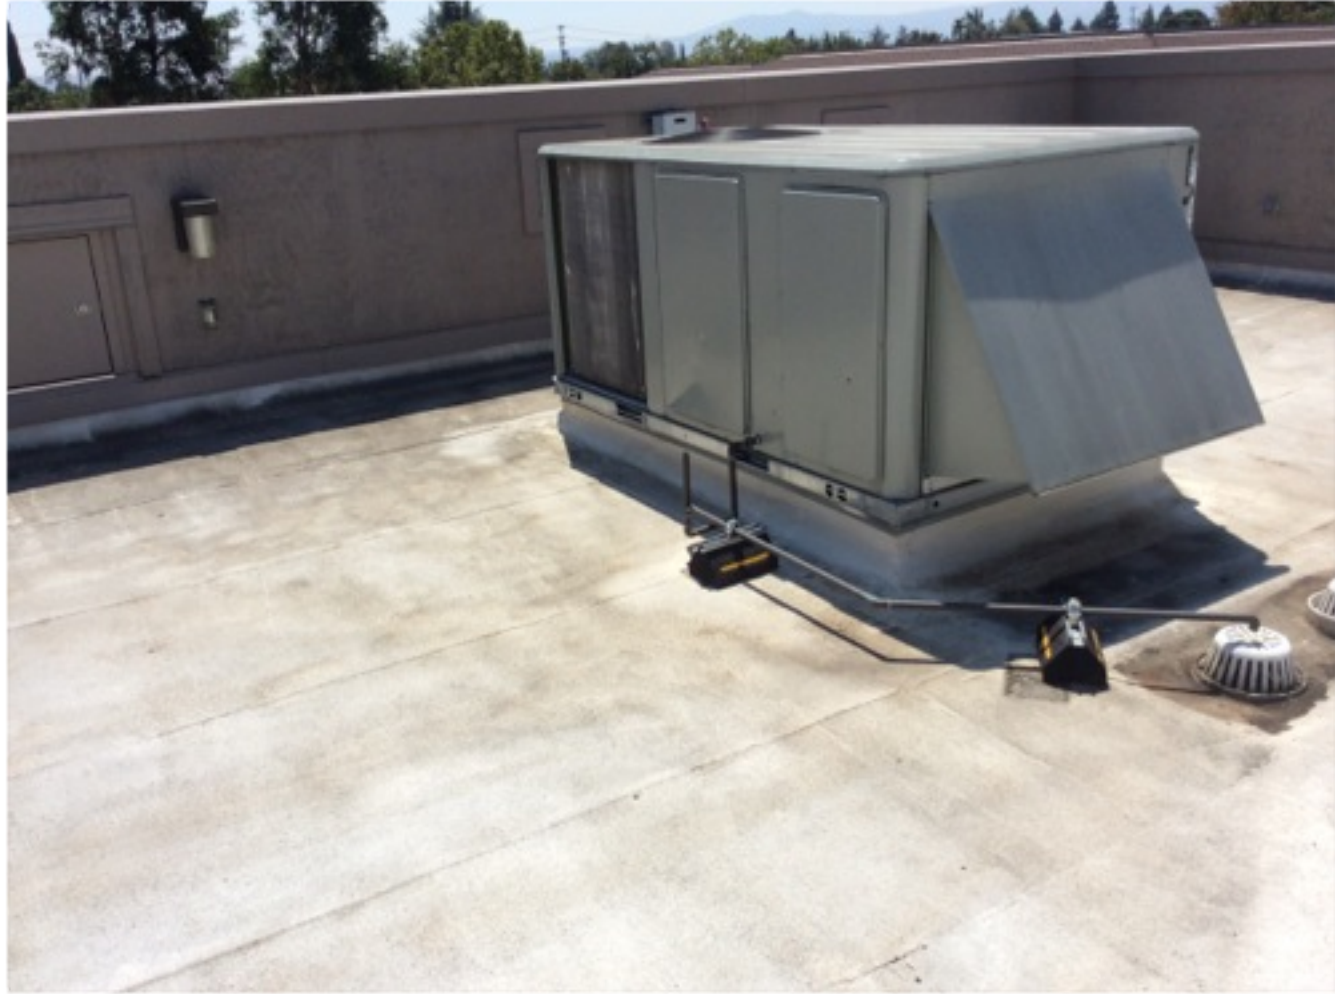
Drainage is doing well.

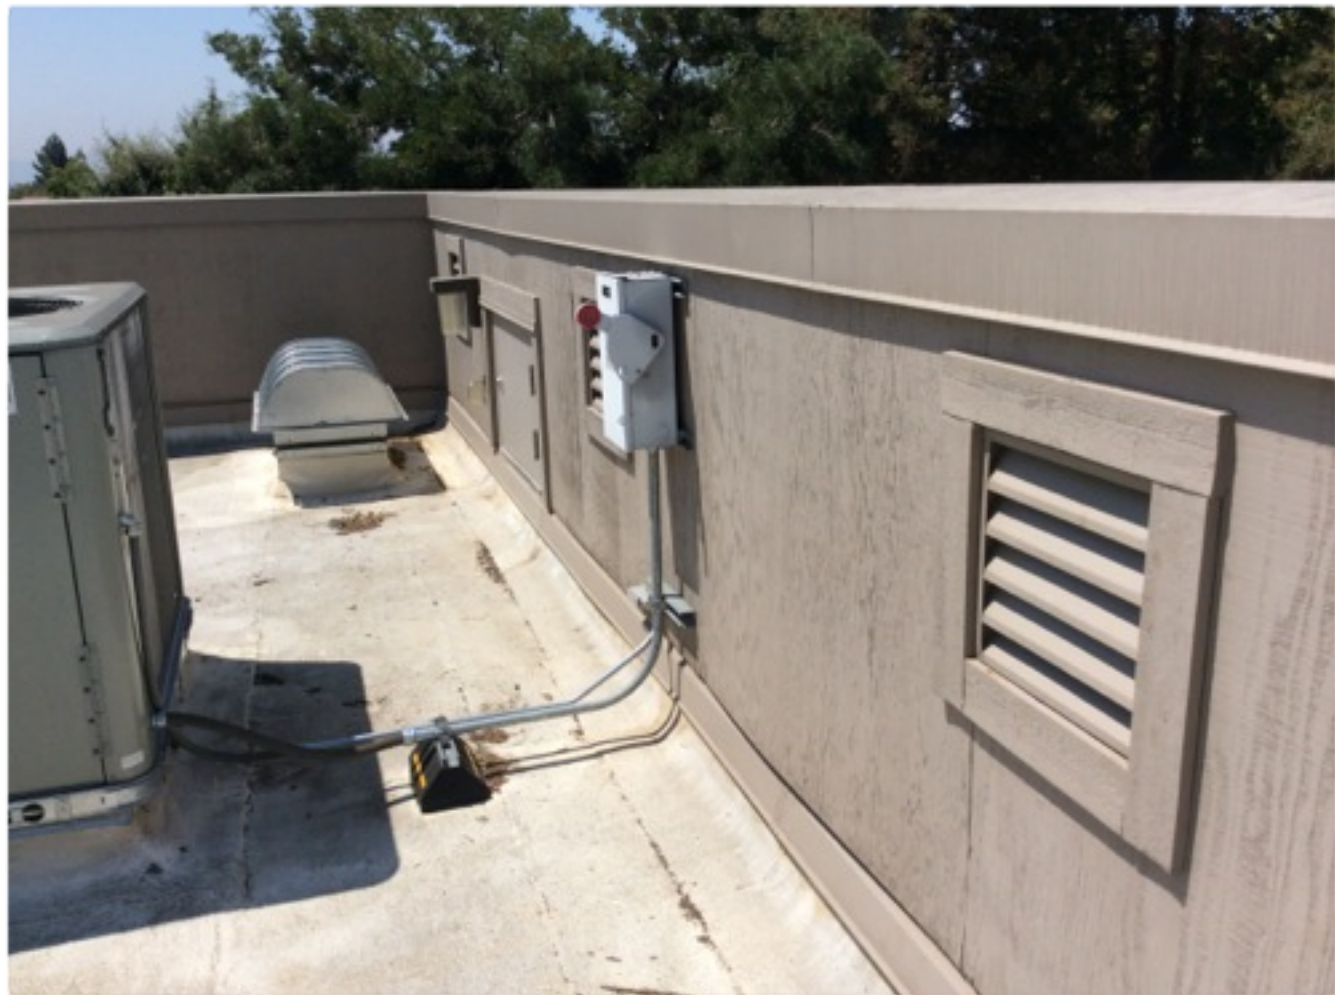
The wall is good shape.

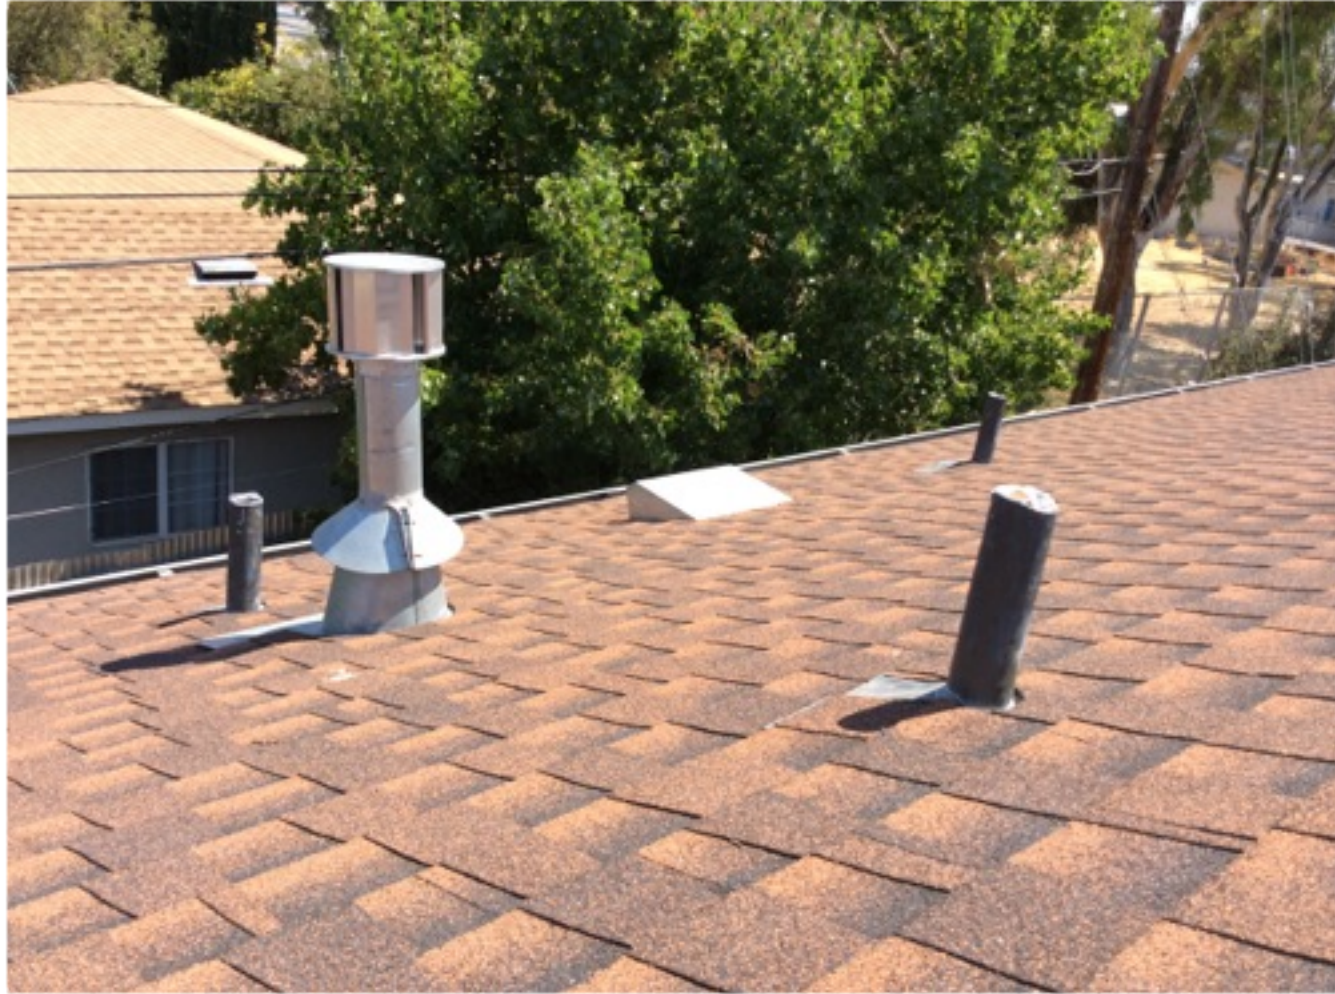
The photo below shows the penetration details in good shape.

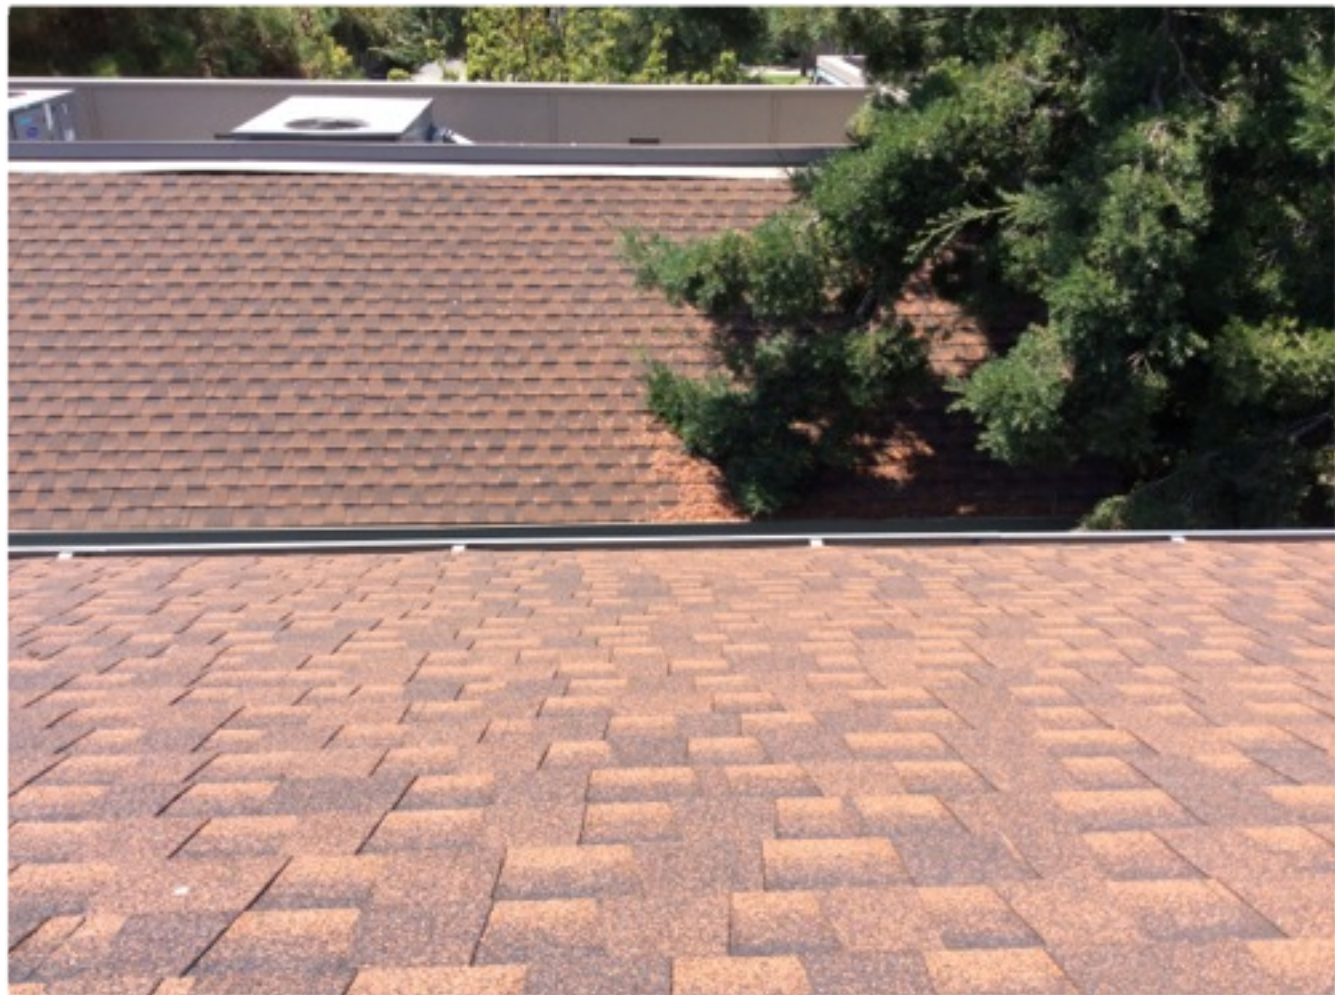
Keep gutters clear of debris.
