BUILDING INFORMATION	
FACILITY	Mt. Pleasant HS
DATE	August 26, 2014
BUILDING	100 Admin, 900 Library, Central Canopy
ROOF SQ FT	30,000

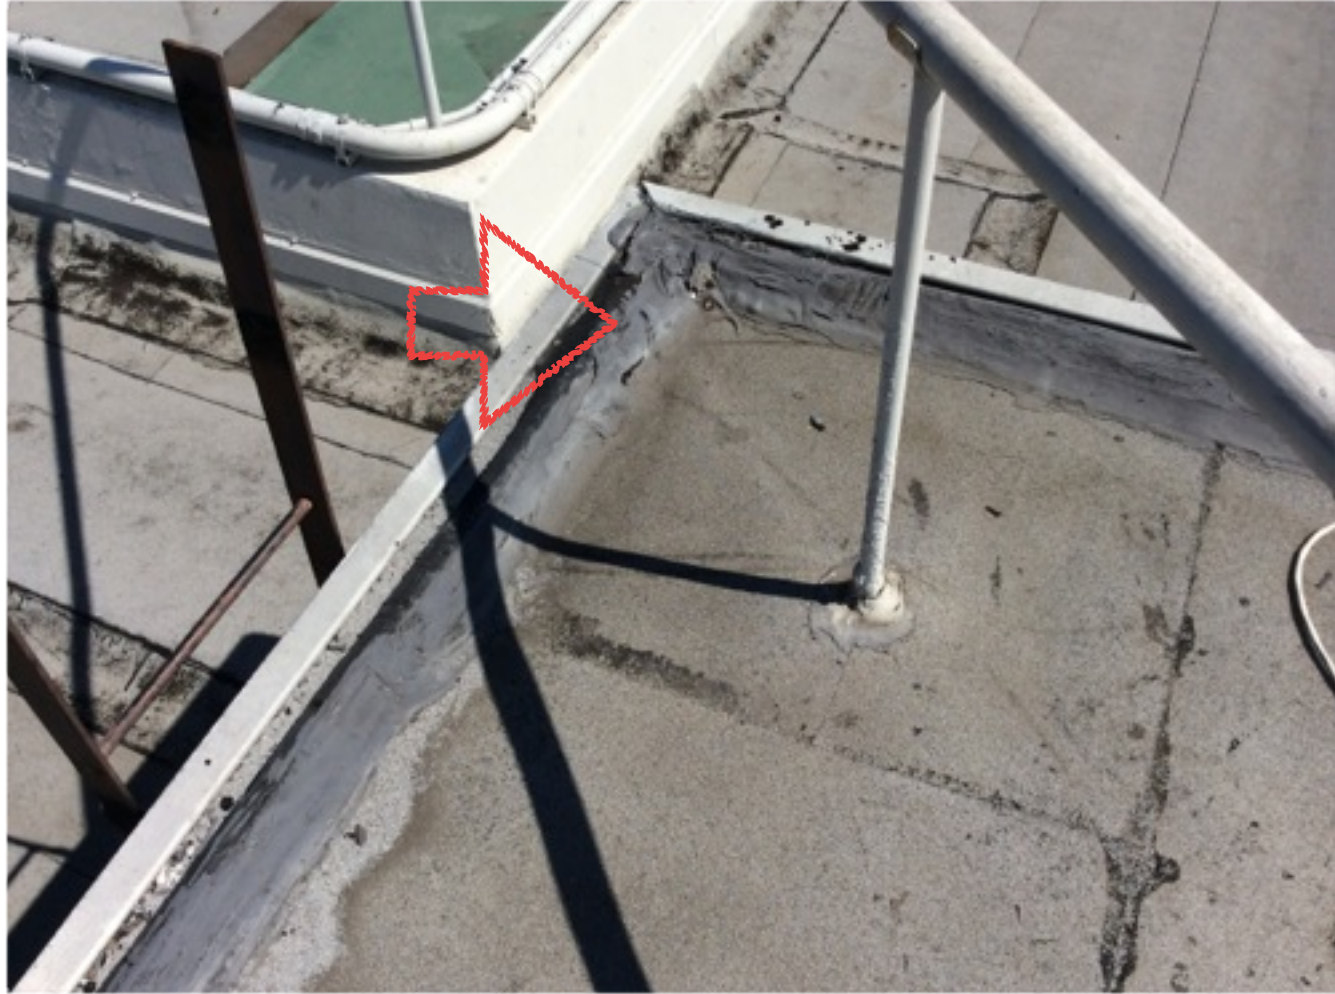
The photo below shows extensive repairs applied to the 900 building roof.

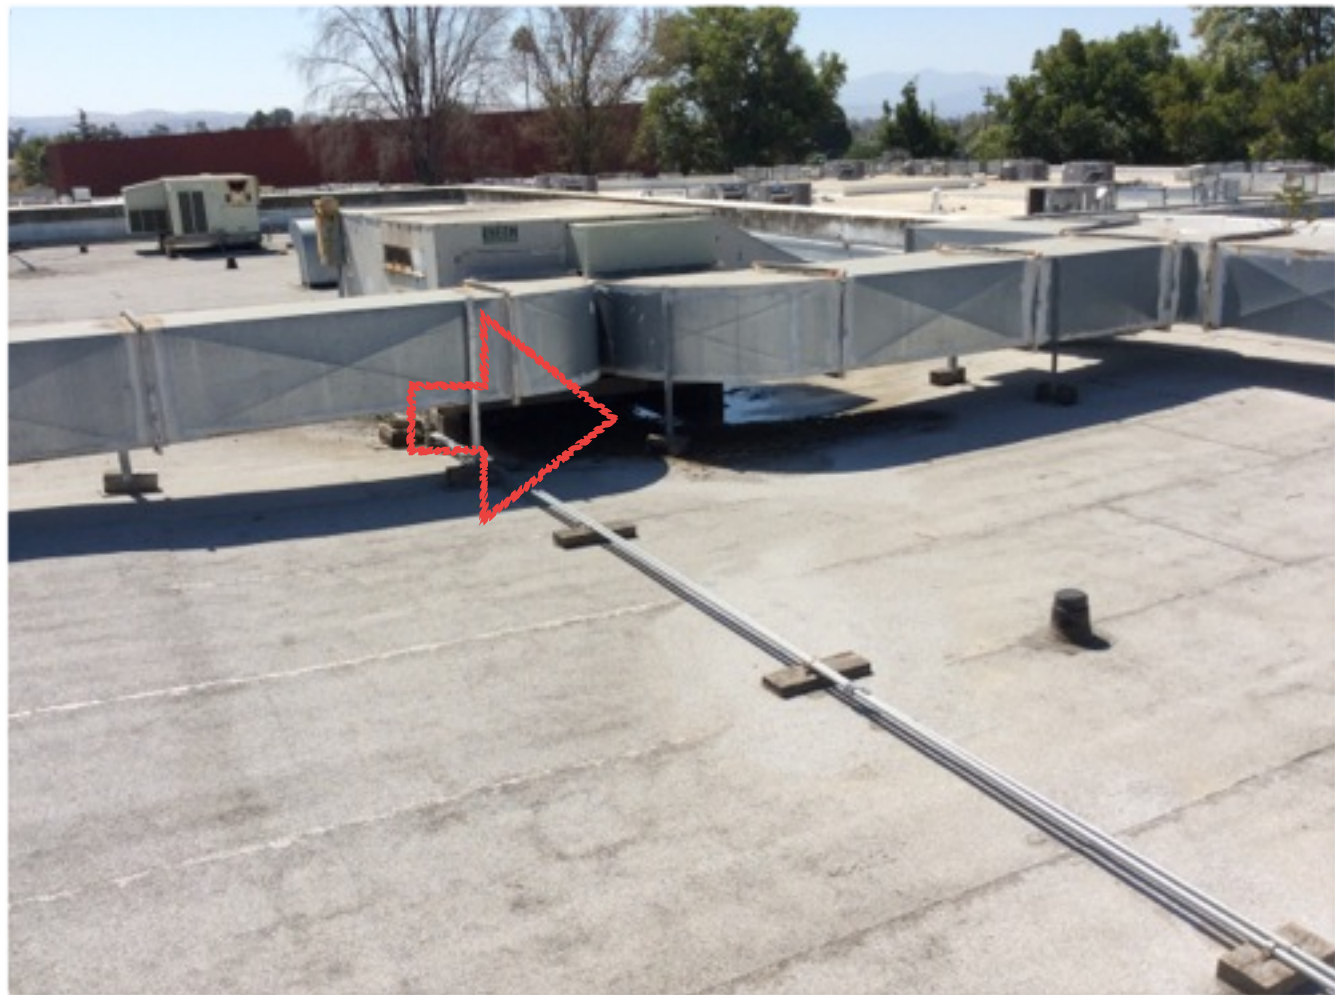
The photo below shows AC units that need repair.

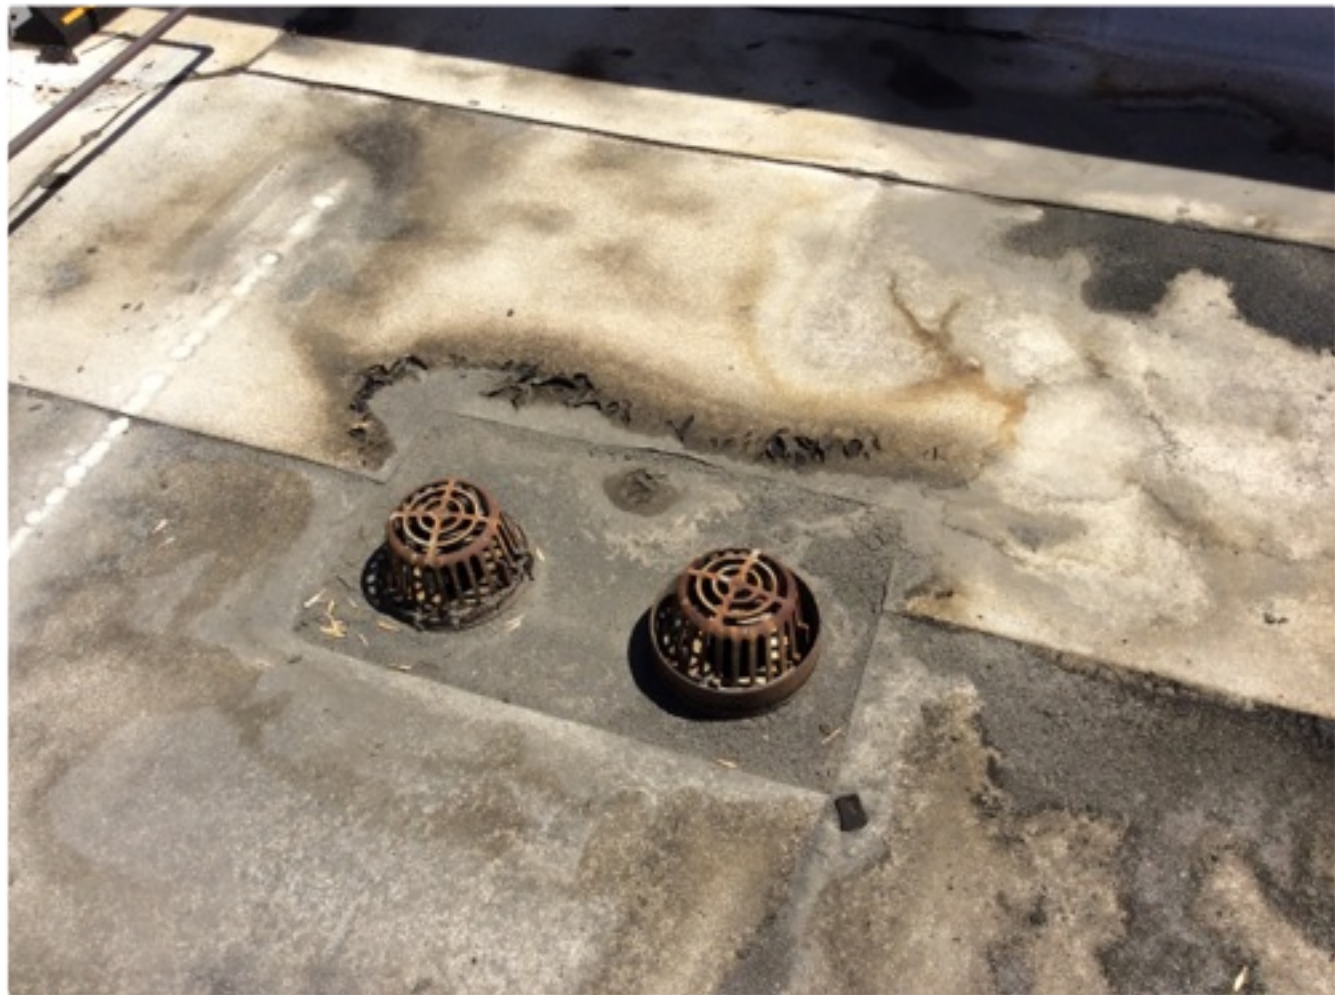
Clear this slow moving drain to prevent ponding - lower level between main roofs.

ADDITIONAL NOTES  
 CLEAR SLOW MOVING DRAINS IN ORDER TO PREVENT PONDING AND PREMATURE ROOF DETERIORATION.

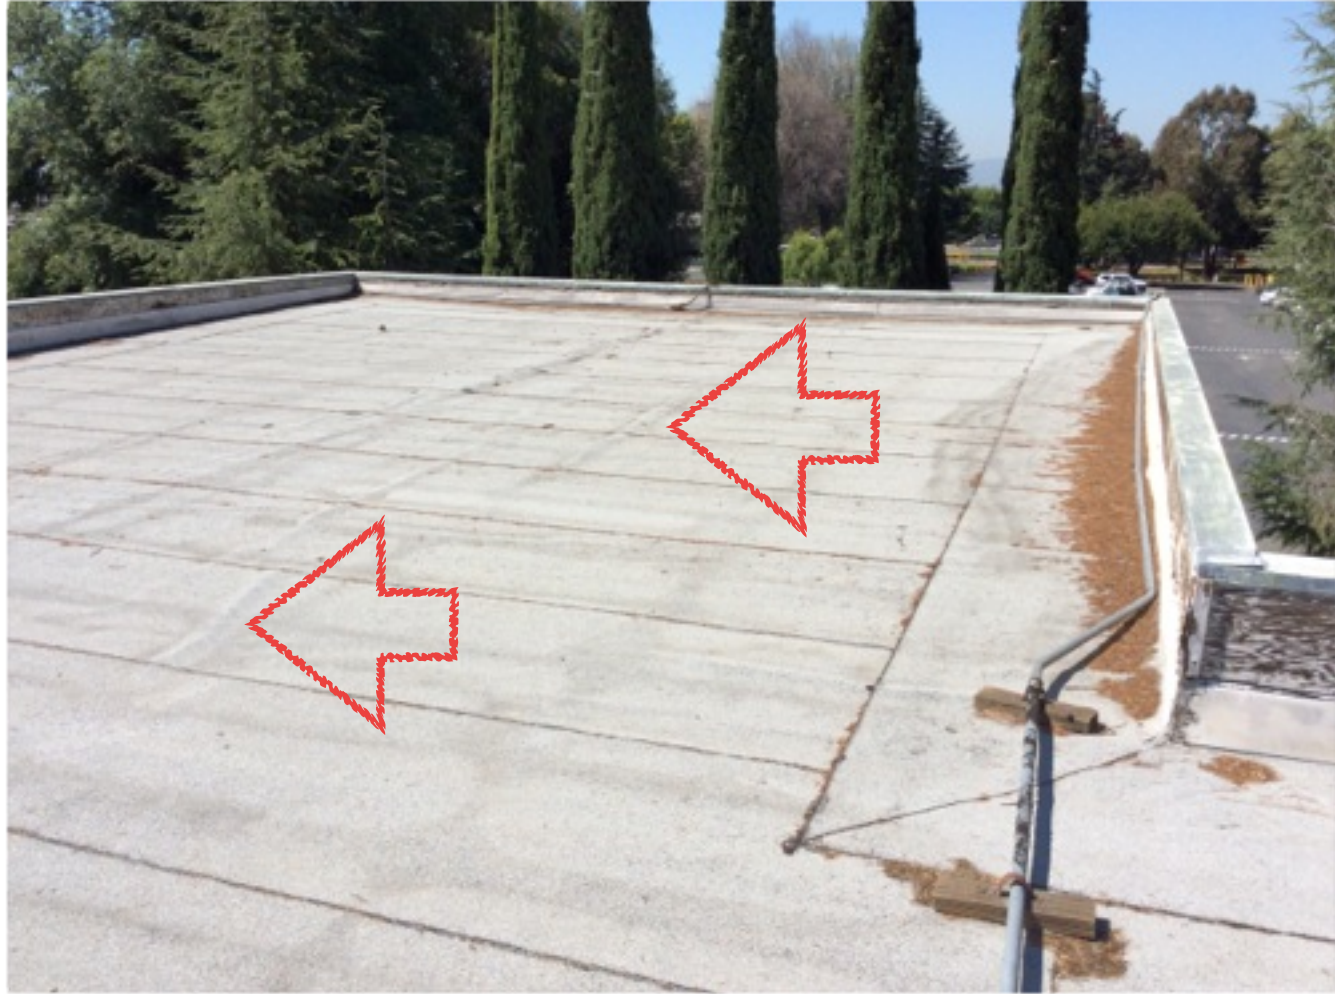
Notice the plethora of ridge lines in the membrane.

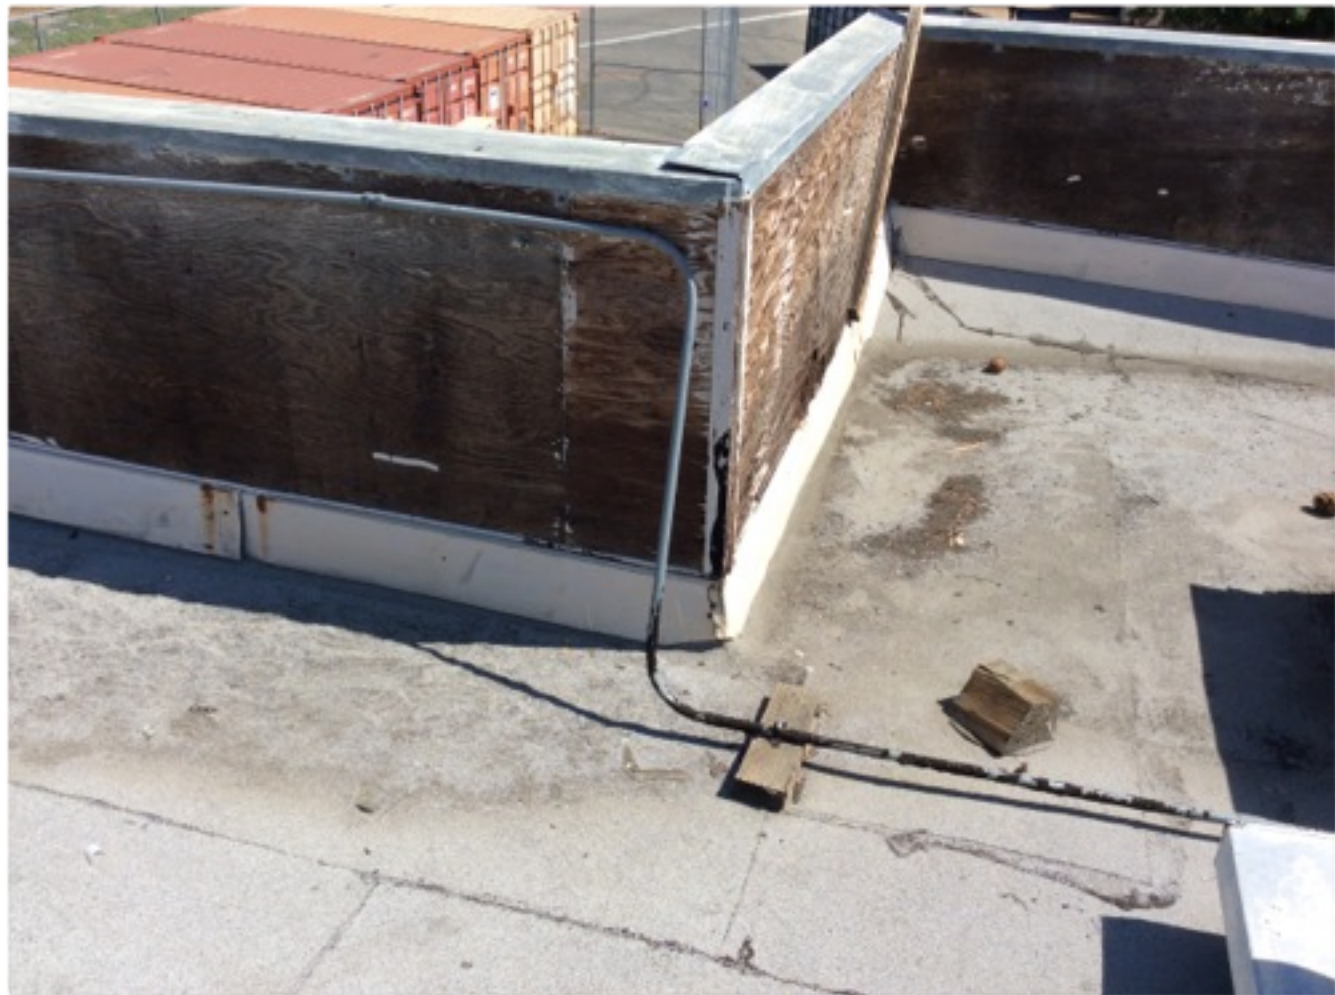
**ADDITIONAL NOTES**  
 ROOF IS IN BAD SHAPE. WALLS AND WALL FLASHING NEEDS TO BE REDESIGNED. A GOOD CHOICE TO BE REPLACED - ARGUABLY IN THE WORST SHAPE ON CAMPUS.

The photo below shows the walls and flashing in horrible shape.

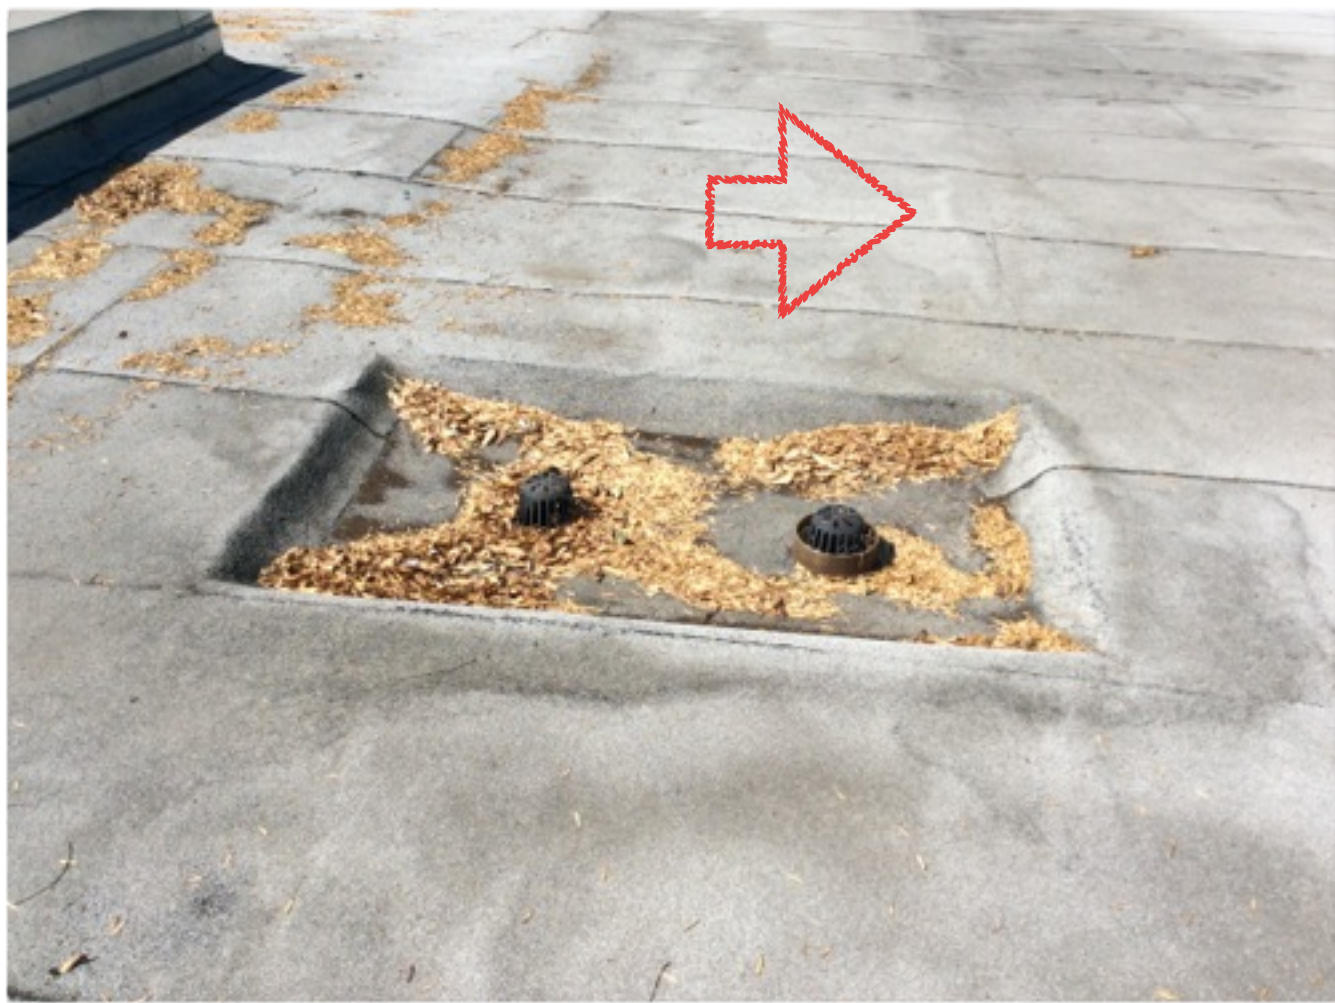
**ADDITIONAL NOTES**  
 ROOFS ARE IN POOR SHAPE. TOO MUCH RIDGING TO REPAIR. ONCE THE RIDGES CRACK, THE ROOF WILL FAIL. NO INSULATION ON THE CANOPIES.

It's difficult to see in the photo but the field is riddled with ridging.

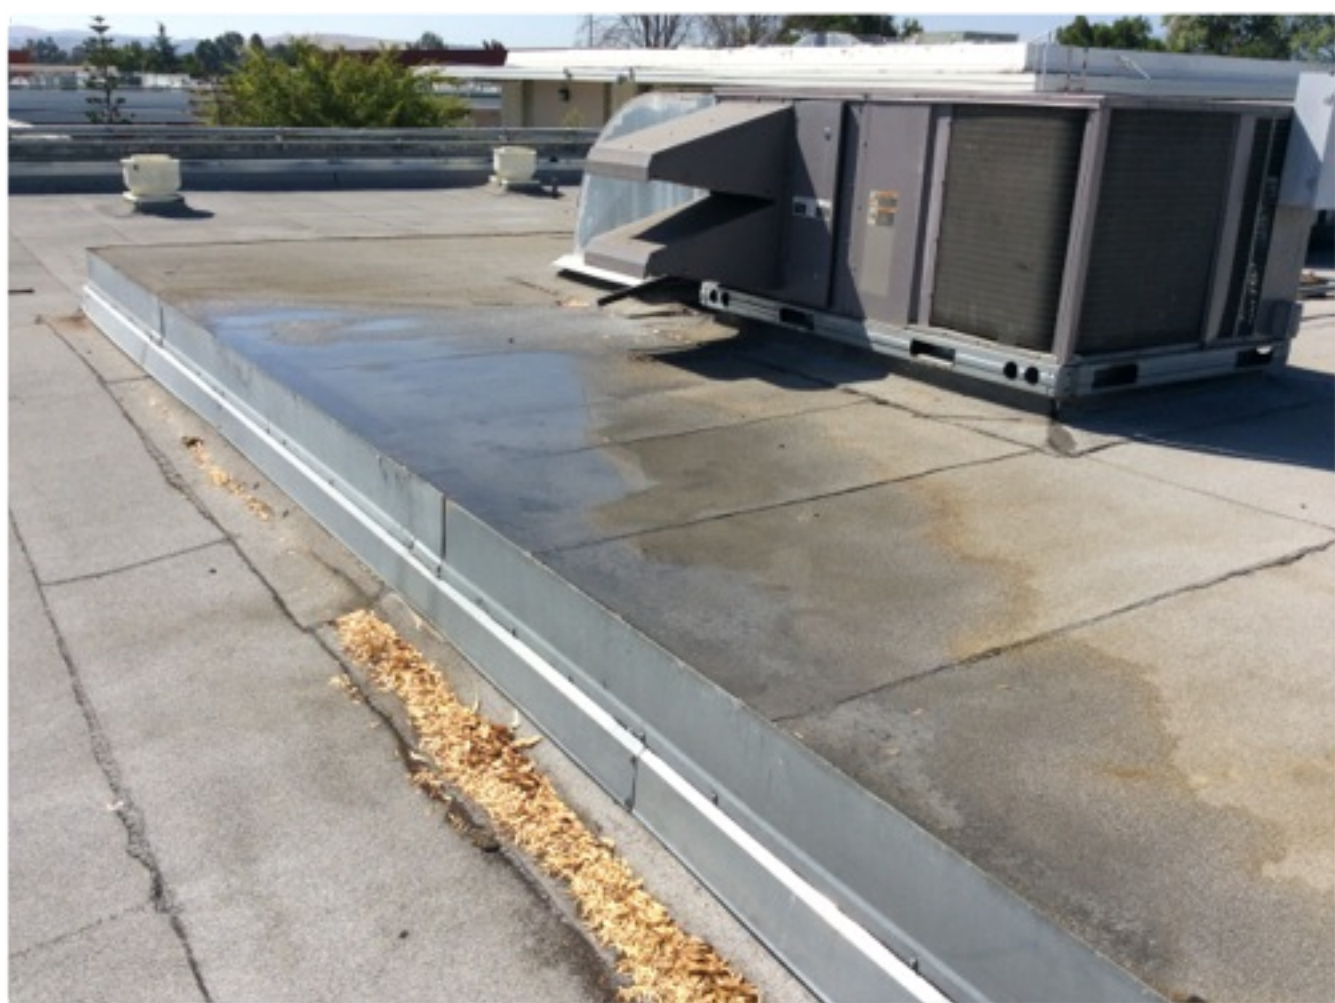
The photo below shows AC units that need repair -this will eventually produce a leak.

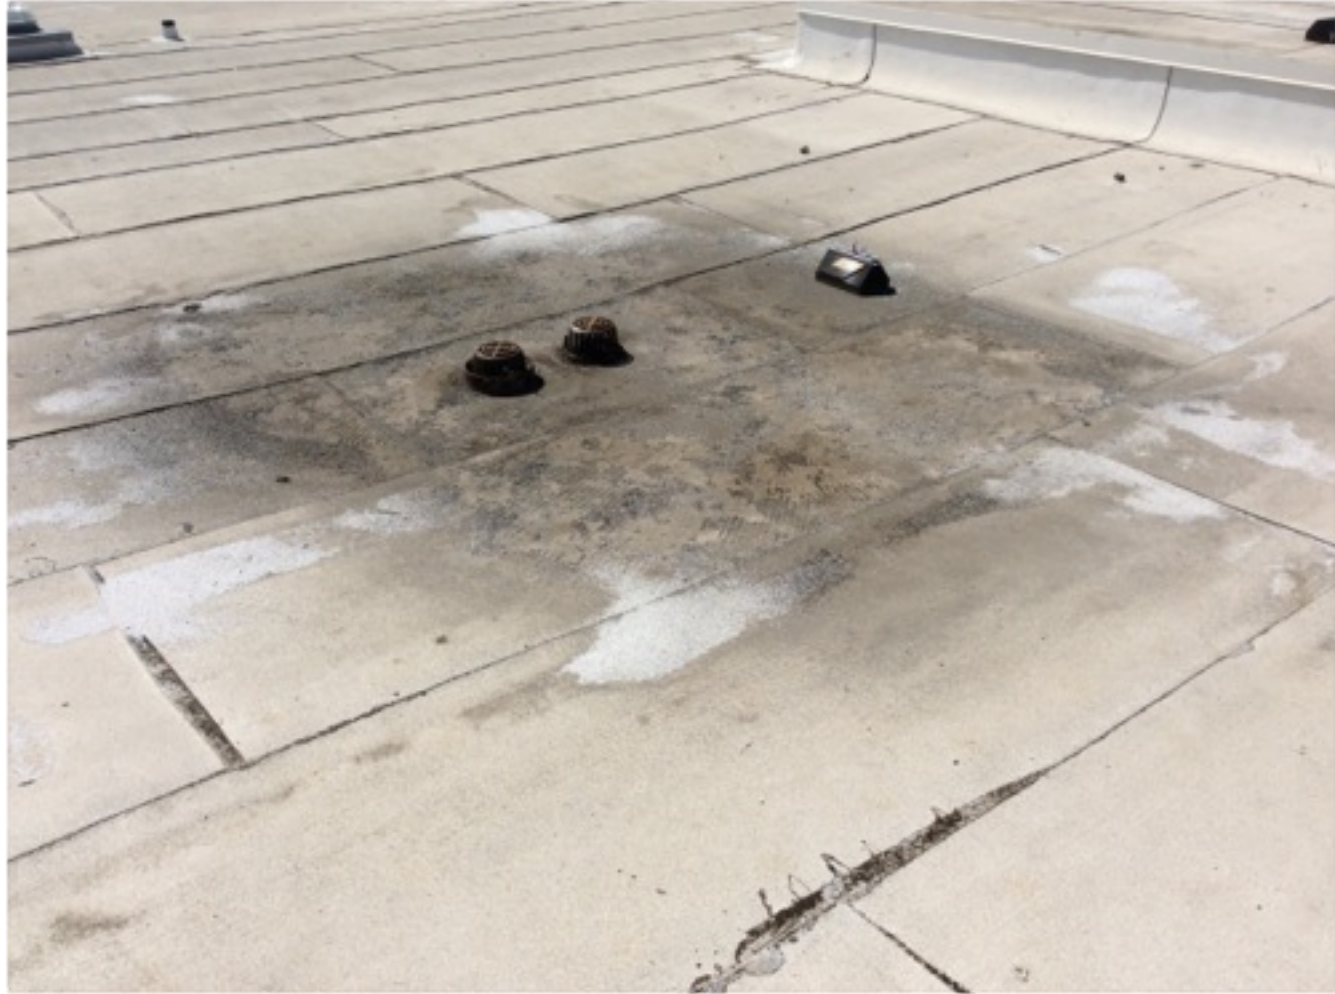
Ensure drains are kept clear in order to prevent excessive ponding.

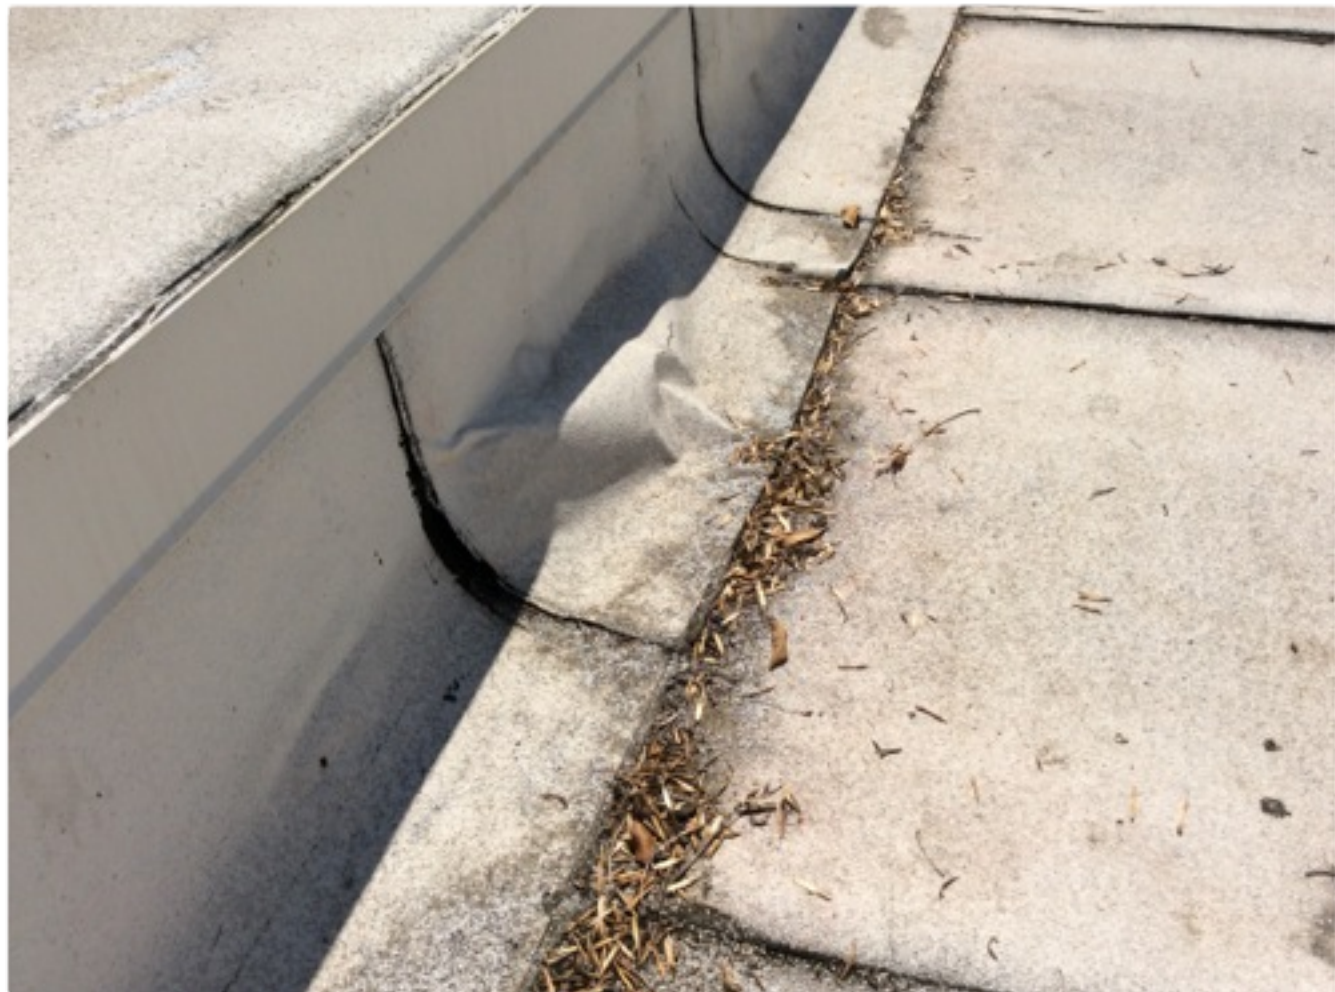
The photo below shows large blistering that needs repair.

**ADDITIONAL NOTES**  
 REPAIR ALL BLISTERS AND EDGE FLASHING CLOSE TO THE BLISTERS (WORST ON 200). CLEAR DRAINS TO PREVENT EXCESSIVE PONDING AND SUBSEQUENT PREMATURE DETERIORATION OF THE ROOF MEMBRANE.

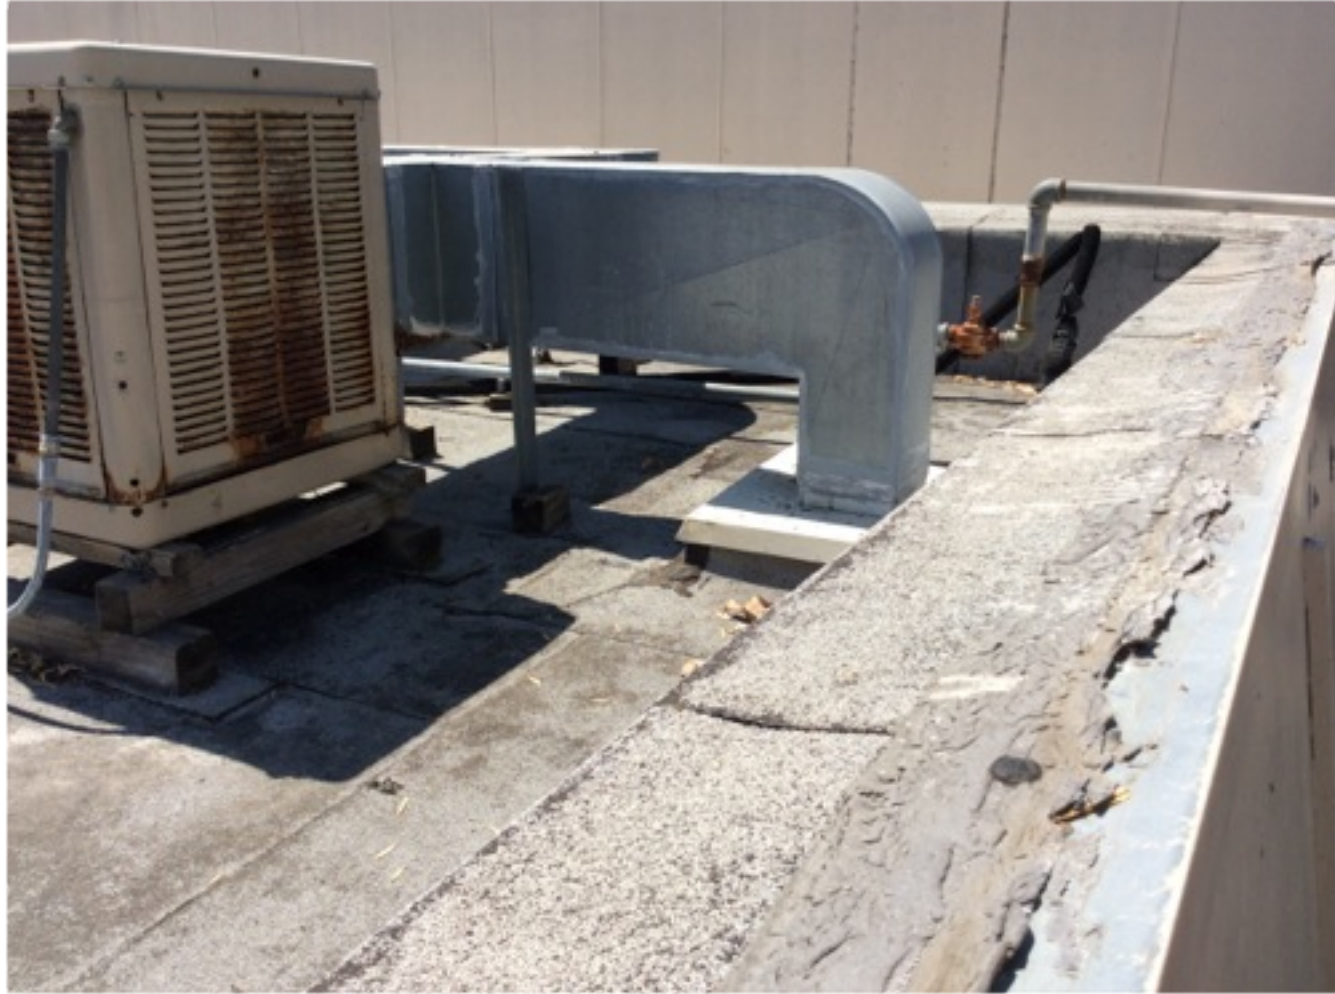
The photo below shows the parapet wall top in bad shape.

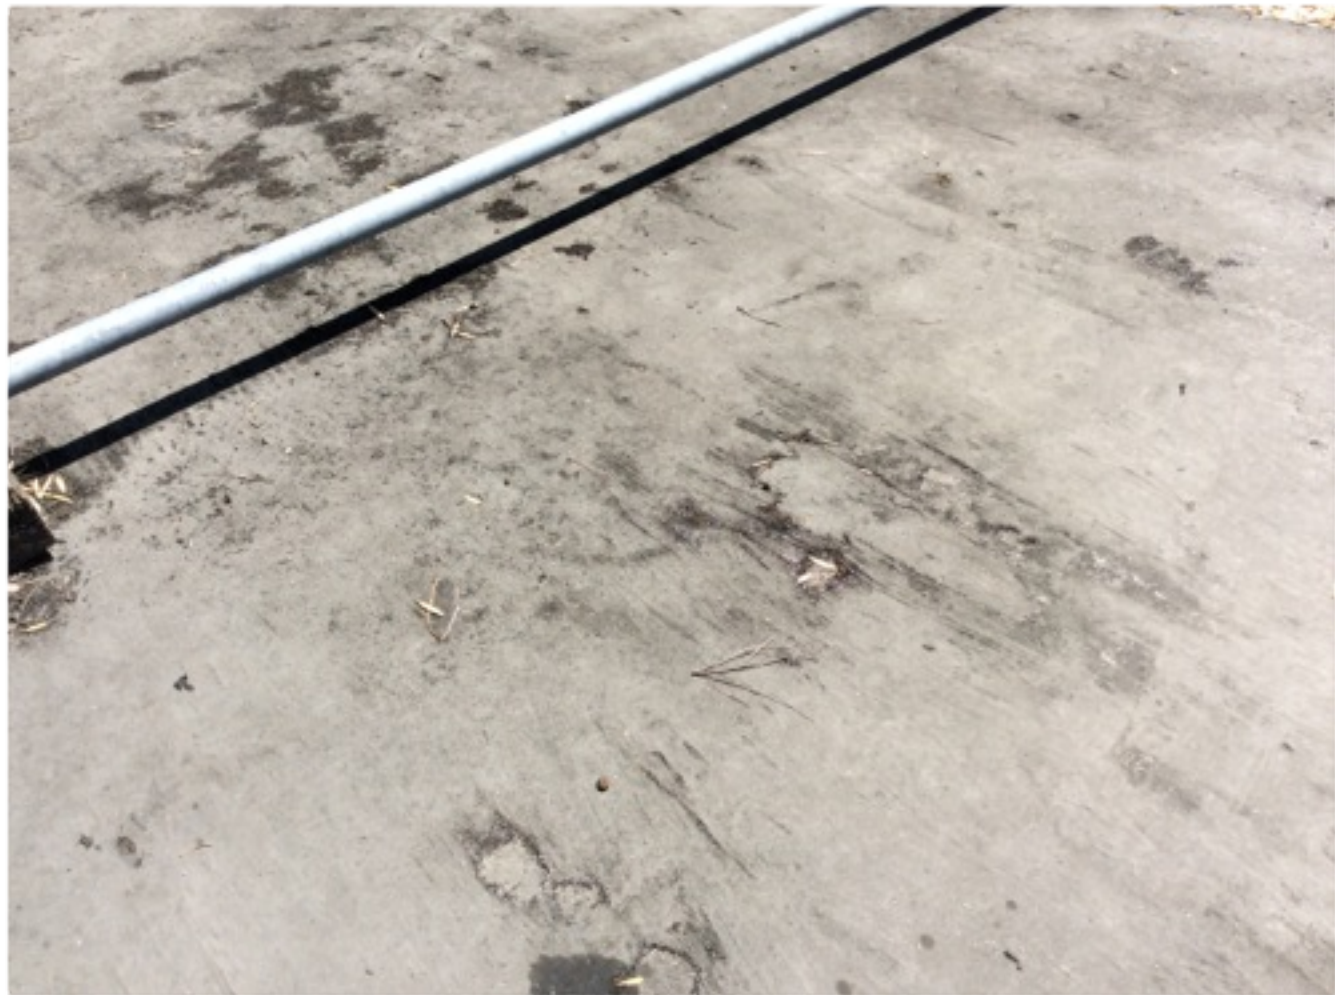
The two adjacent canopies are in worse shape than the Kitchen - the membrane gone.

**ADDITIONAL NOTES**  
 ROOFS ARE IN VERY POOR CONDITION. ADJACENT CANOPIES RECOMMENDED TO BE INCLUDED IN THE REROOF PROJECT.

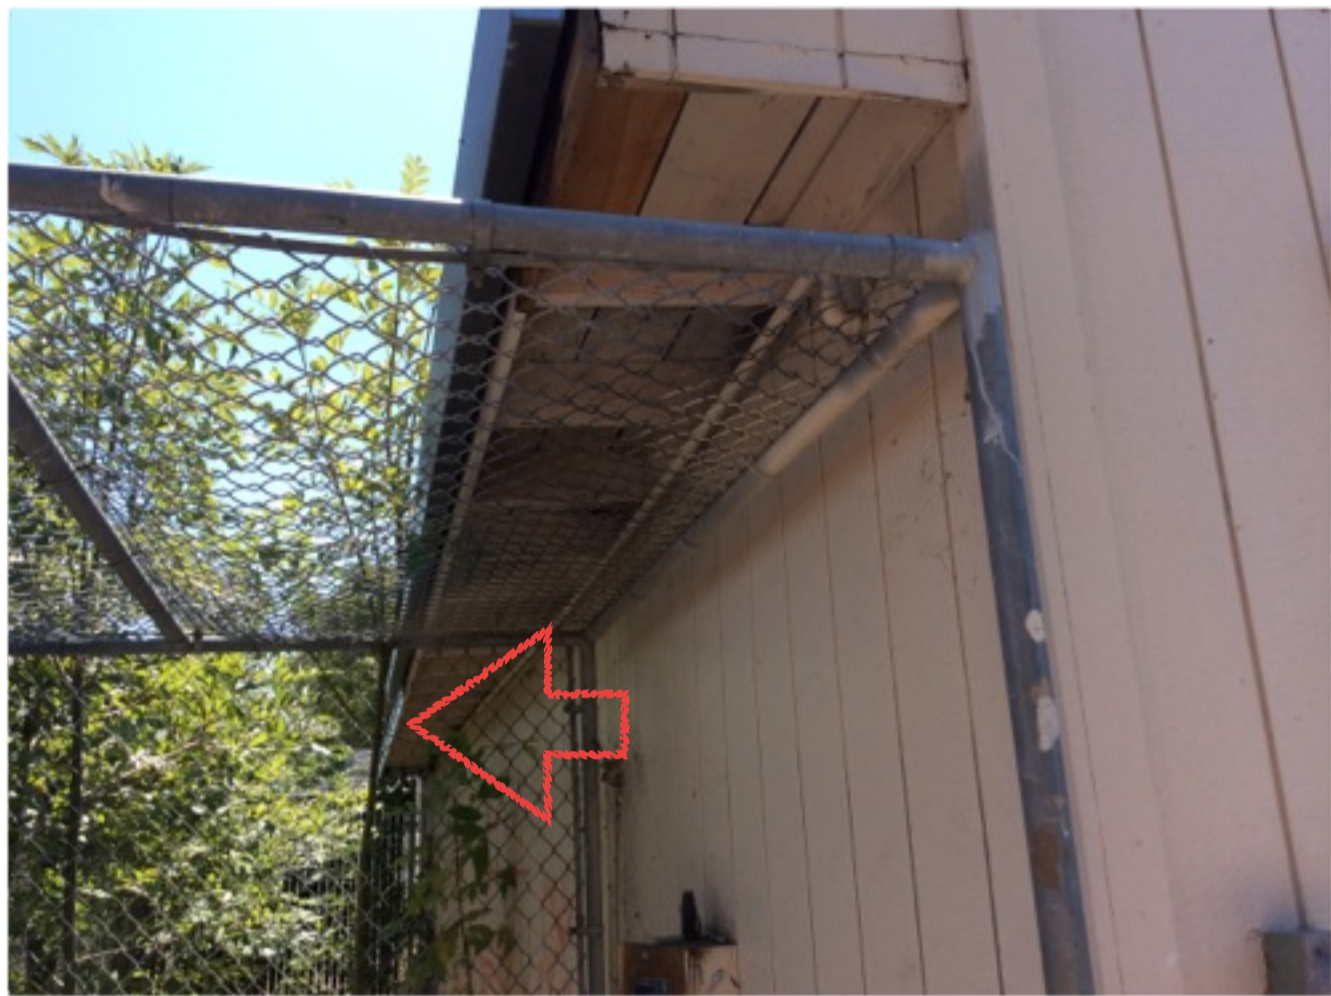
A portion of the gutter is missing.

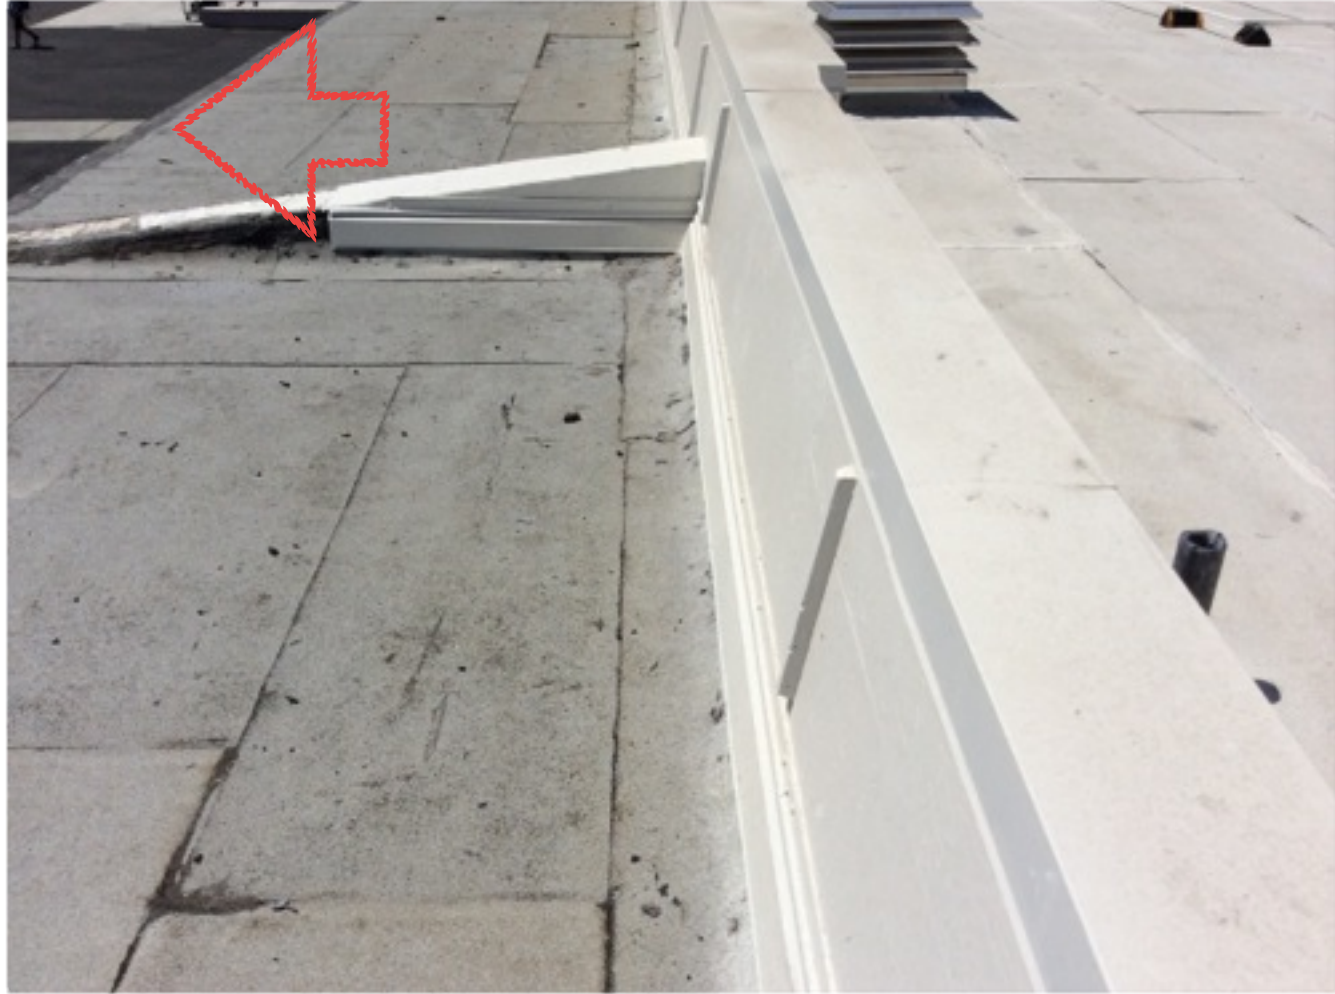
The photo below shows perimeter repairs on the roof level

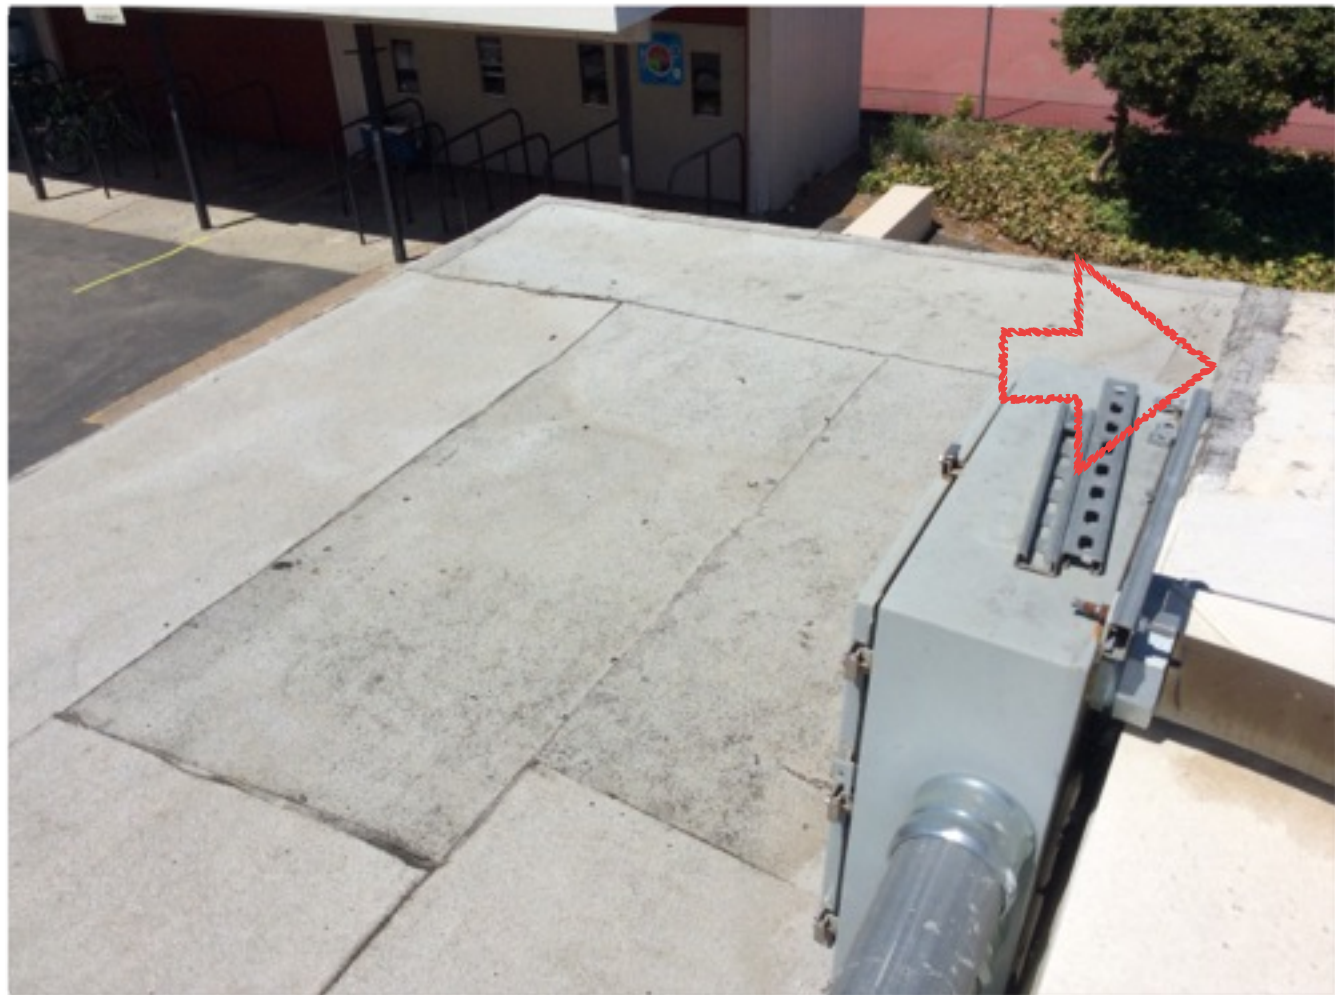
The photo below shows field repairs on the roof level.

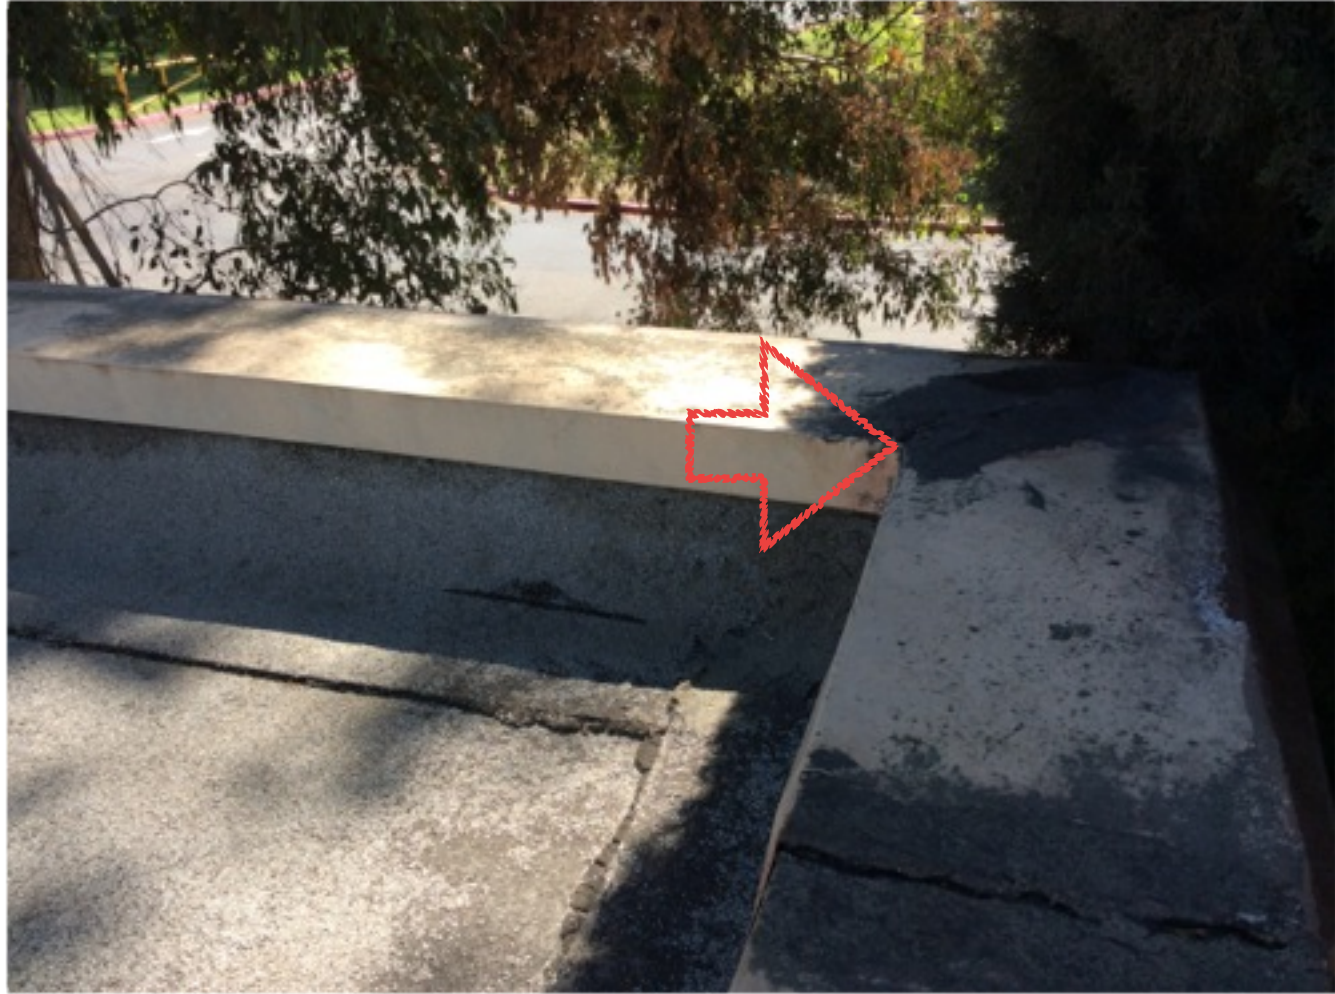
The photo below shows how in bad shape the cap flashing is - with many repairs.

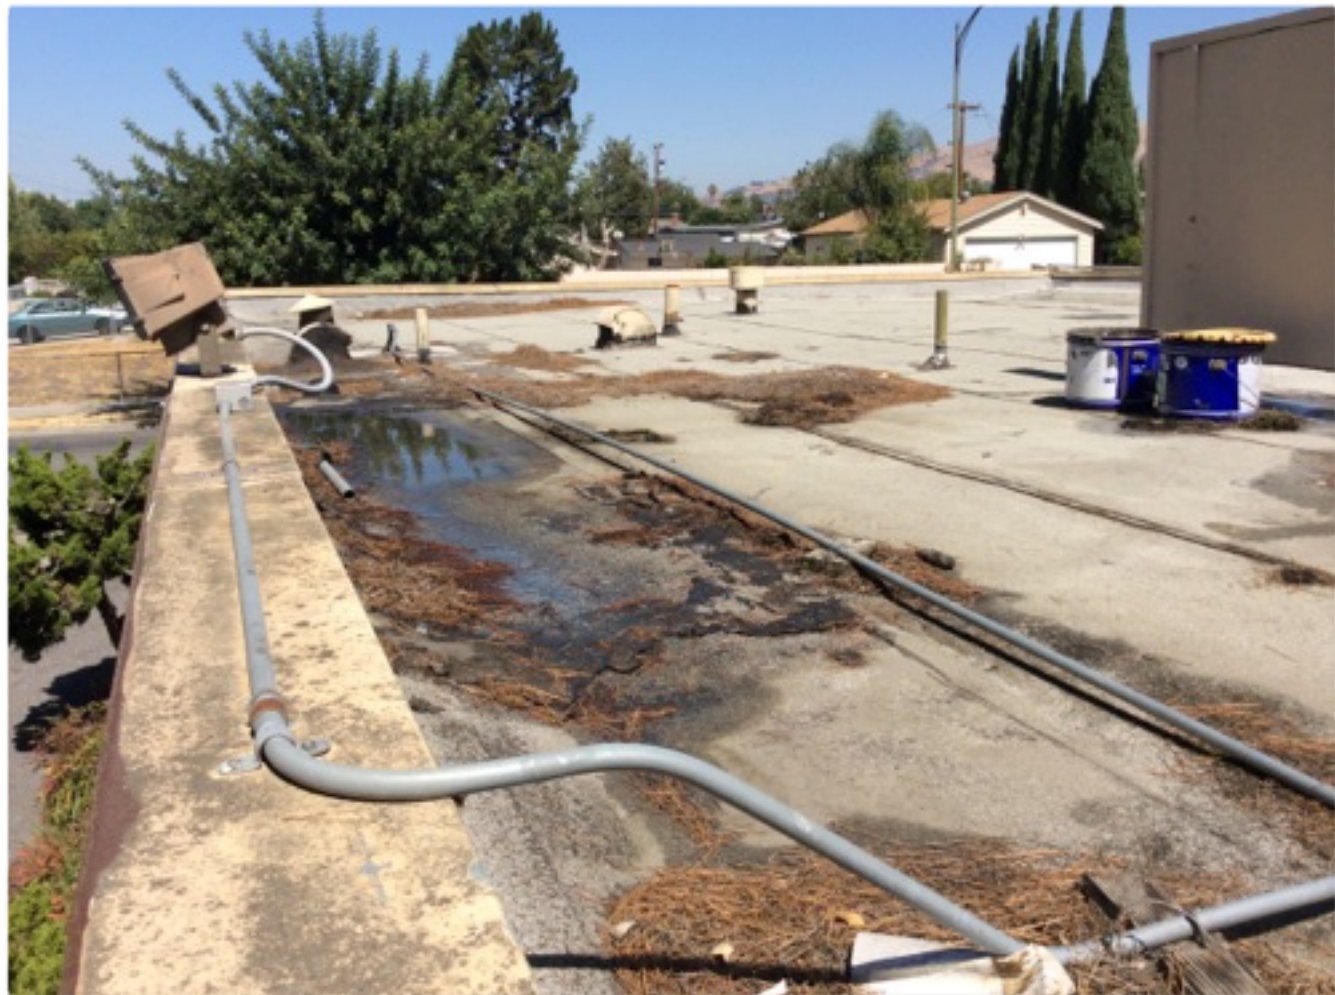
The photo below shows the roof in very poor condition.

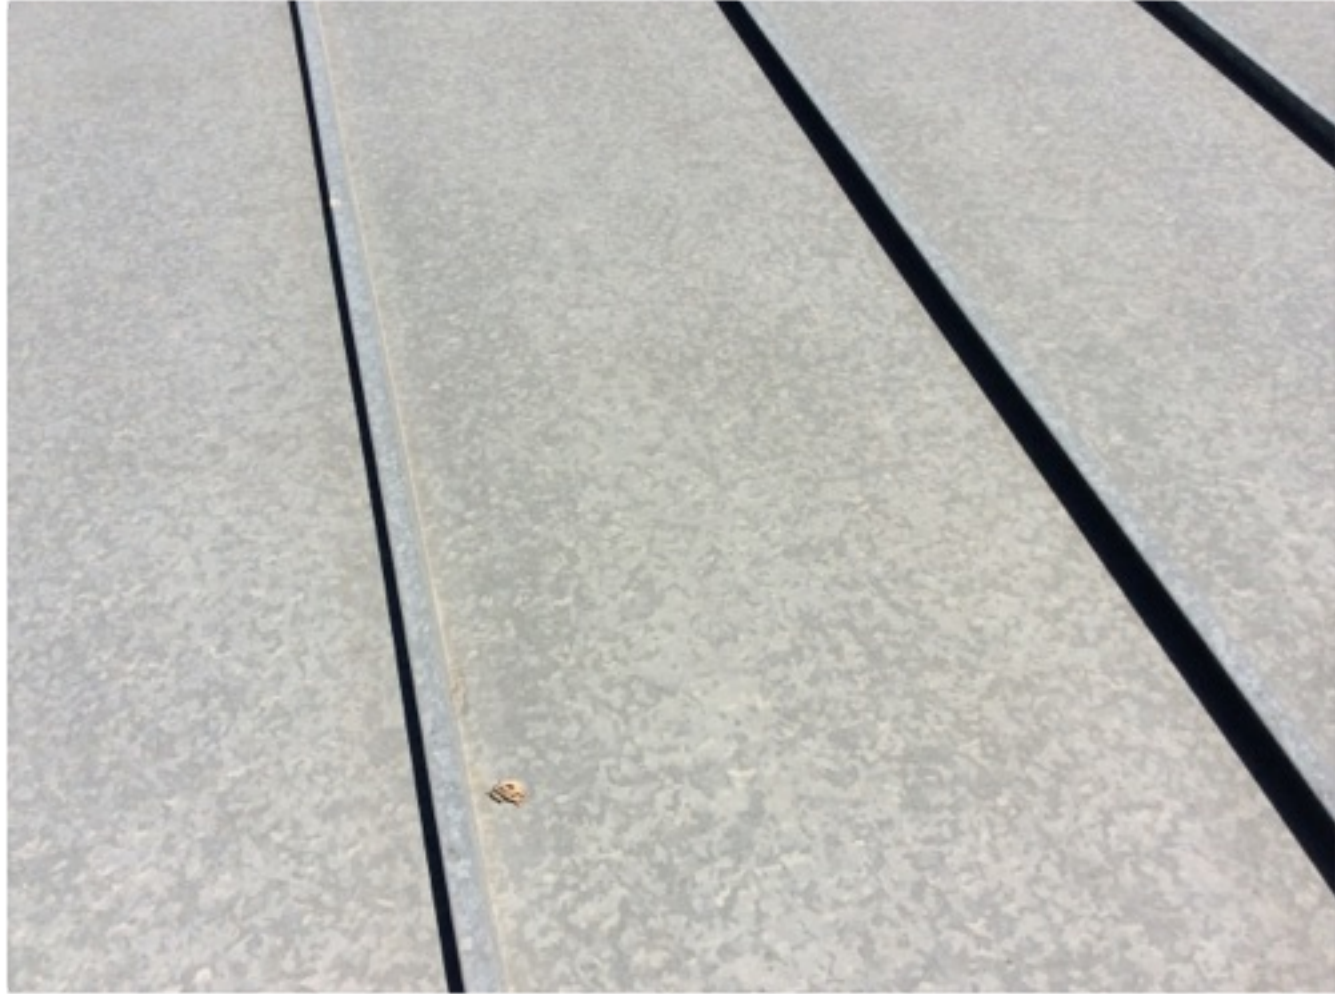
The photo below shows galvanized metal field in good shape.
