BUILDING INFORMATION	
FACILITY	Mt. Pleasant HS
DATE	August 26, 2014
BUILDING	100 Admin, 900 Library, Central Canopy
ROOF SQ FT	30,000

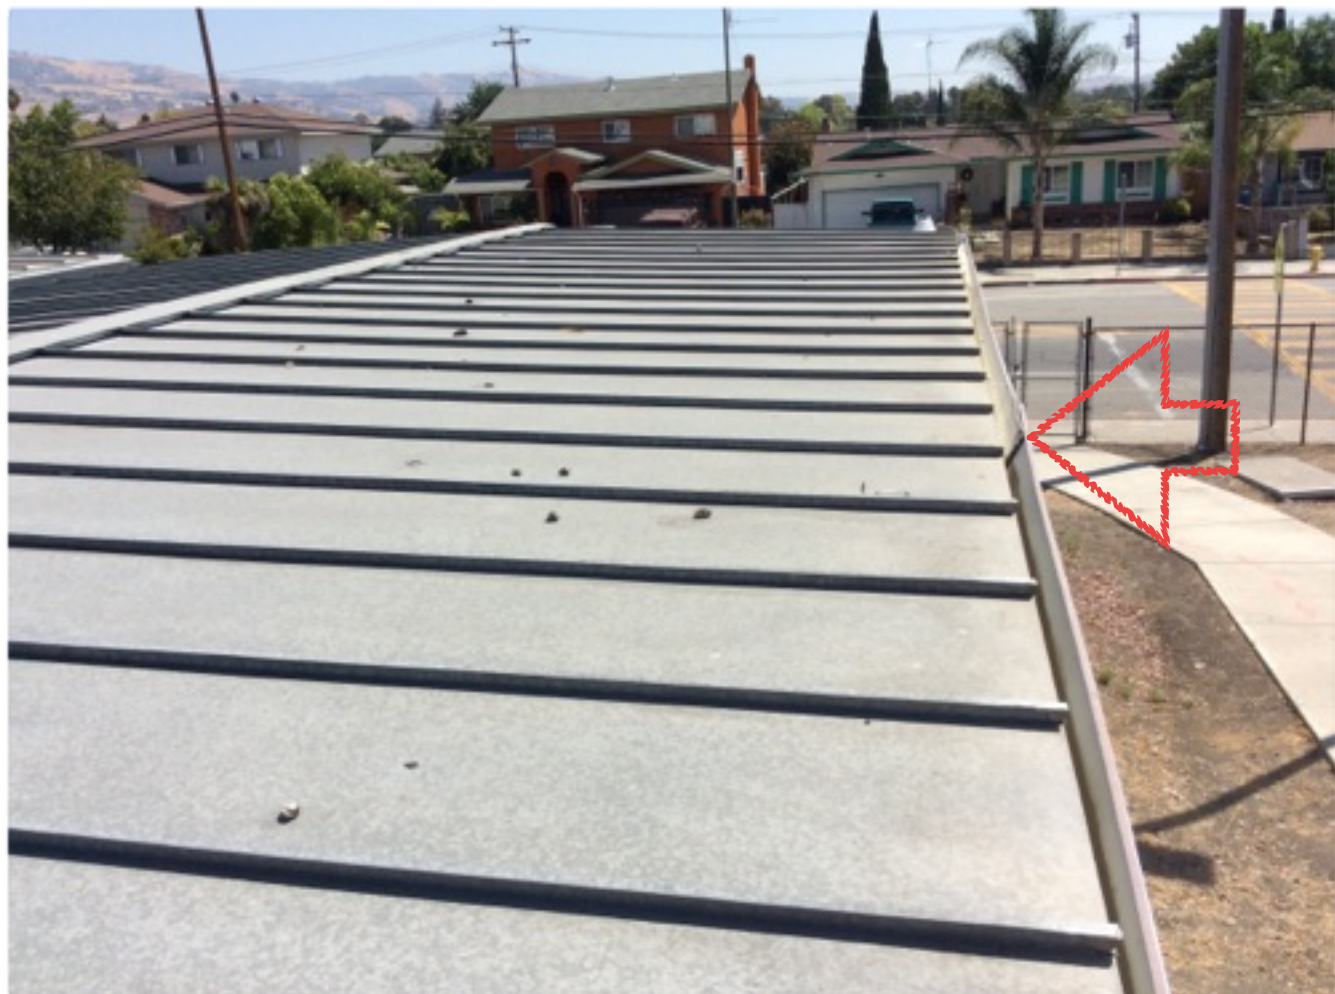
The photo below shows the gutter in need of some repair.

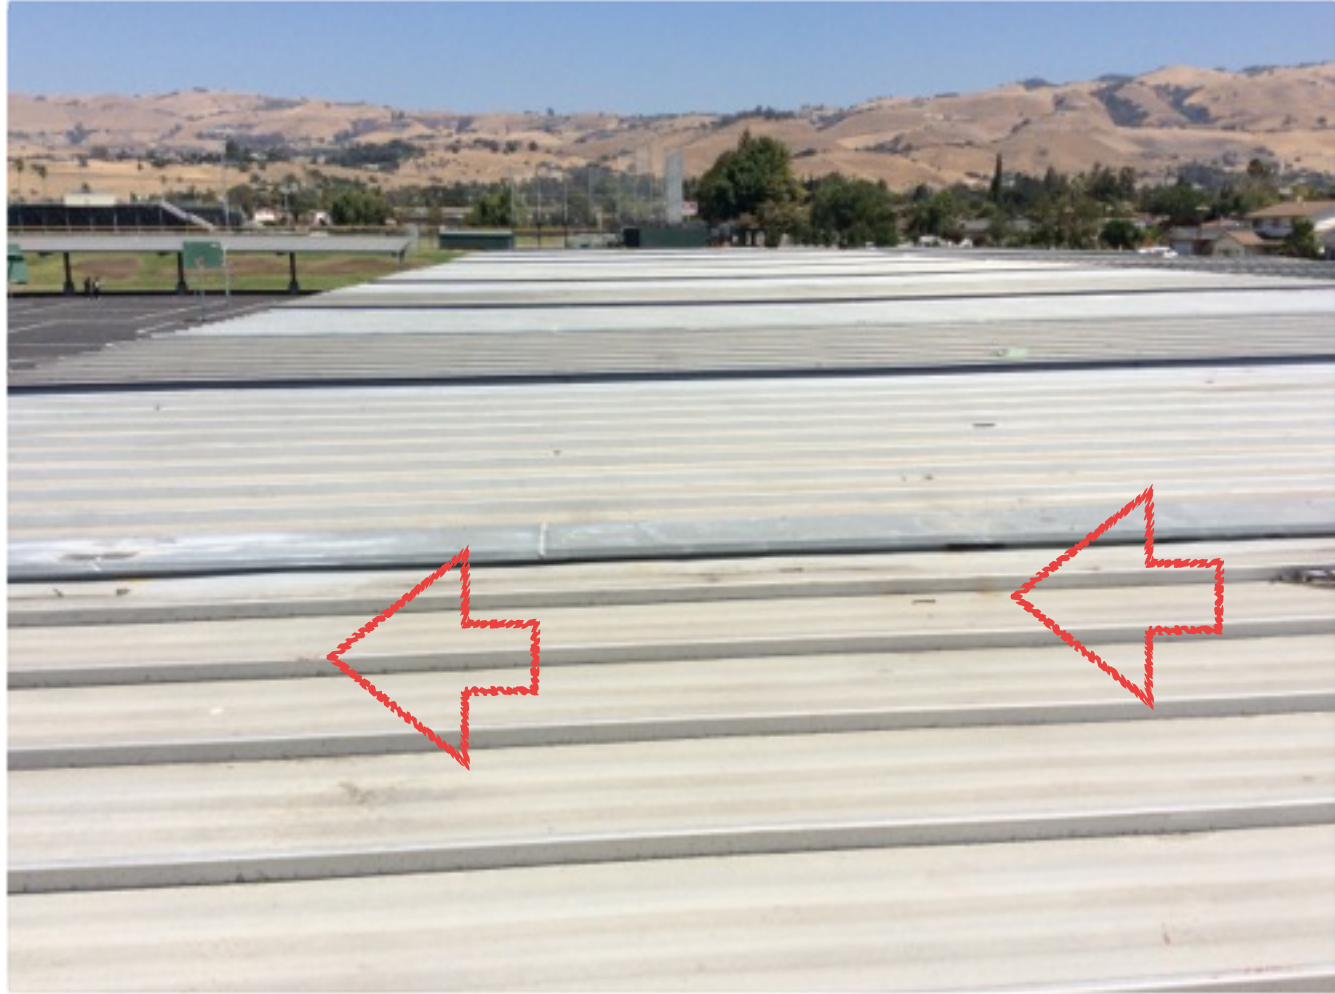
The photo below shows small amounts of rust forming in the field.

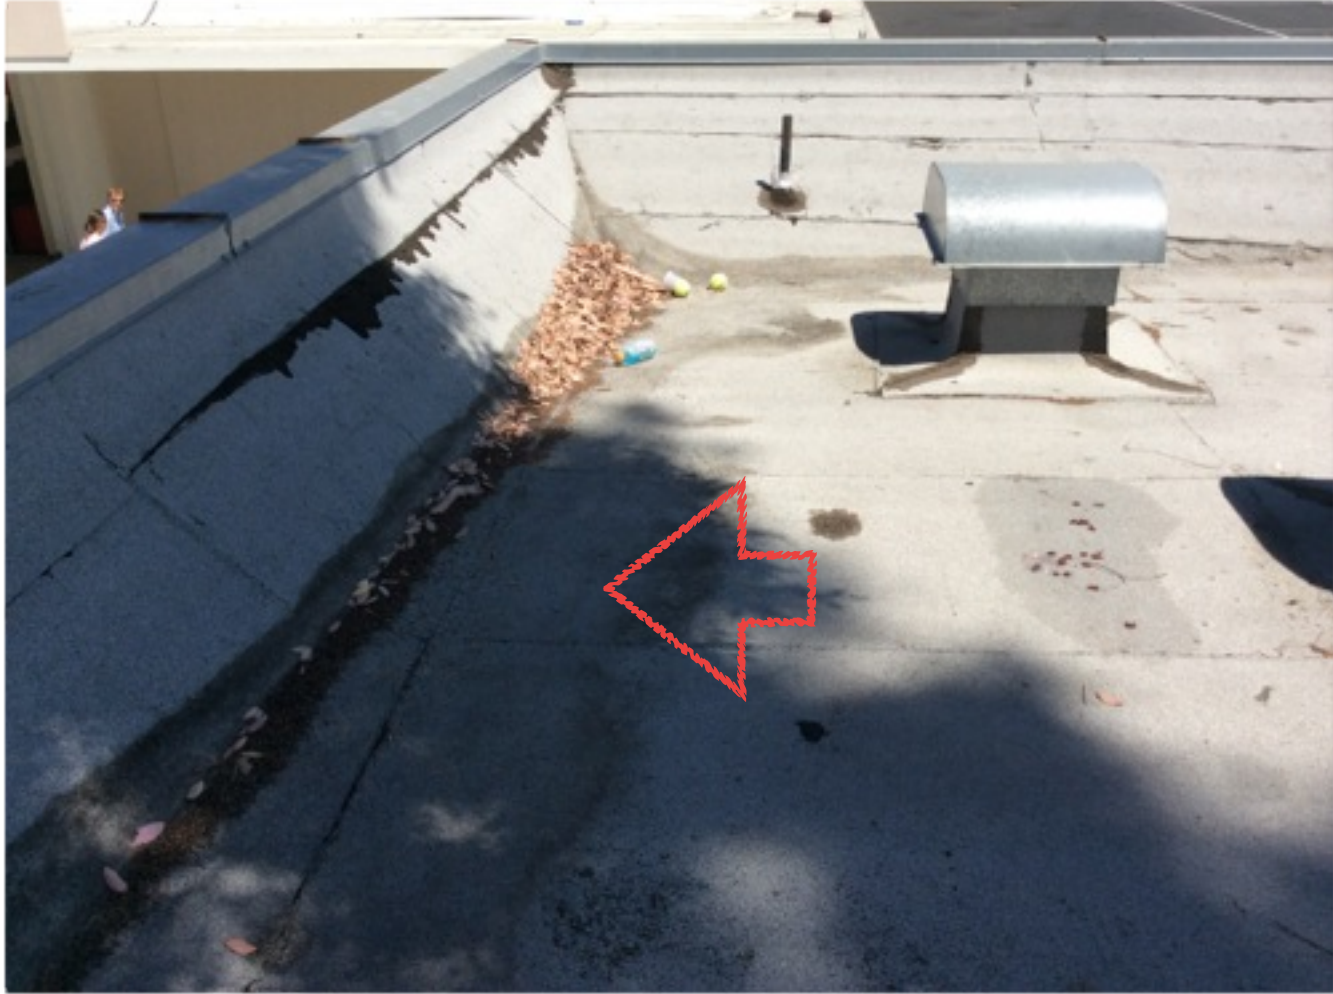
The photo below shows some ponding problems.

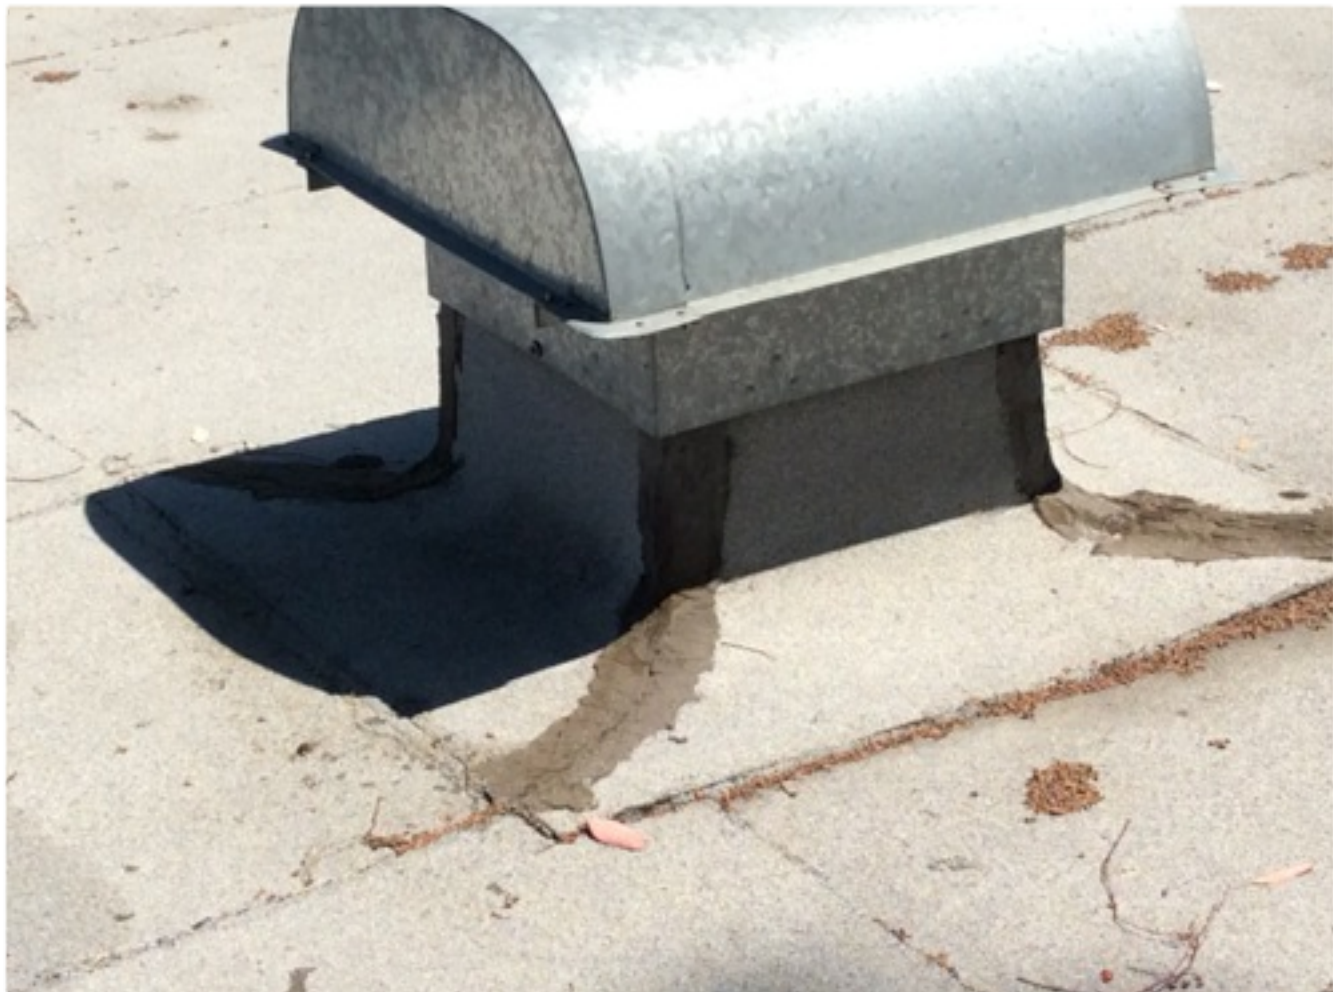
The photo below shows that all penetration details are failing - mastic on corners.

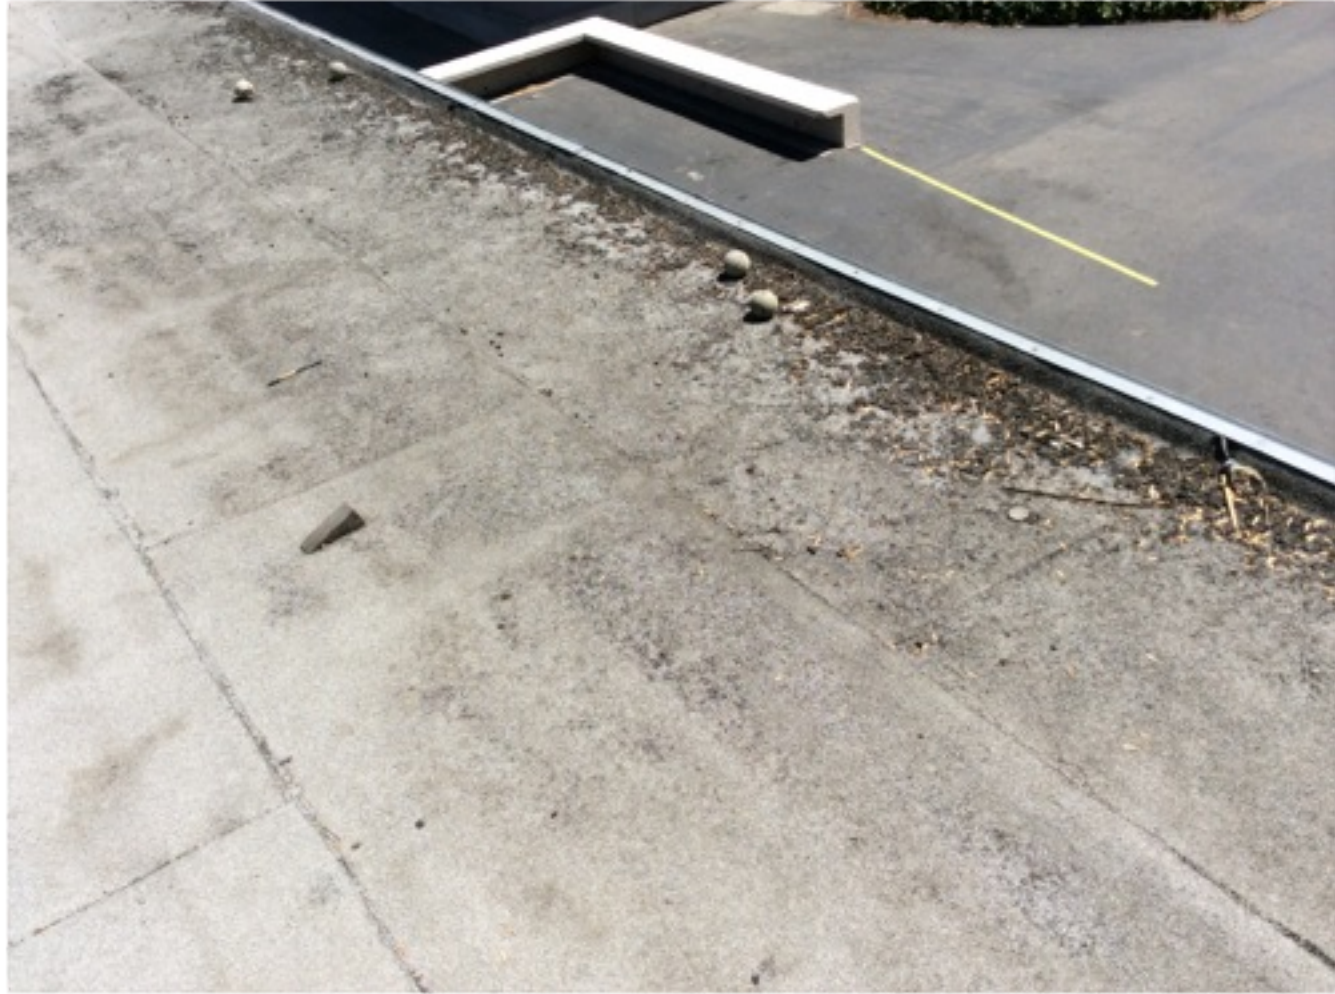
The photo below shows excessive ponding - cricket enhancement is necessary.

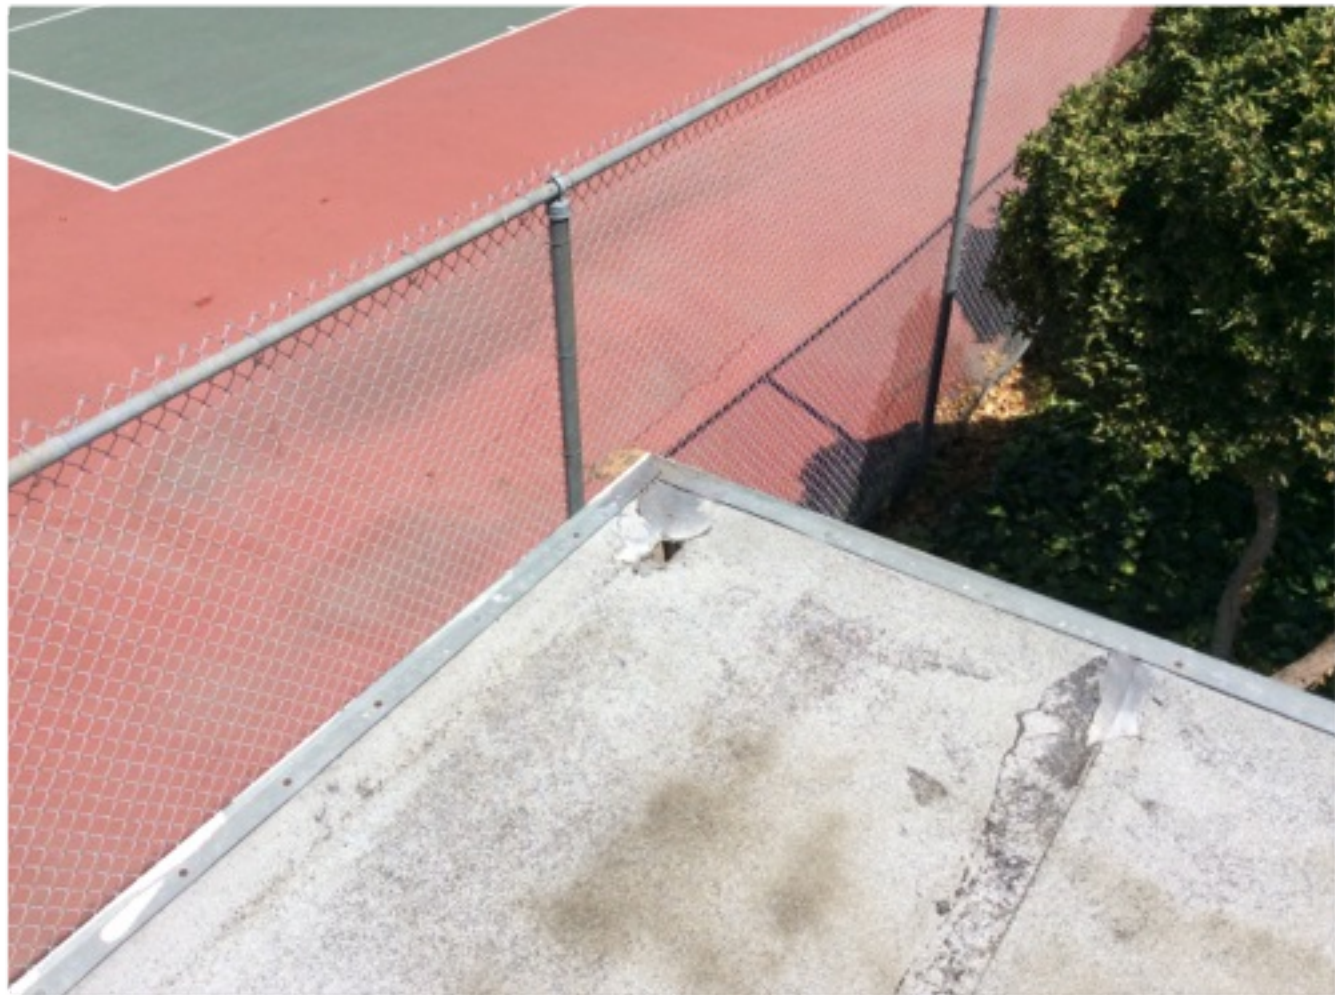
The photo below shows the drains - or simply holes in the roof. A redesign is needed.

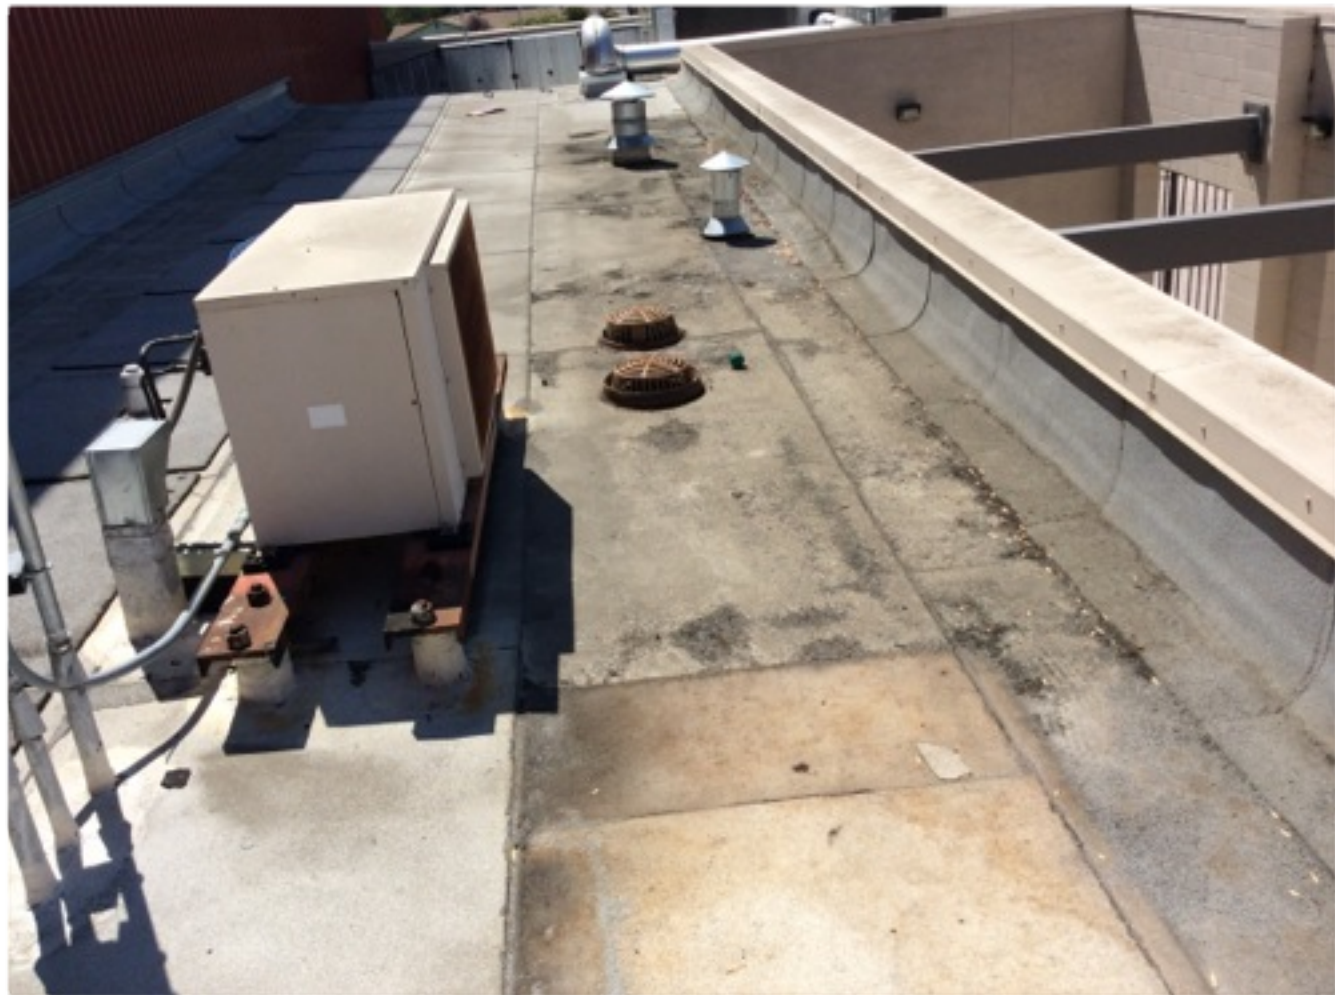
Clear this slow moving drain to prevent ponding - mid level school side.
