BUILDING INFORMATION	
FACILITY	Santa Teresa HS
DATE	October 17, 2014
BUILDING	100, 900, 1000, and 1100
ROOF SQ FT	24,000

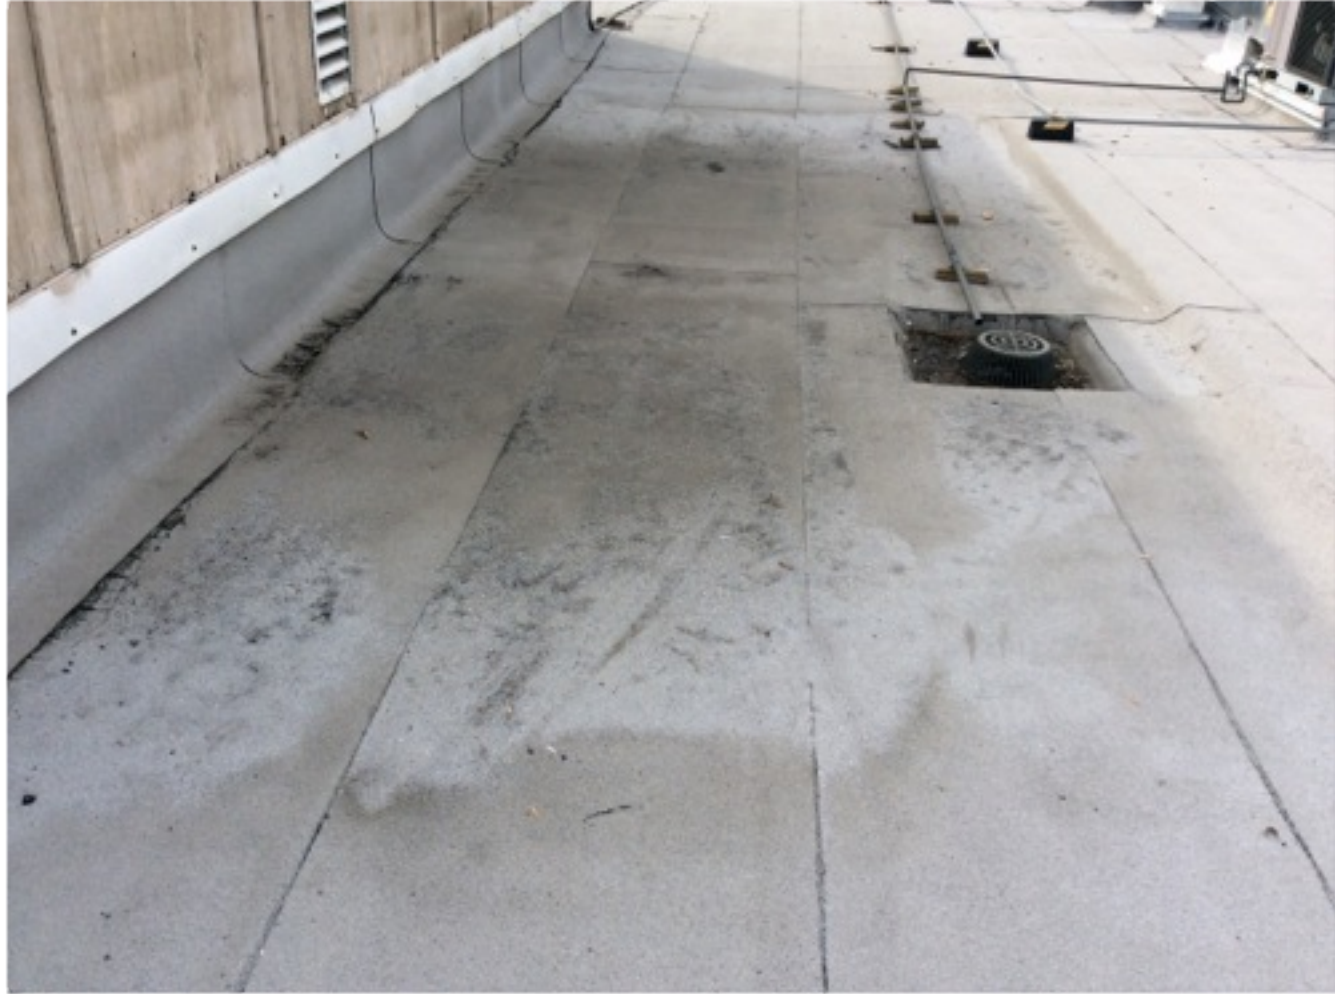
The photo below shows signs of excessive ponding.

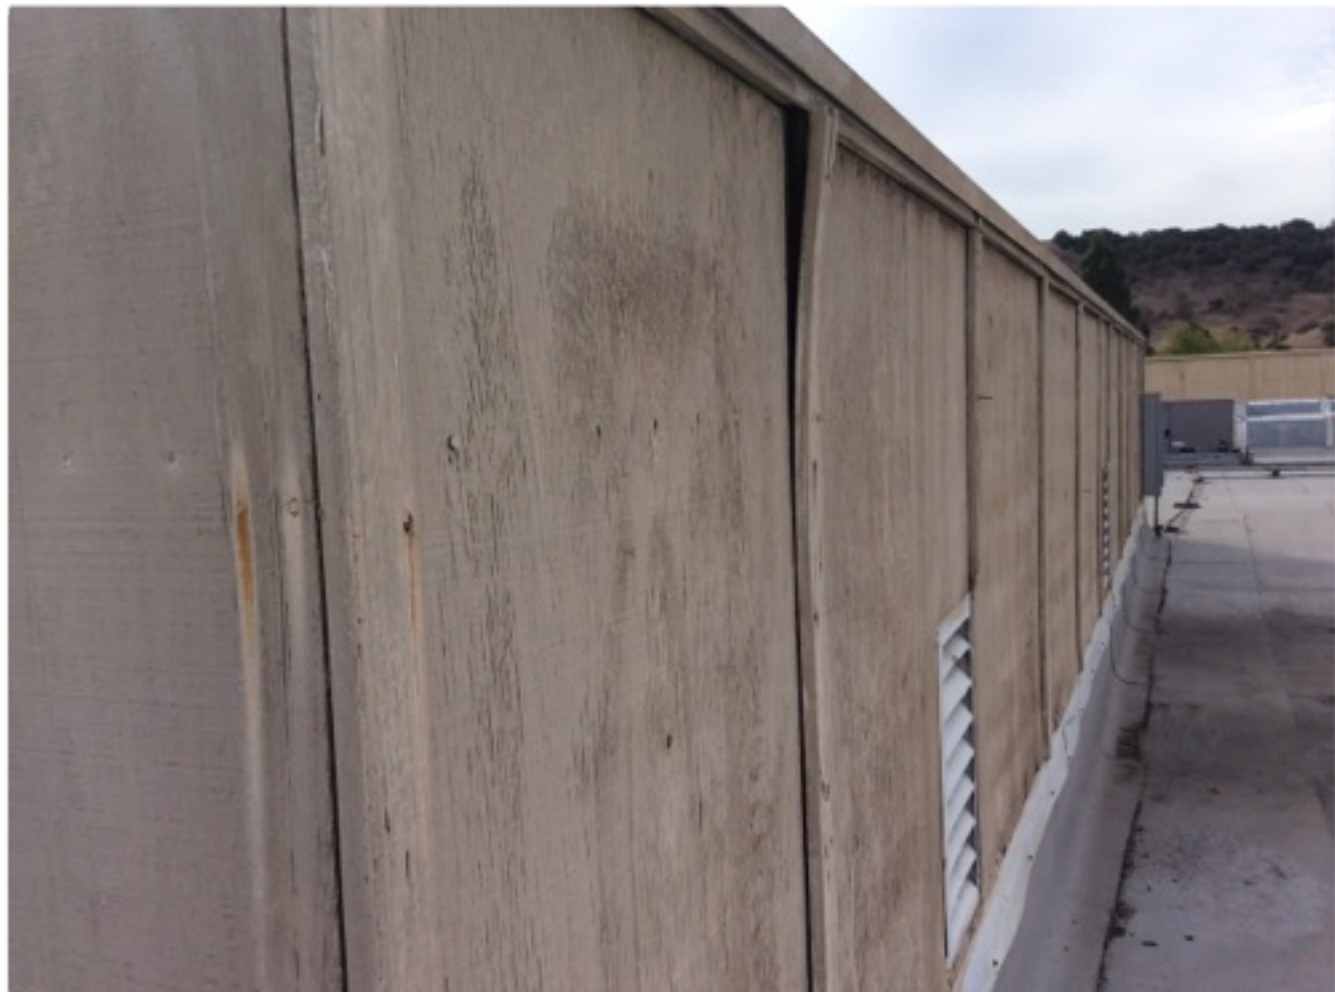
**ADDITIONAL NOTES**  
 THREE YEARS AT THE MOST LEFT IN LIFE WITH THIS ROOF. THE WALLS ARE IN MUCH WORSE SHAPE AND MAY ALLOW MOISTURE INTO THE SYSTEM.

The photo below shows the wall in need of repair and a coating.

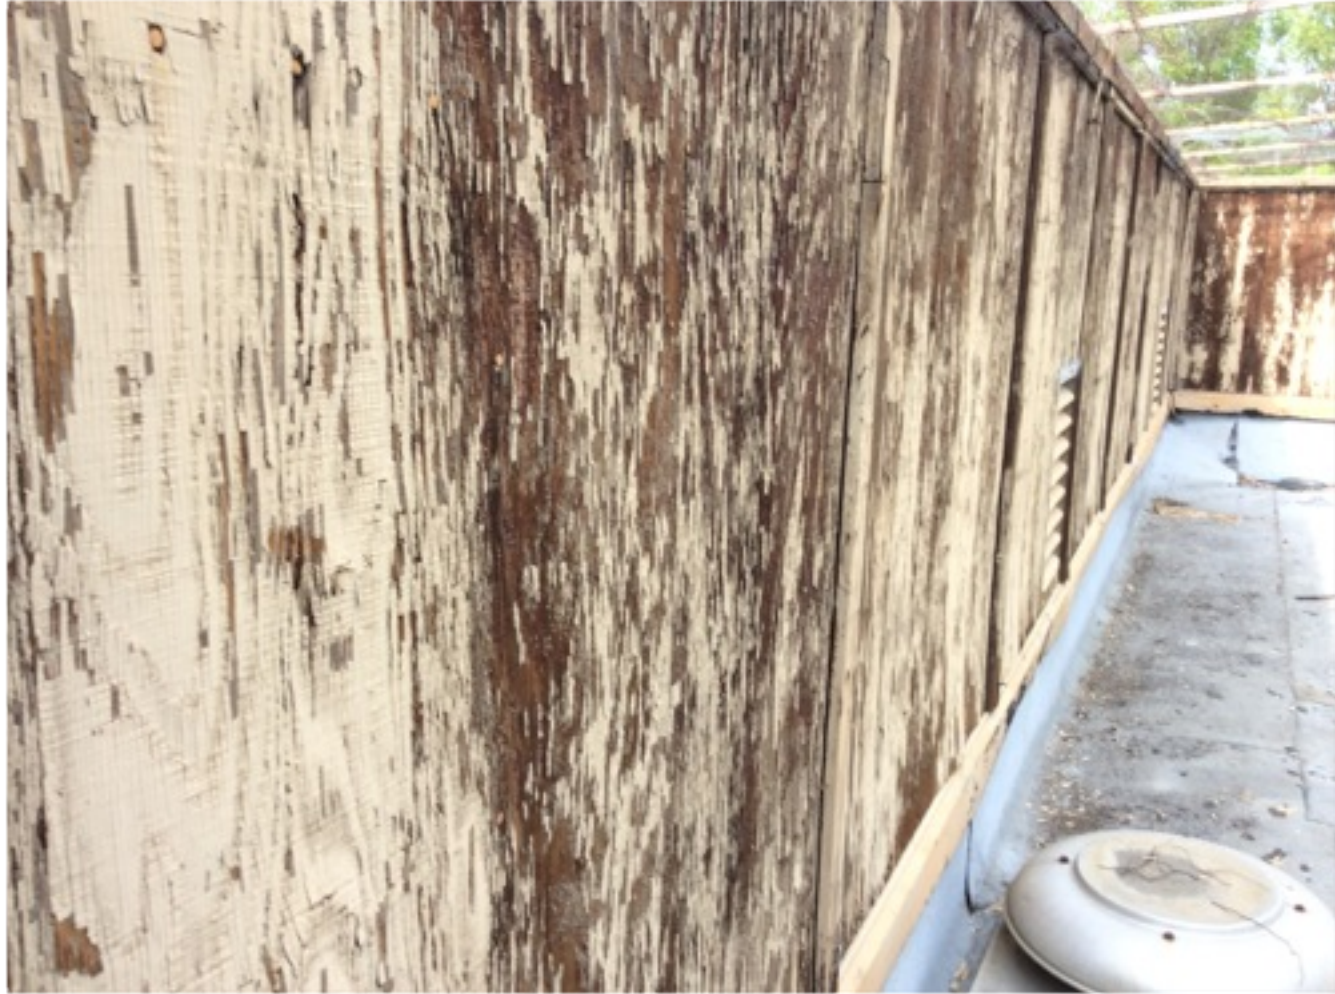
**ADDITIONAL NOTES**  
 THE ROOF IS IN FAIR CONDITION - THE WALLS AND WALL FLASHINGS ARE POOR. BUDGET TO REPLACE IN THREE YEARS MAXIMUM. WOULD BE TEMPTED TO ADD THIS TO ANOTHER LARGER ROOF PROJECT TO GET A GOOD PRICE.

The photo below shows the wall in need of repair and recoating.

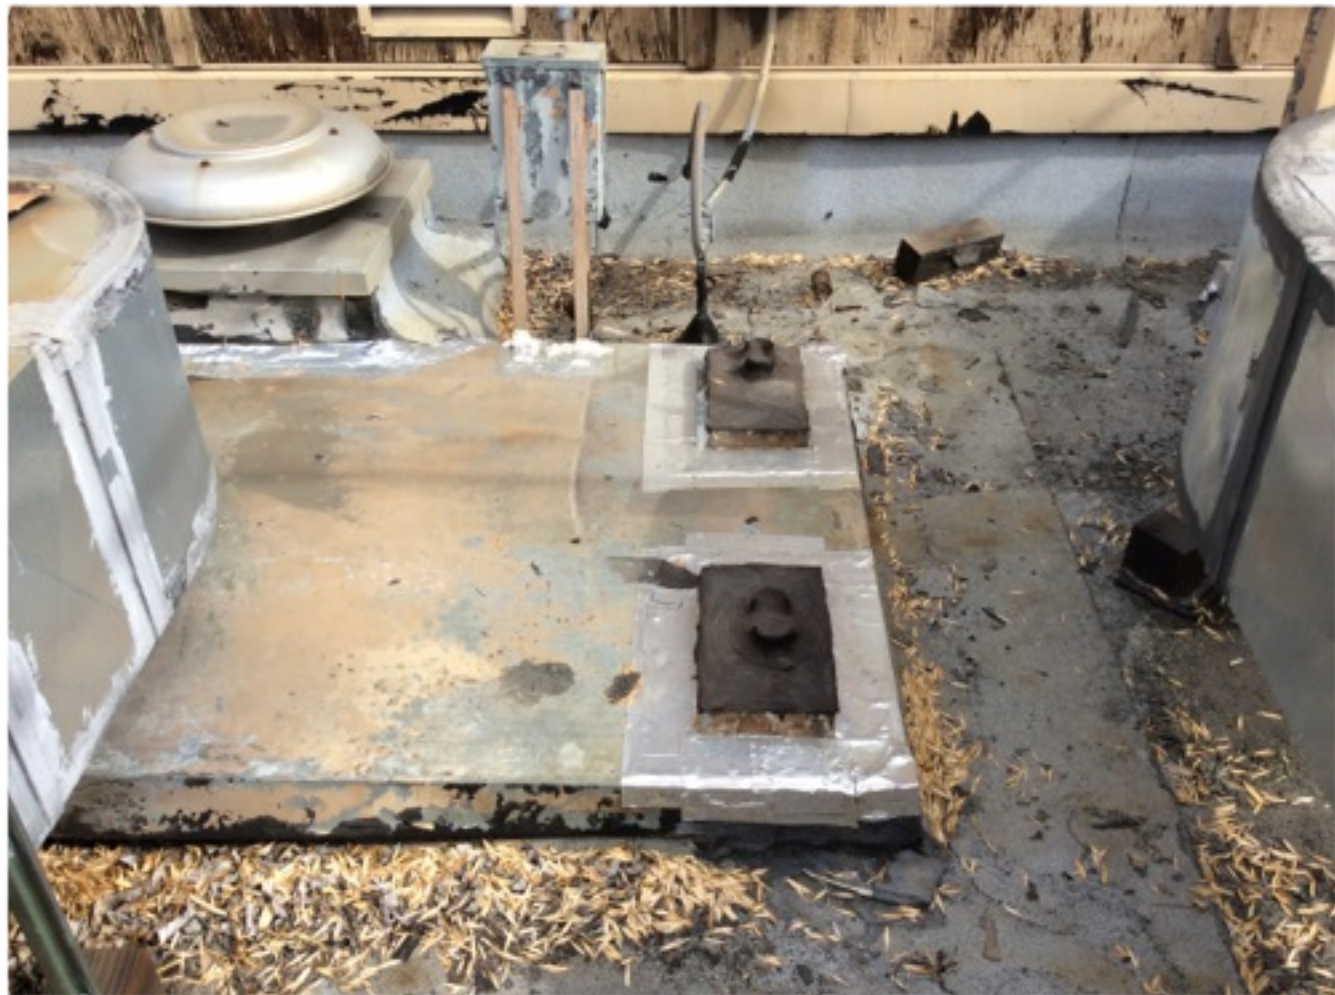
The photo below shows heavy ponding.

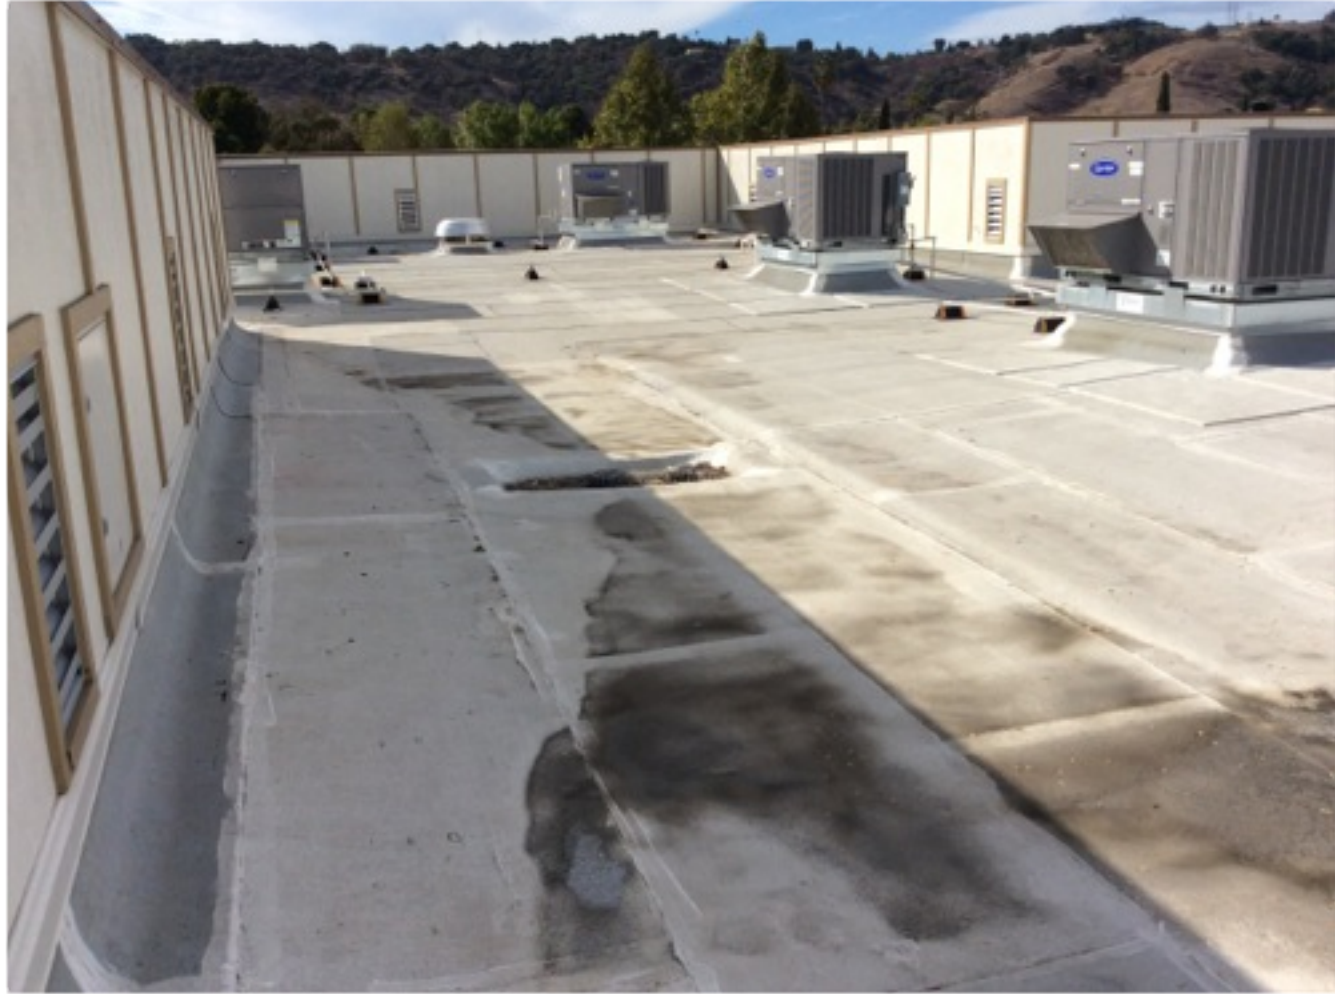
The photo below shows signs of ponding.

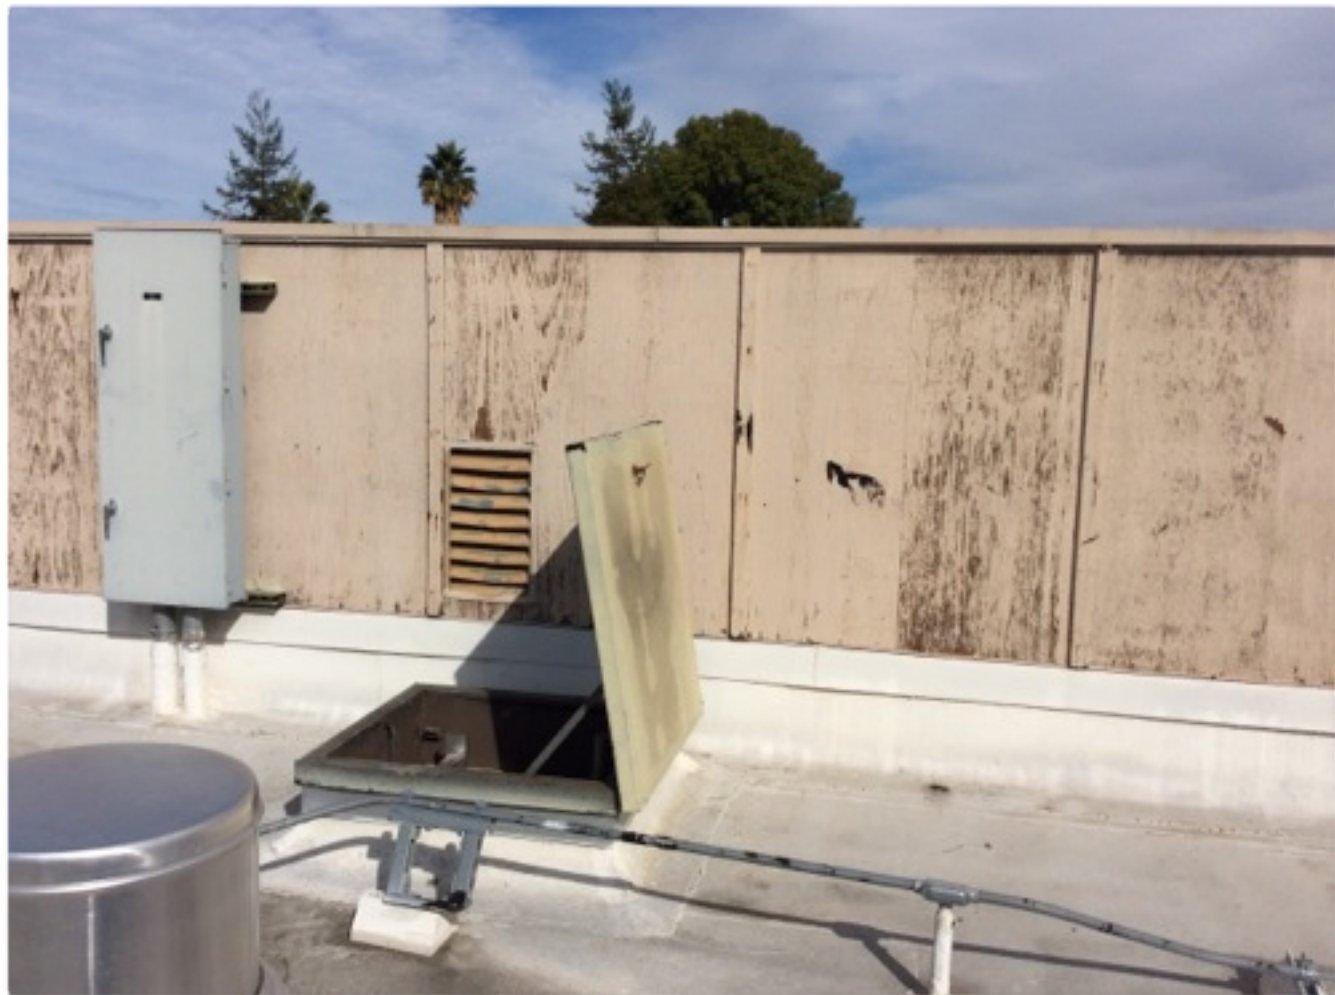
ADDITIONAL NOTES  
 THE ROOF LOOKS GOOD. THE WALLS ARE IN BAD SHAPE. IF MOISTURE ENTERS THE SYSTEM THROUGH THE WALLS THE ROOF LIFE EXPECTANCY COULD BE REDUCED.

The photo below shows the wall in need of repair and coating.

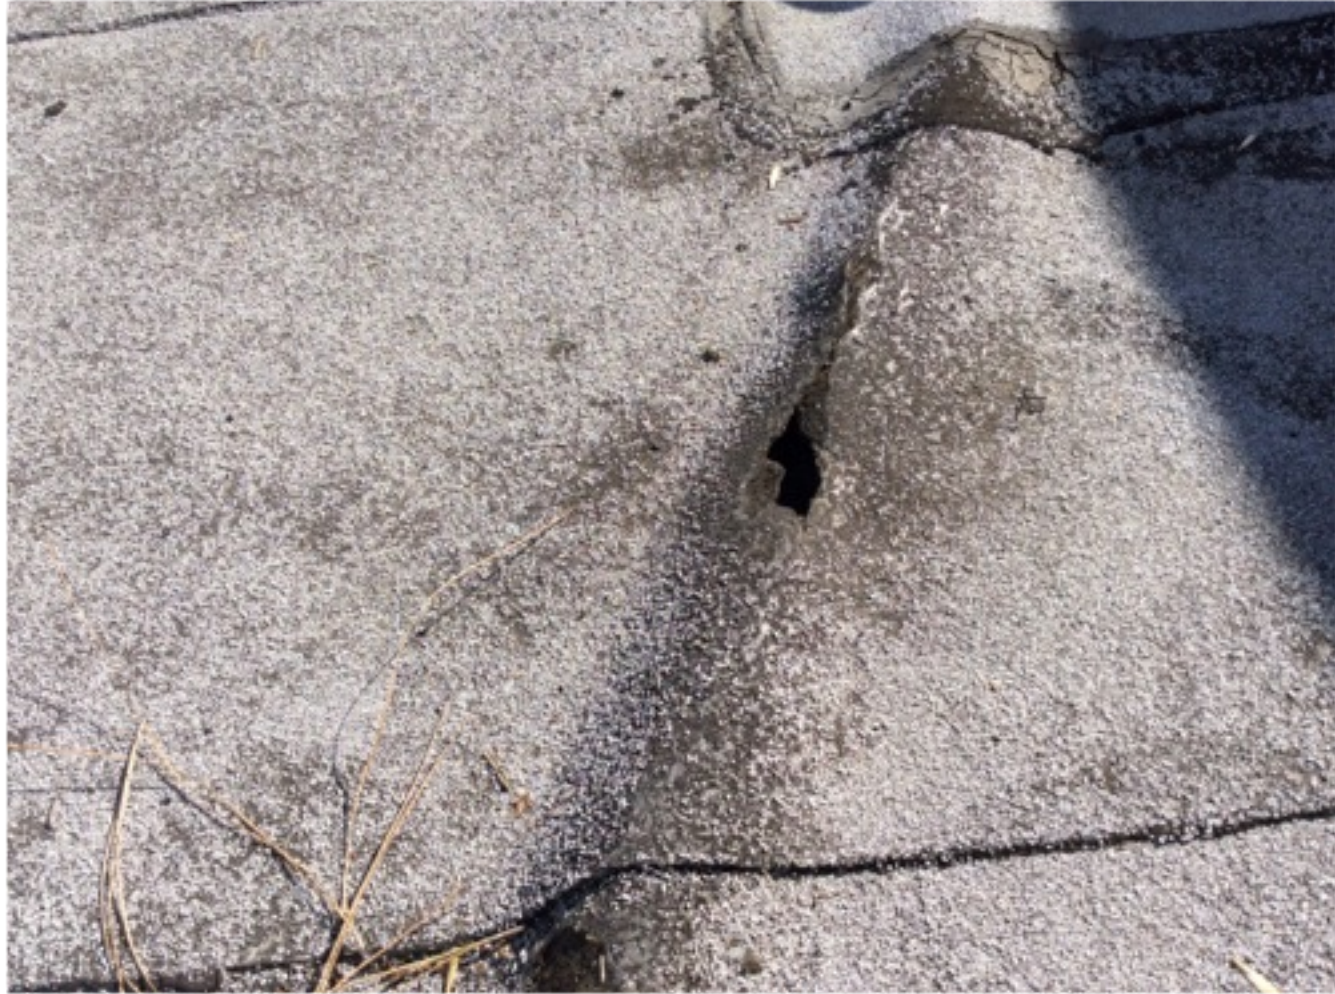
ADDITIONAL NOTES  
 REPLACE AS SOON AS POSSIBLE - OPEN HOLES IN THIS ROOF.

The photo below shows the excessive wear - open hole - of the membrane.

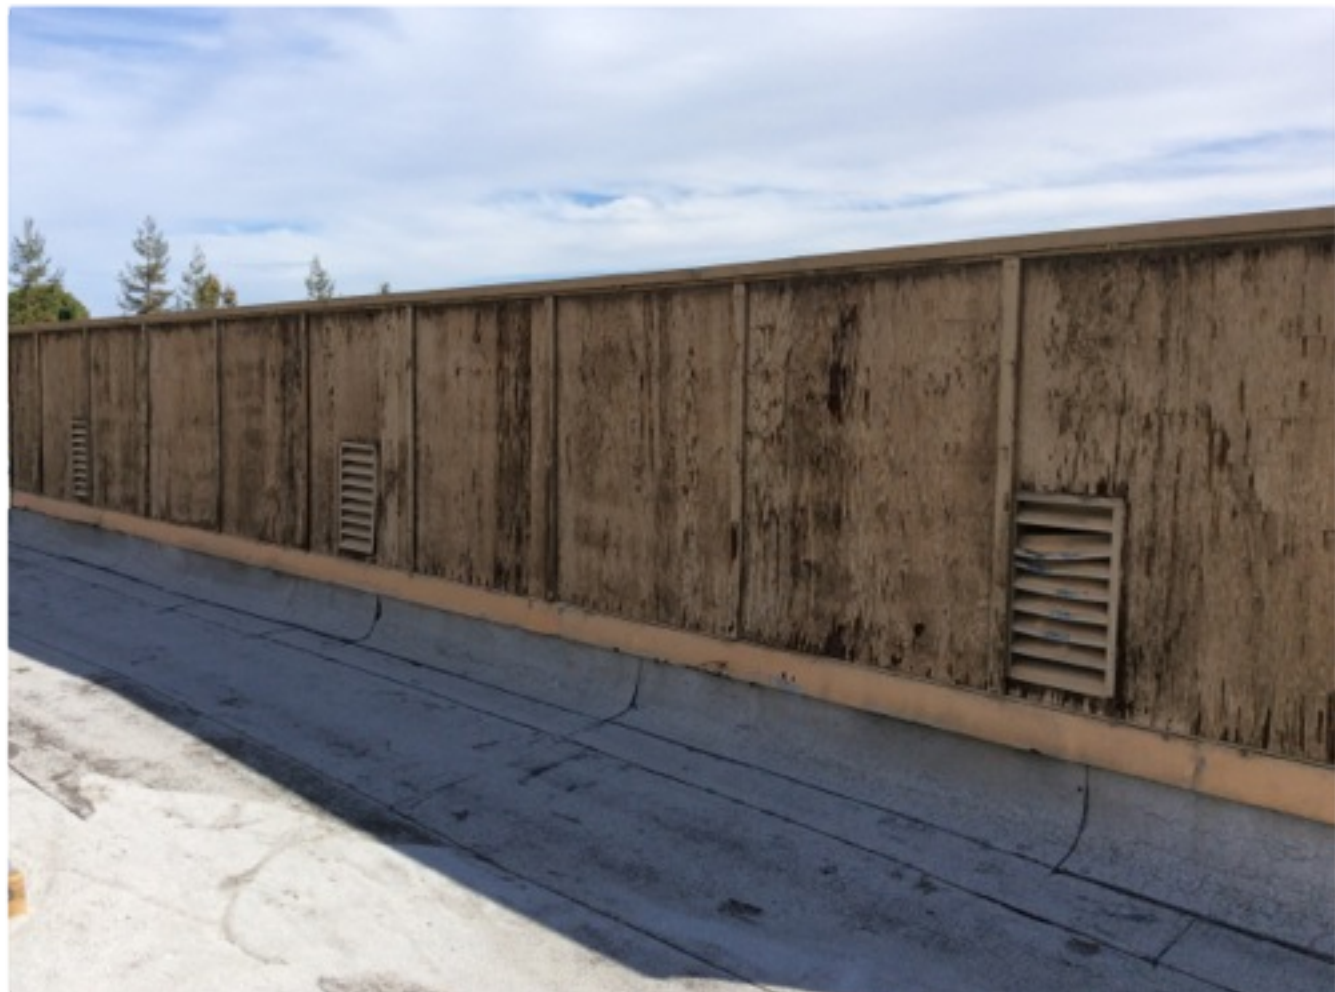
The photo below shows the wall in need of repair and coating.

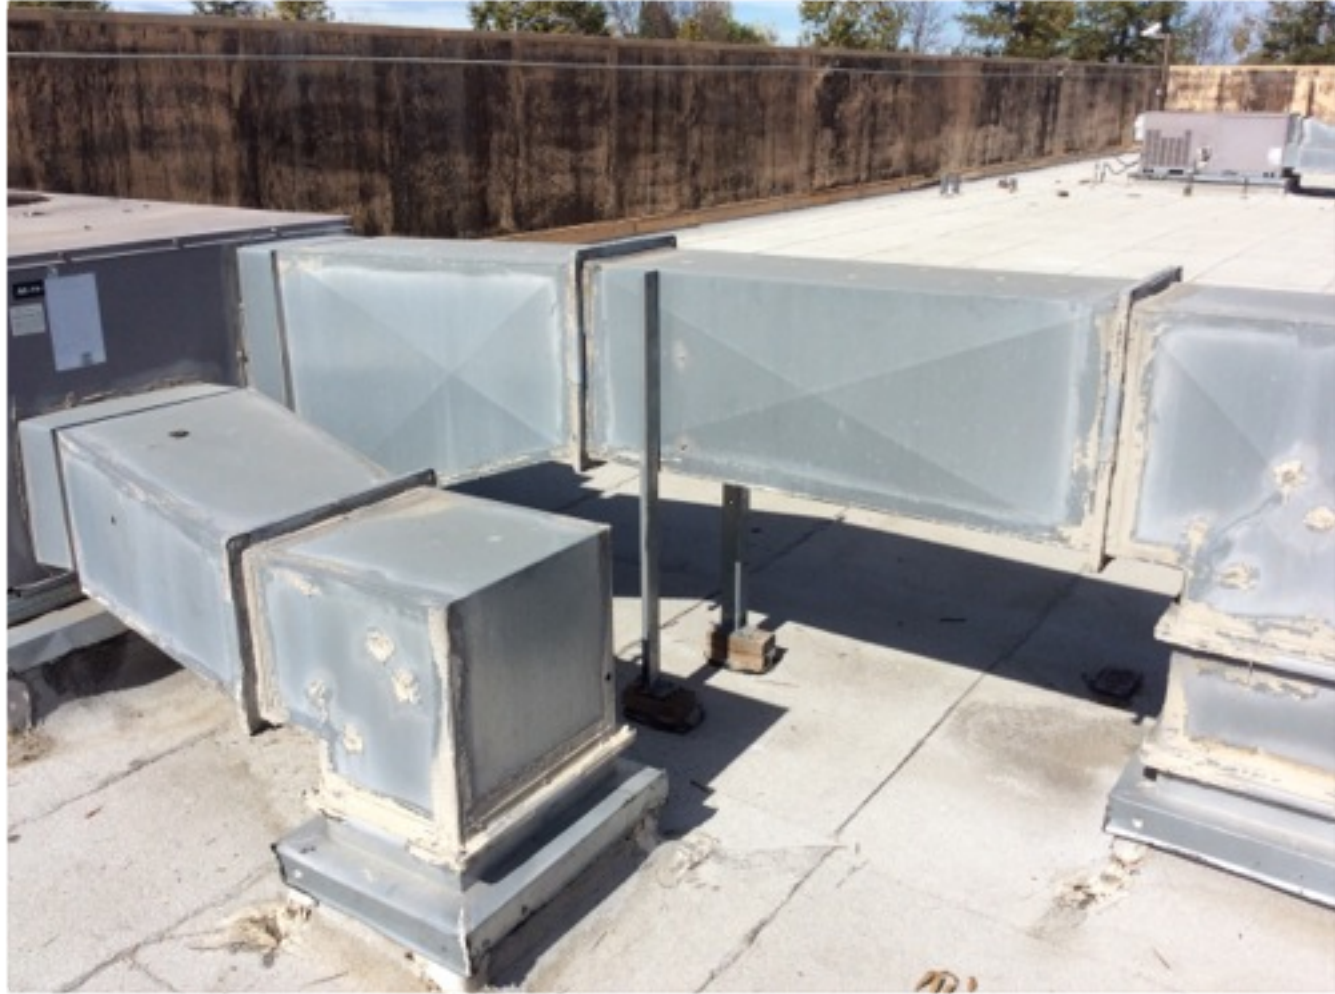
The photo below shows the AC ducts in need of a reseal and recoating.

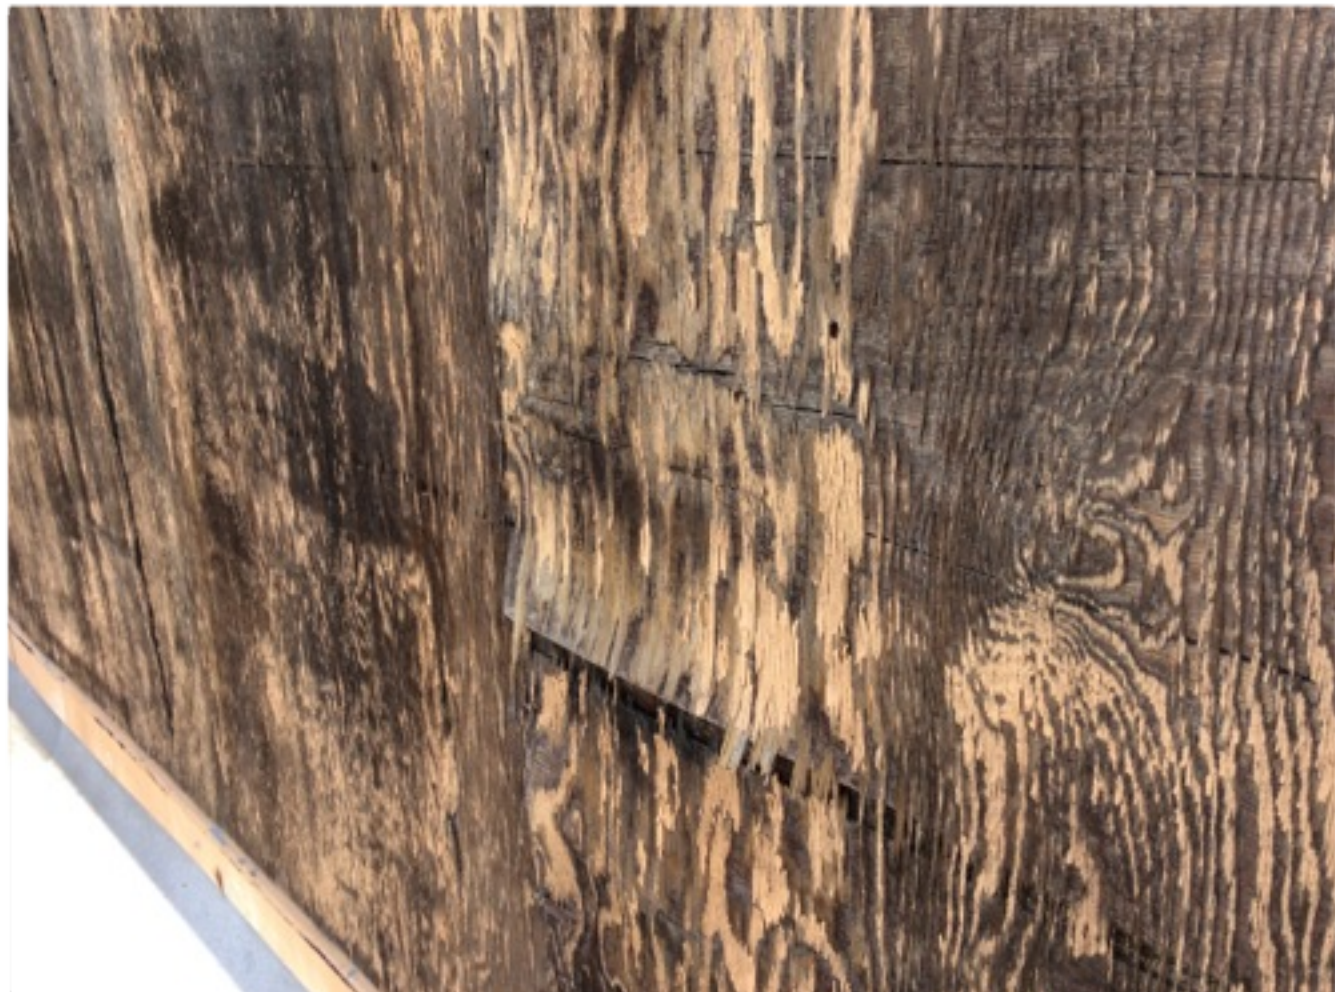
The photo below shows the wall in need of repair and coating.

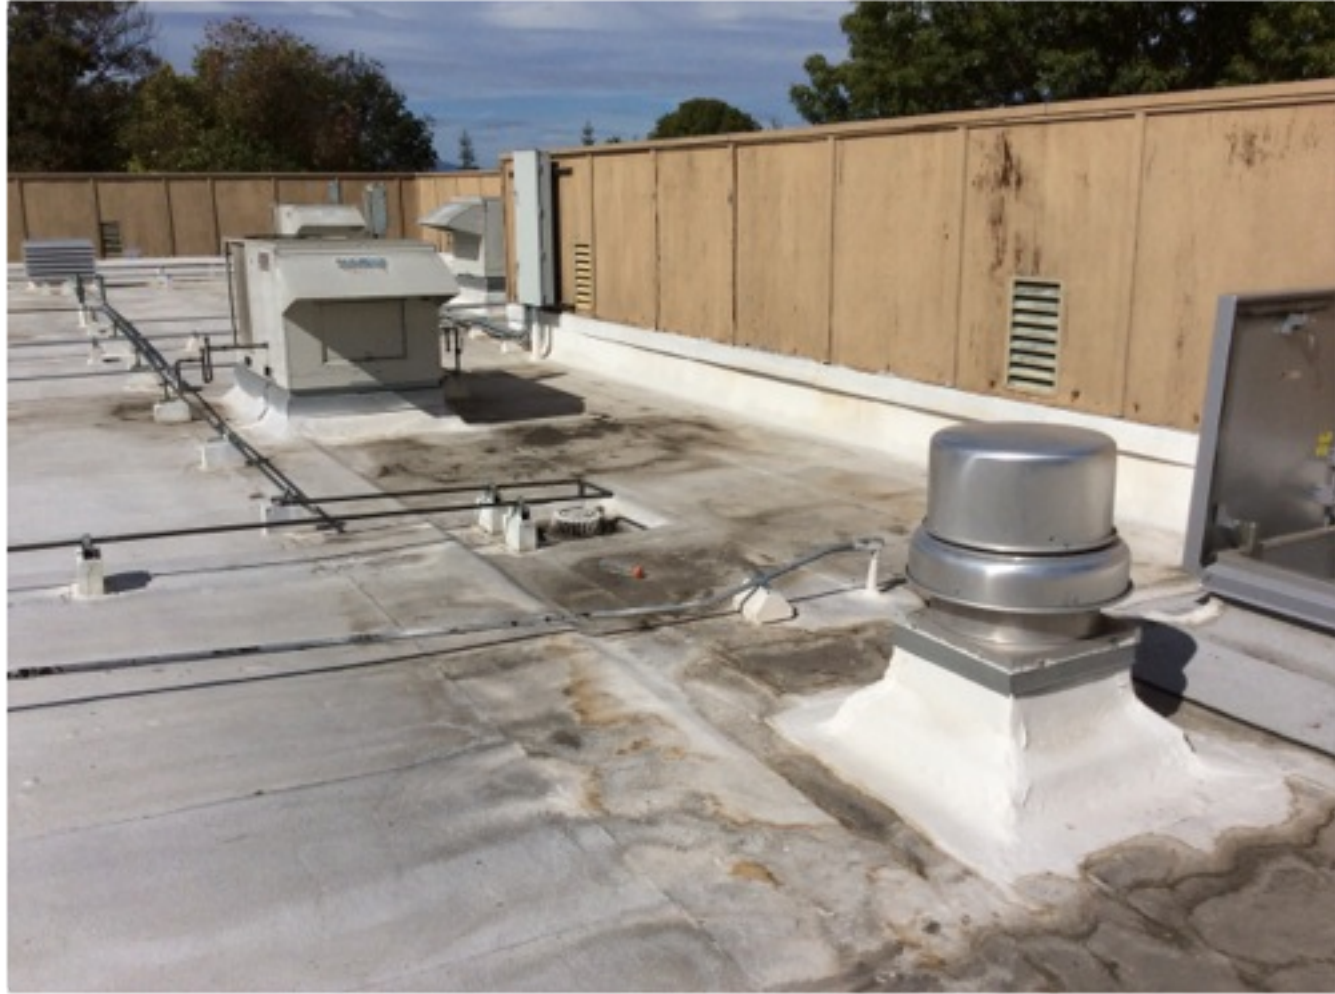
The photo below shows that there is a ponding problem at this roof.

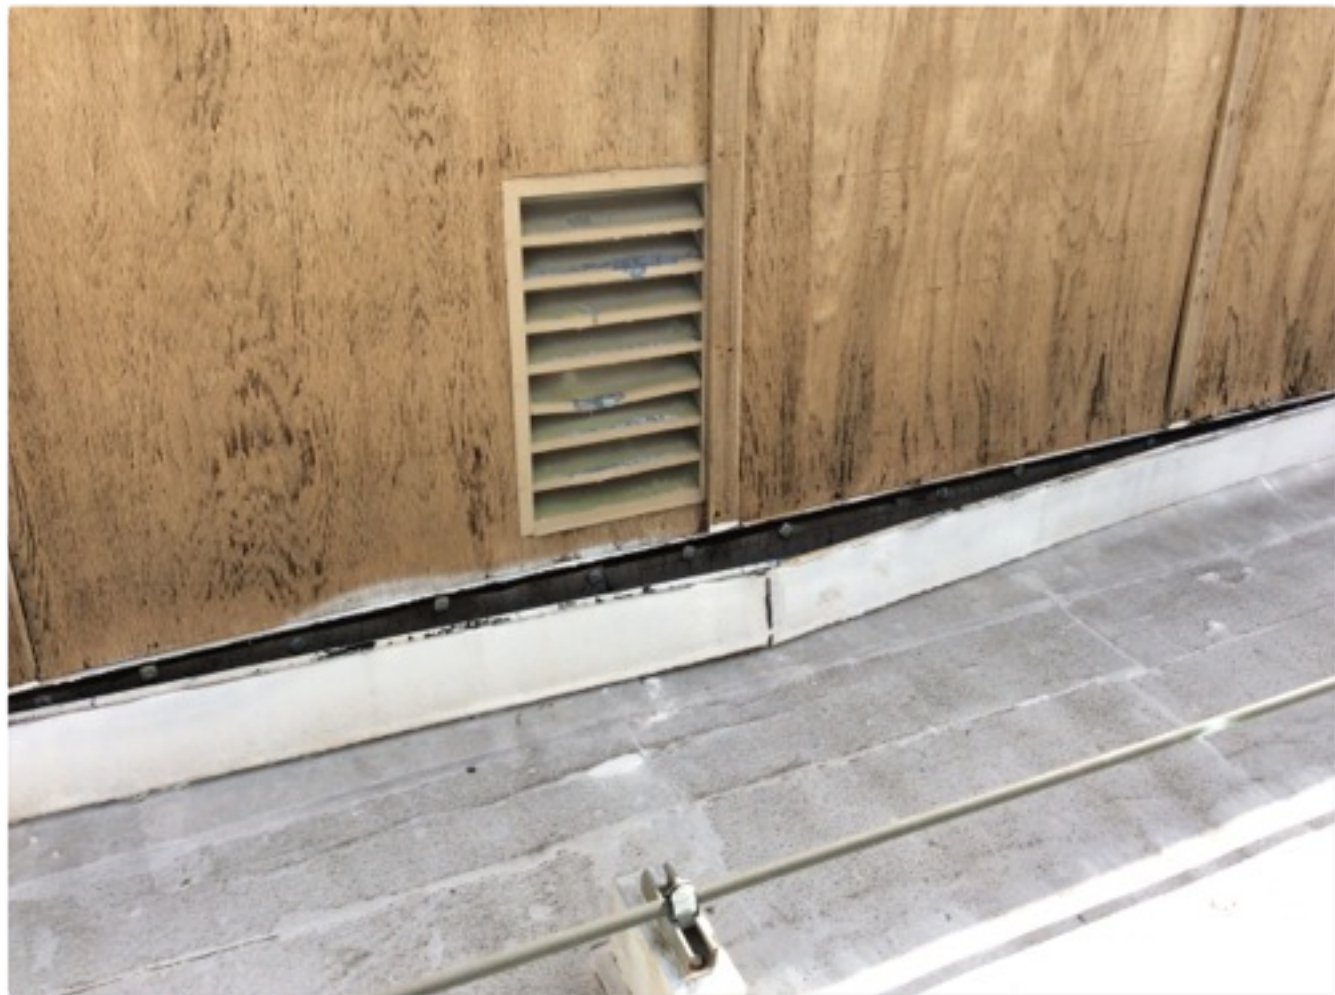
The photo below shows the wall flashing in need of repair.

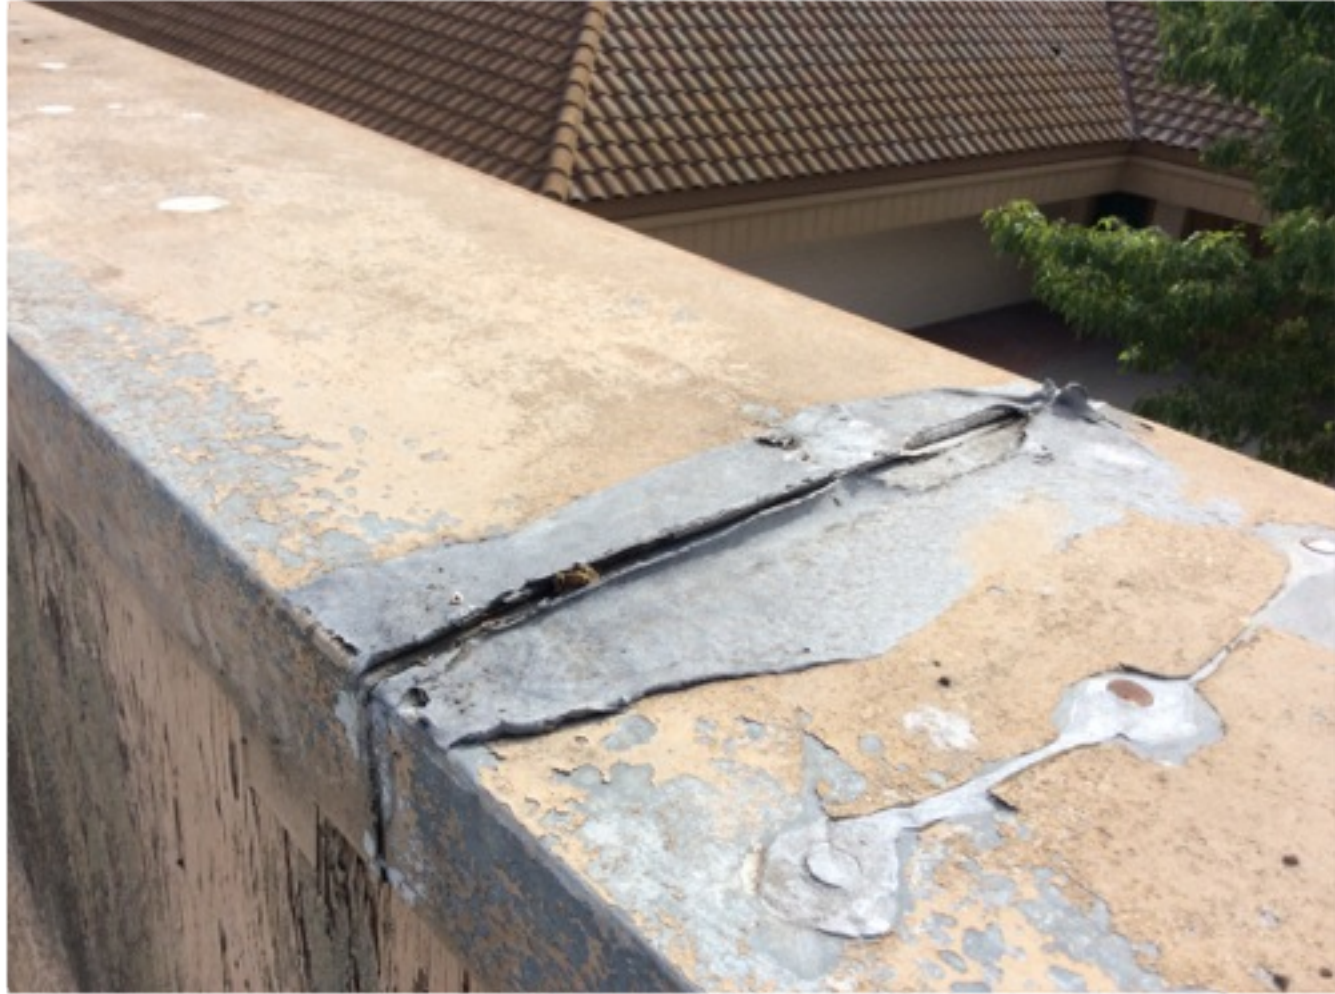
The photo below shows the wall and flashings in bad shape.

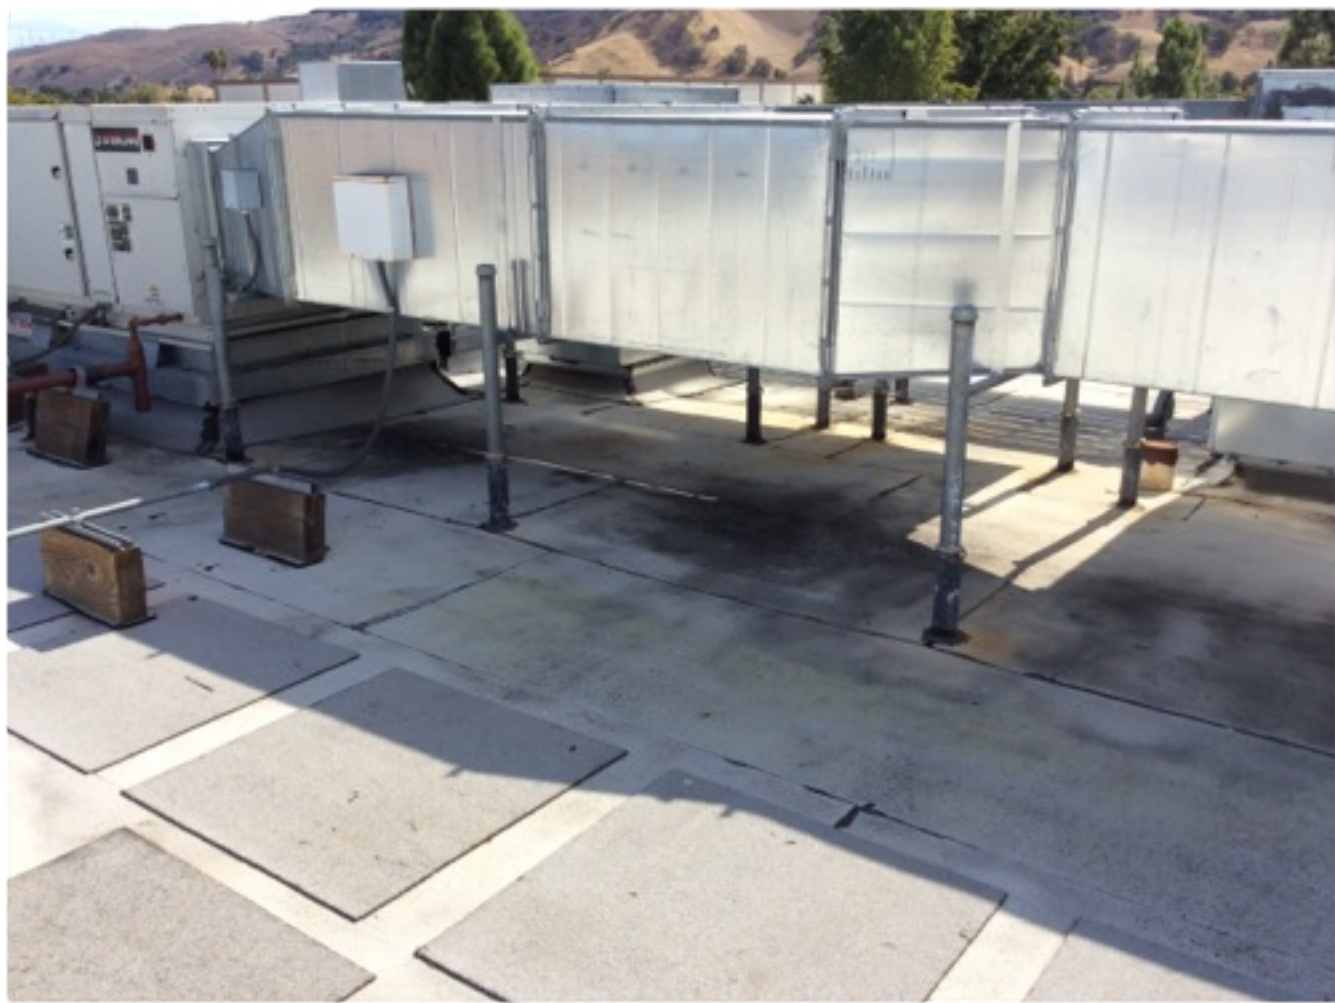
The photo below shows signs of very little ponding.

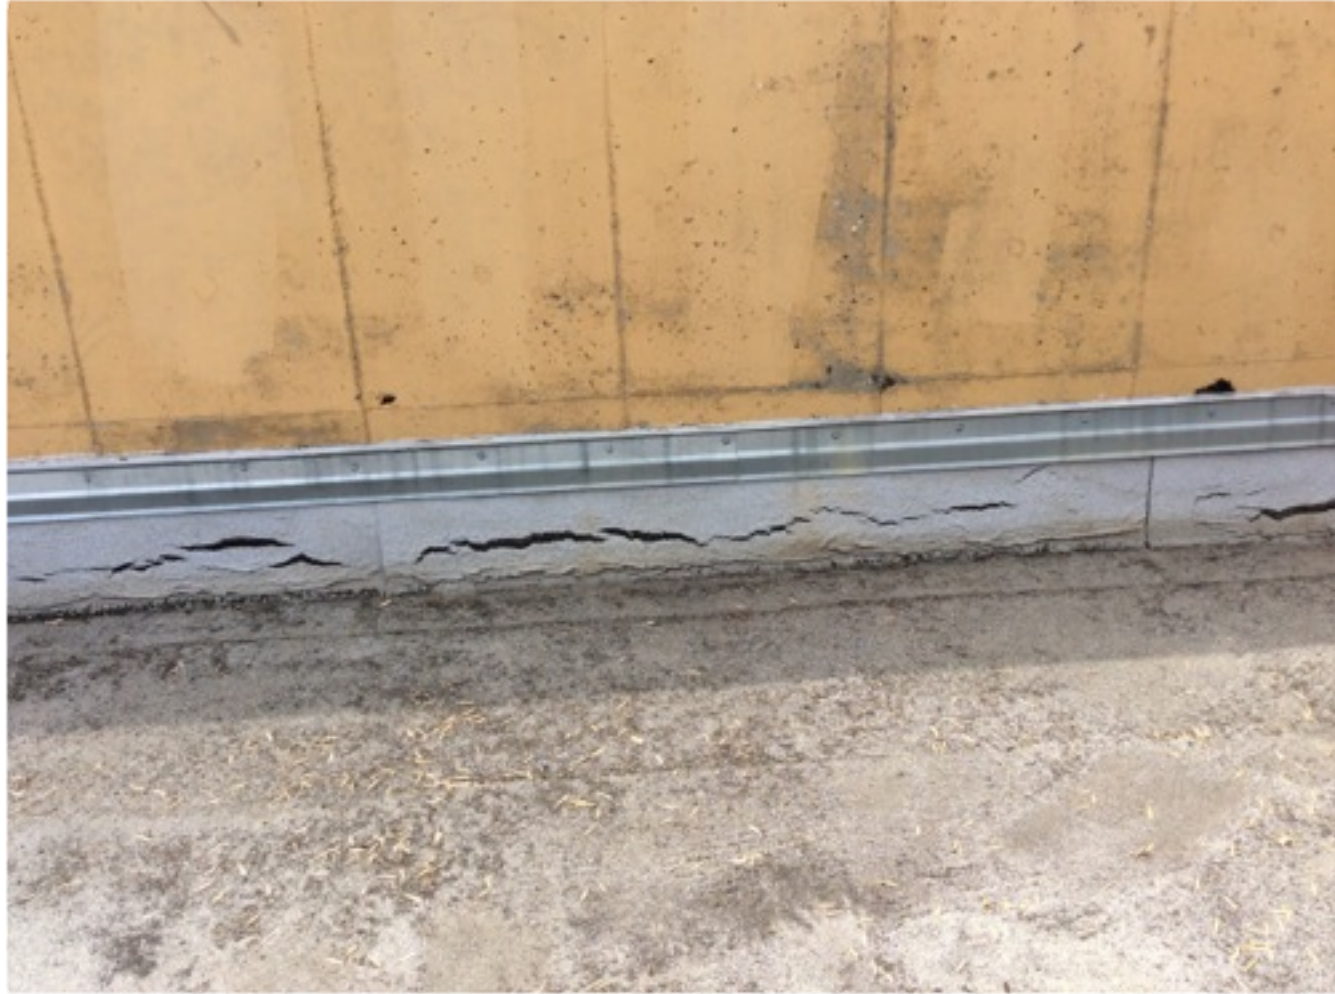
The photo below shows the base flashing failing.

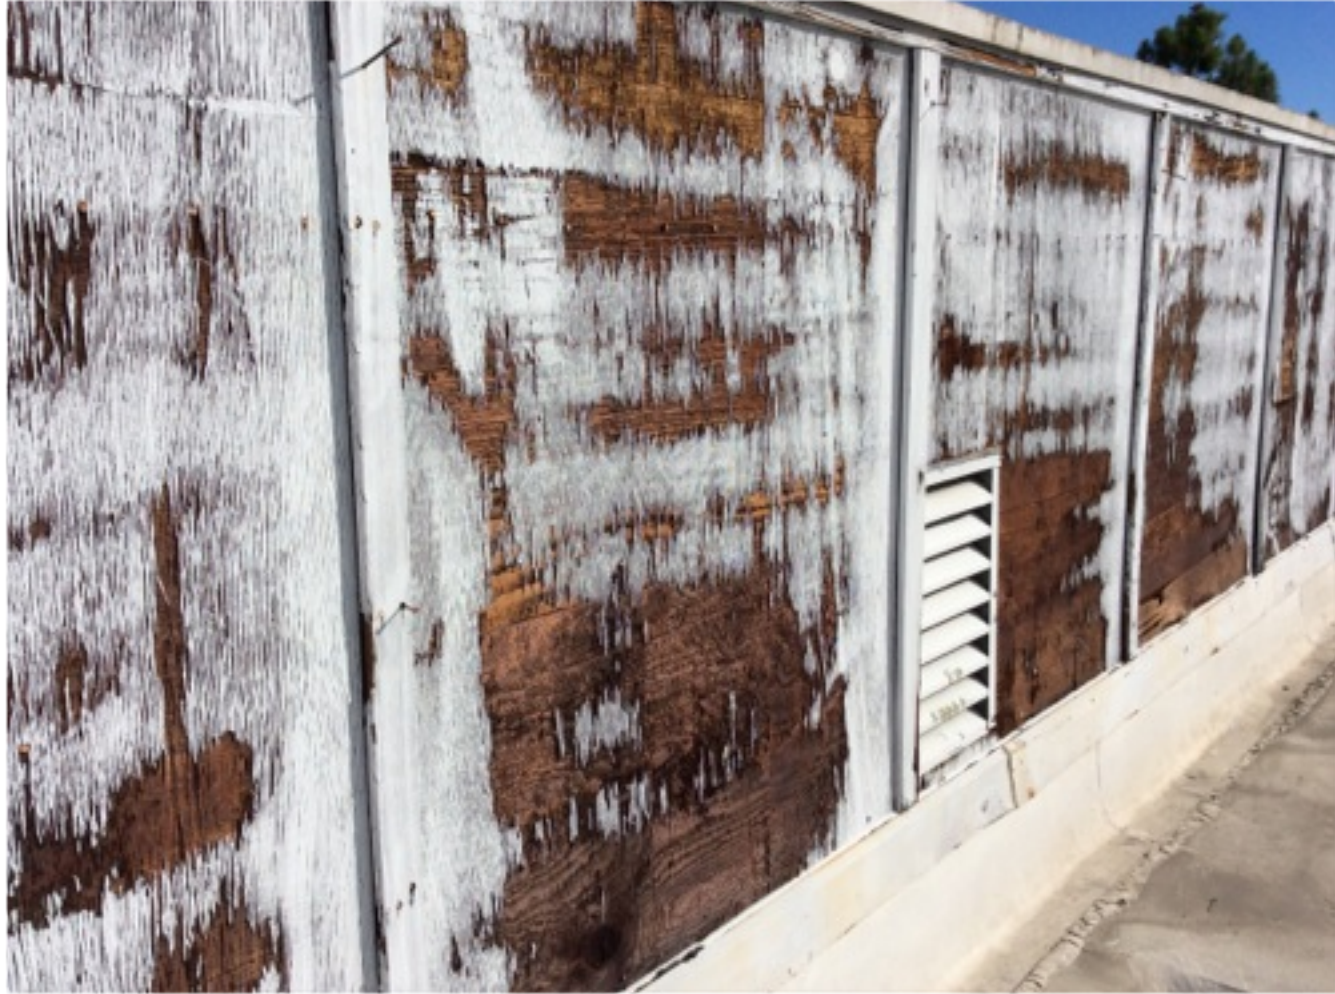
The photo below shows the walls in need of repair and recoating.

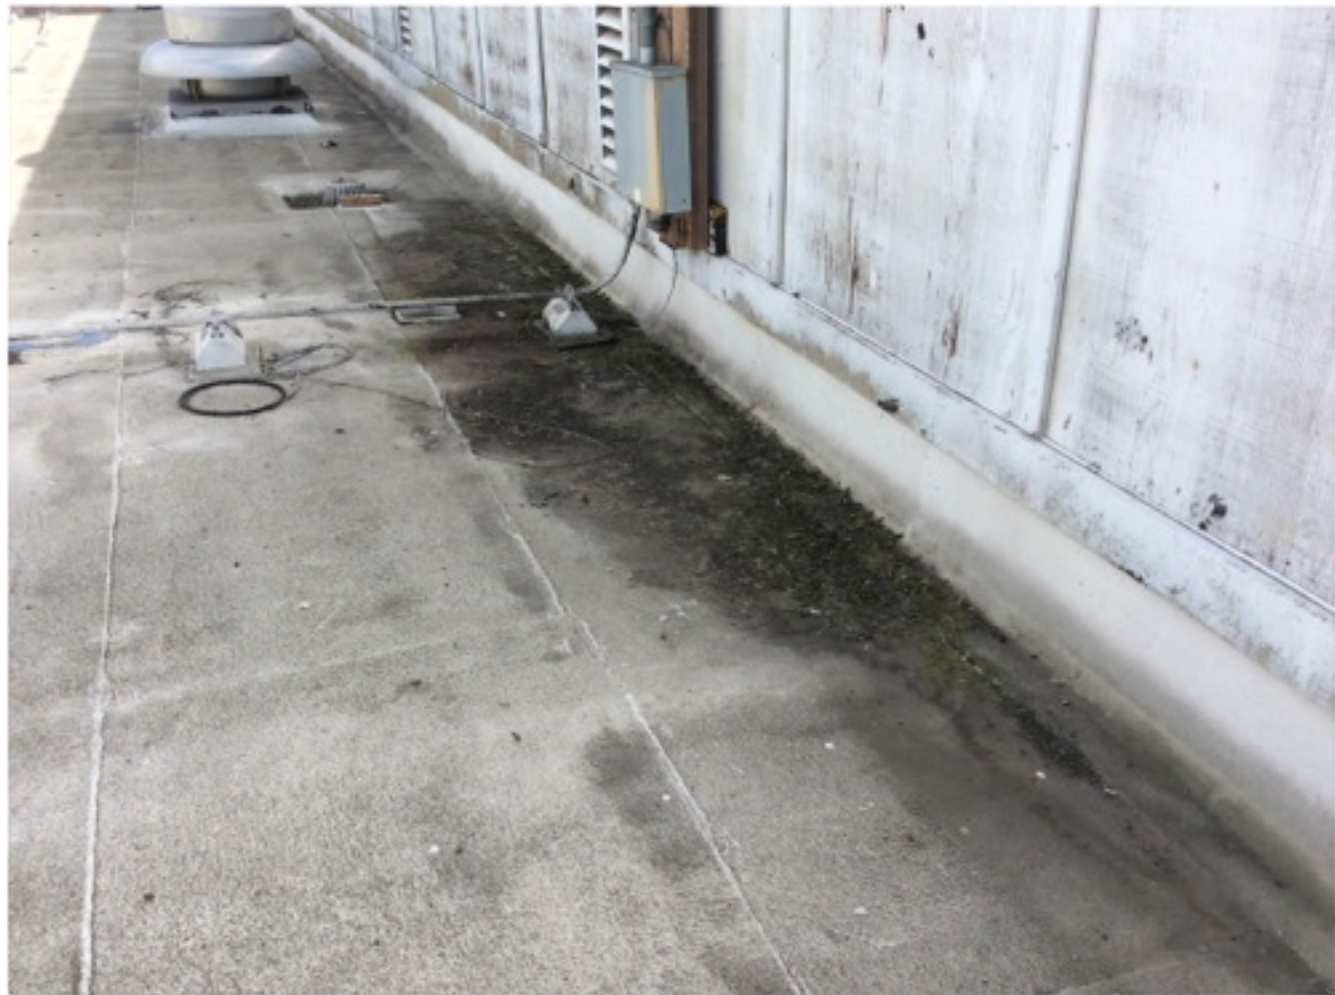
The photo below shows signs of heavy ponding.
