BUILDING INFORMATION	
FACILITY	Santa Teresa HS
DATE	October 17, 2014
BUILDING	100, 900, 1000, and 1100
ROOF SQ FT	24,000

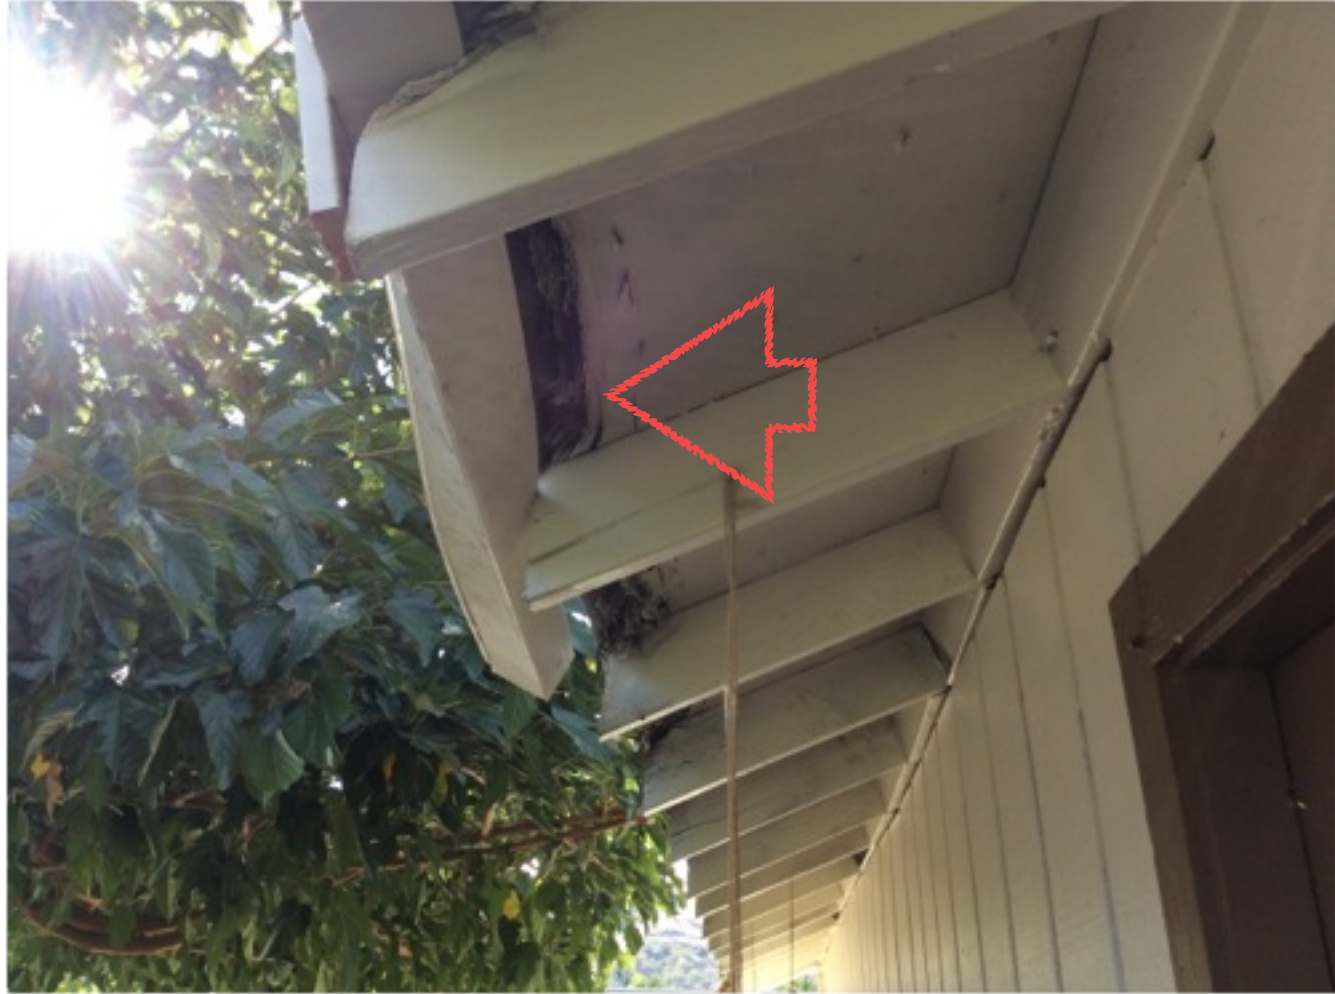
The photo below shows dryrot of the deck at the roof perimeter eaves.

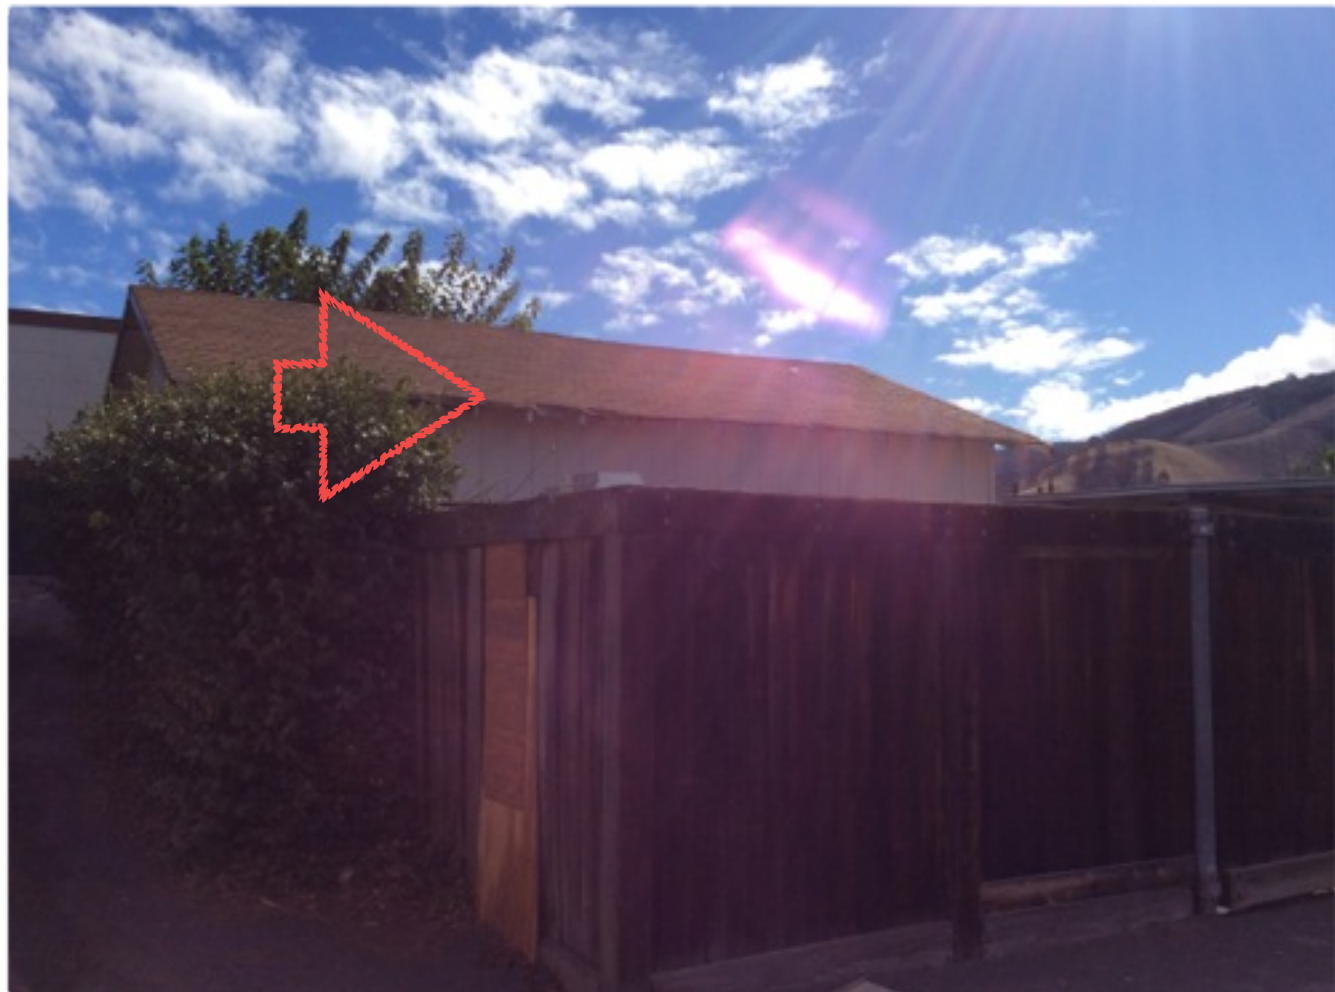
The photo below shows damage on both sides of the building.

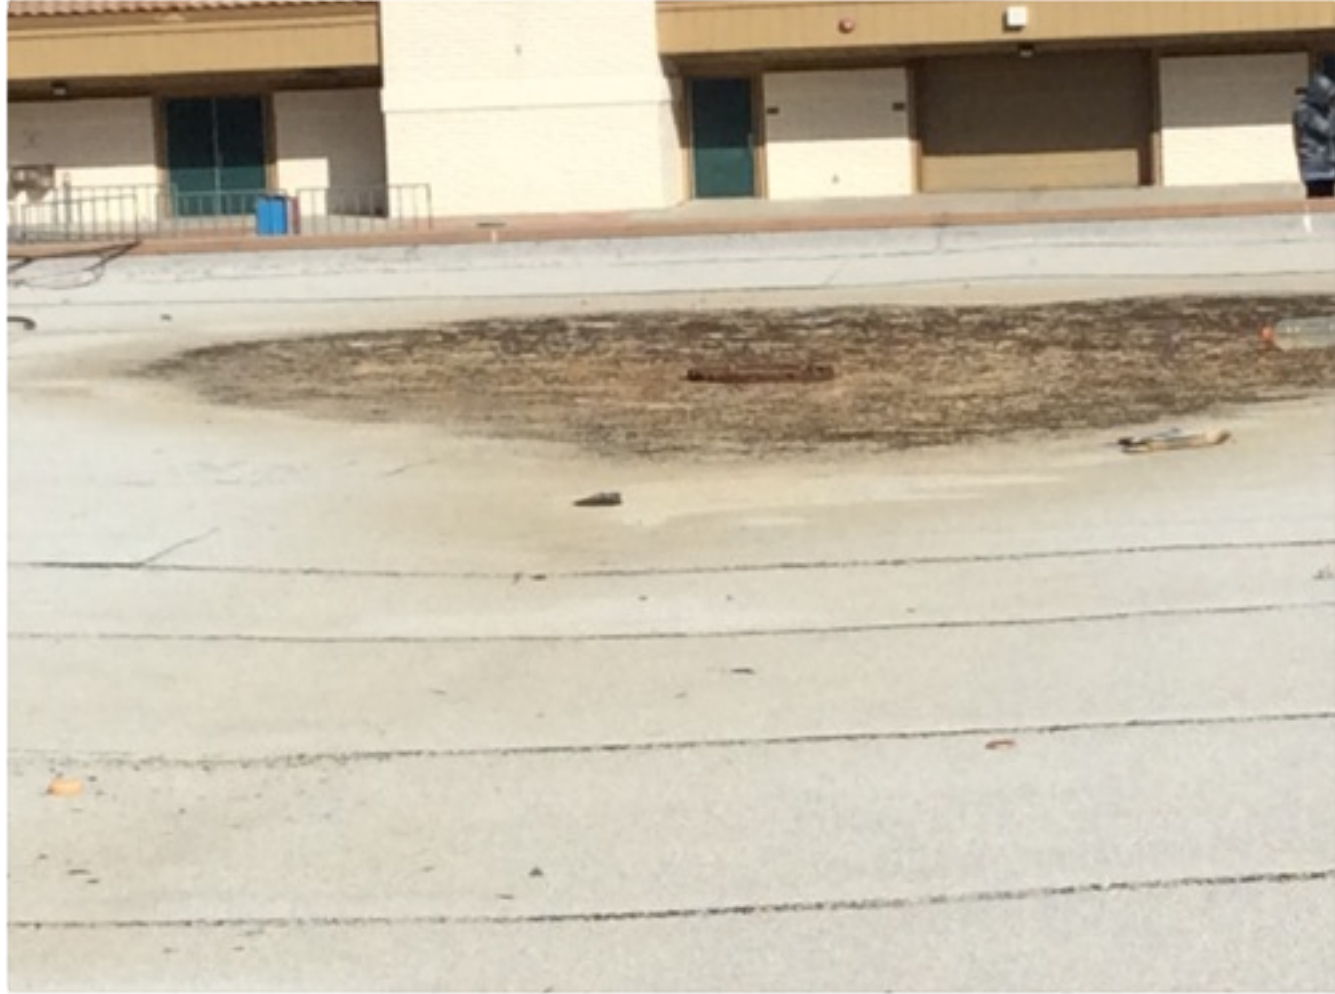
The photo below shows the excessive ponding on the roof.

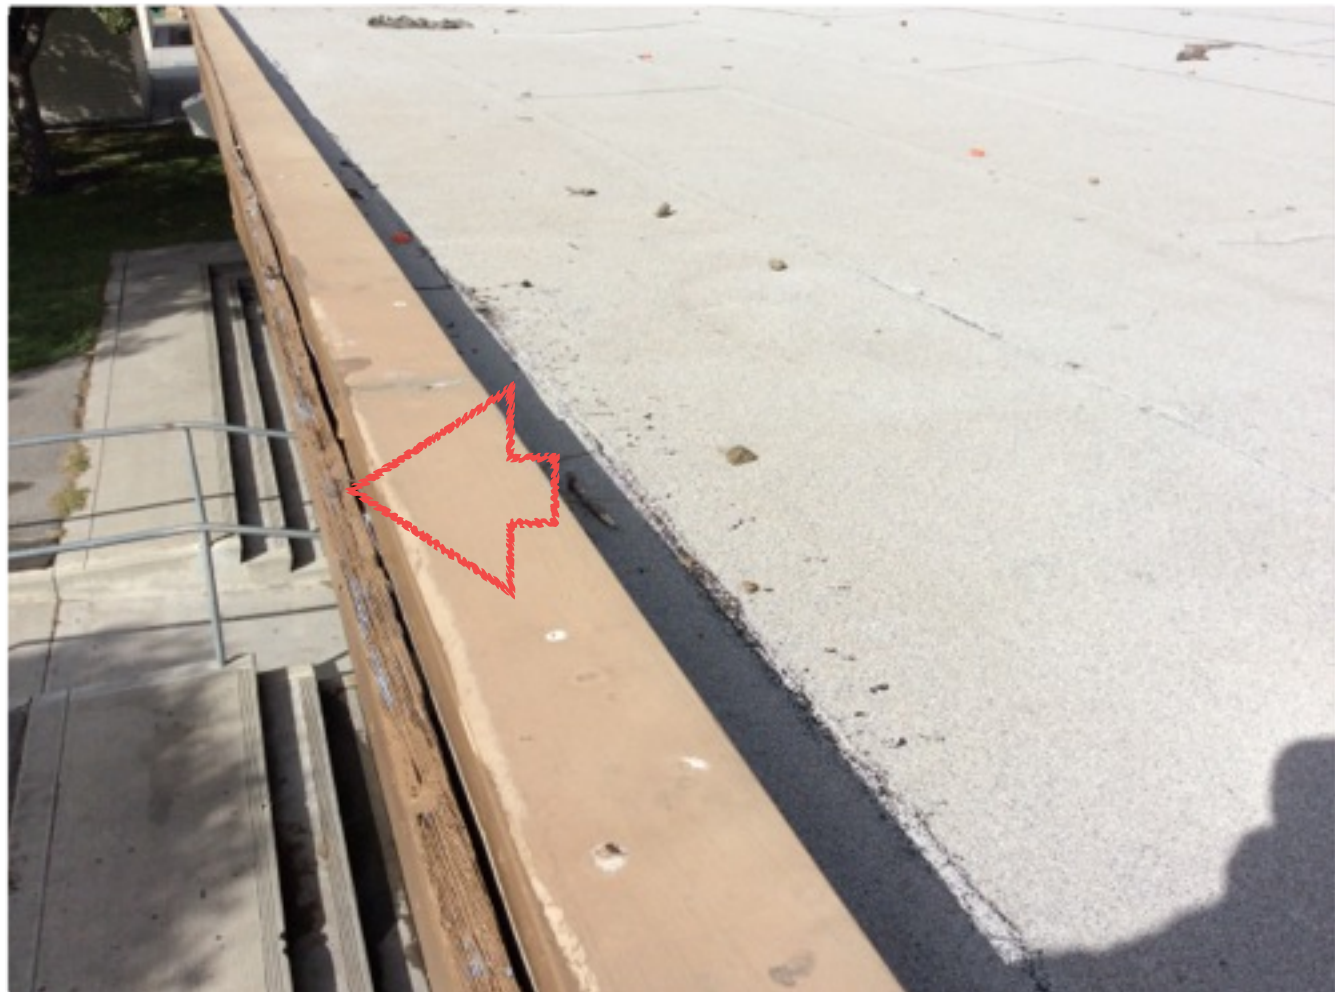
The photo below show the fascia deteriorating.

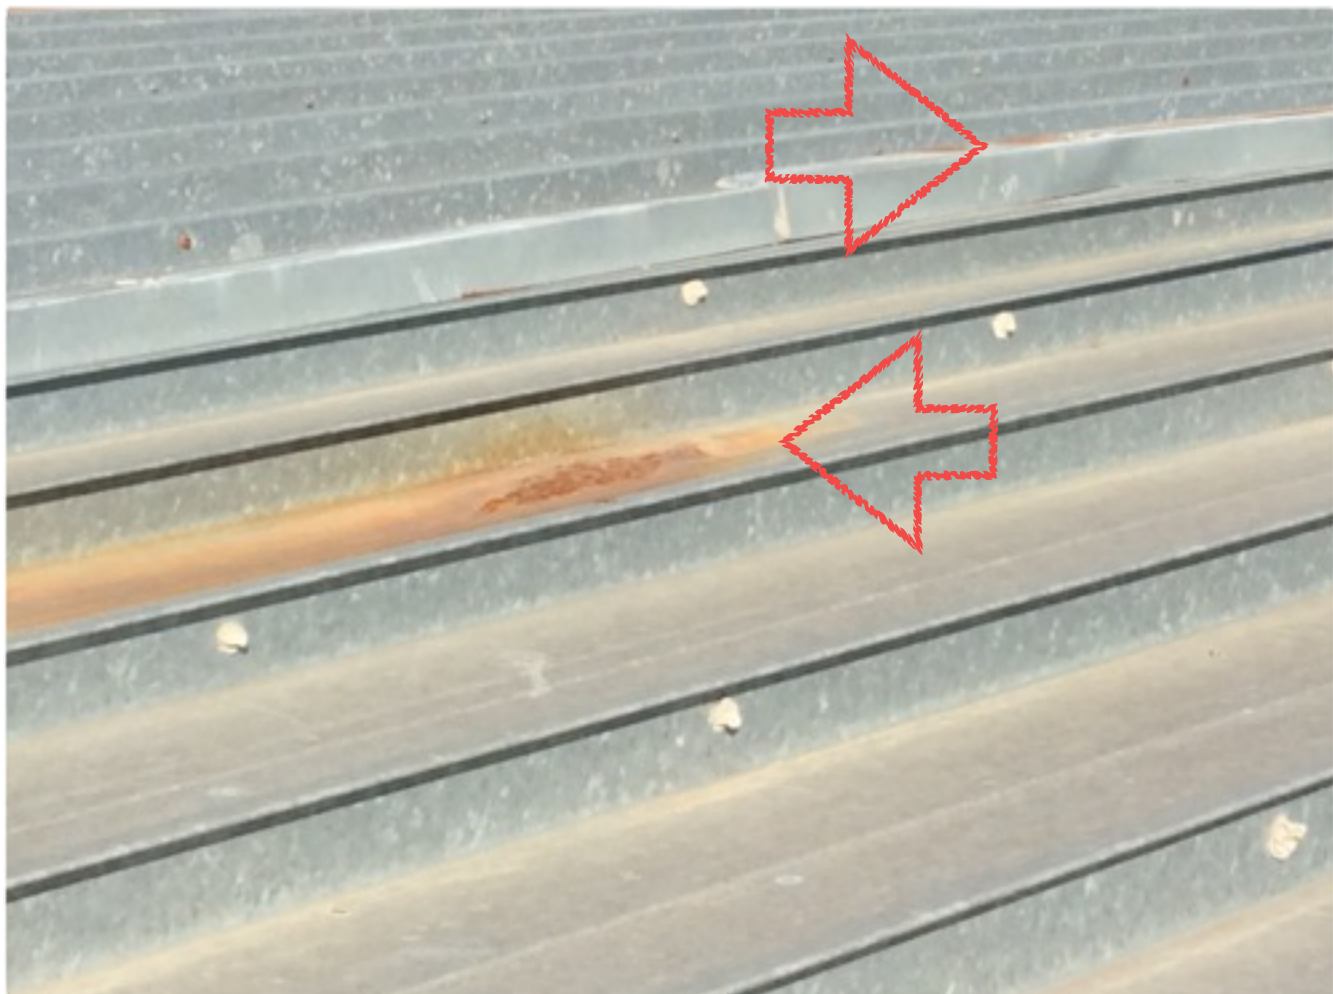
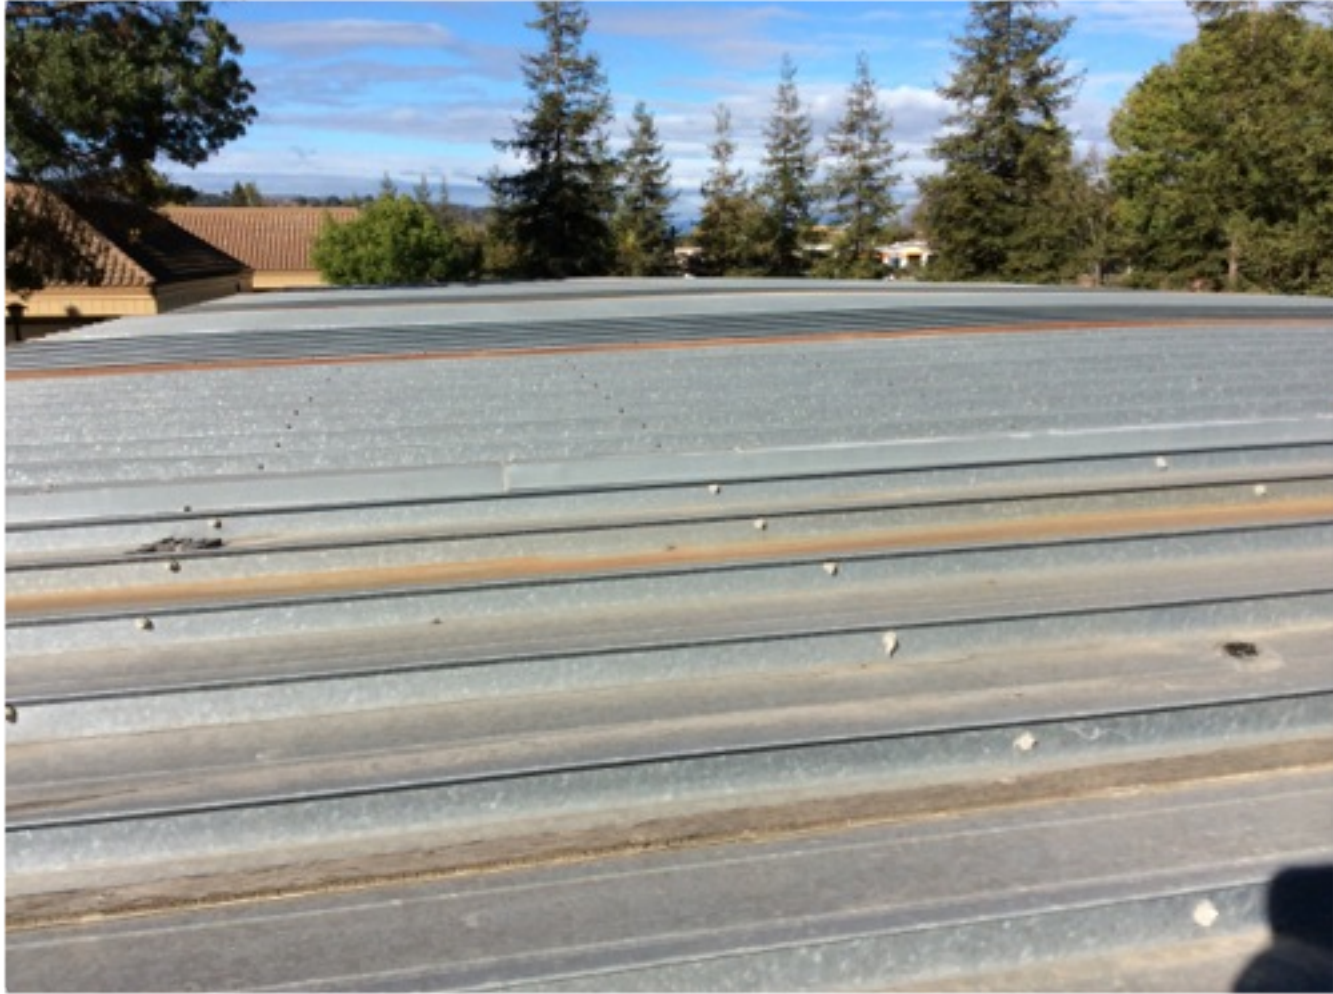
The photo below shows significant rusting - also the photo above.

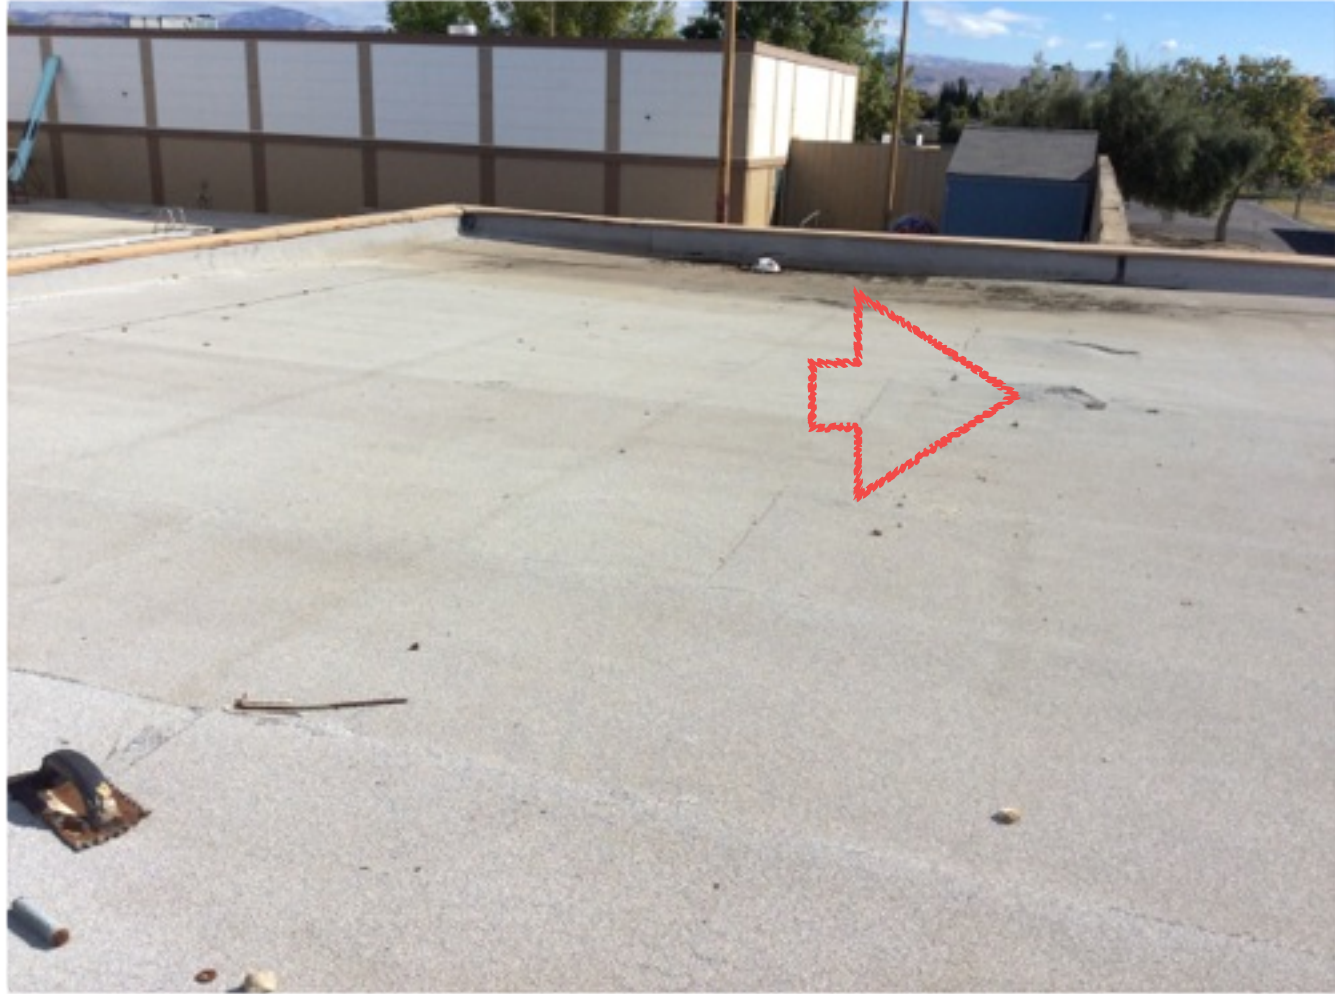
The photo below shows large blisters - the roof also has ridging.

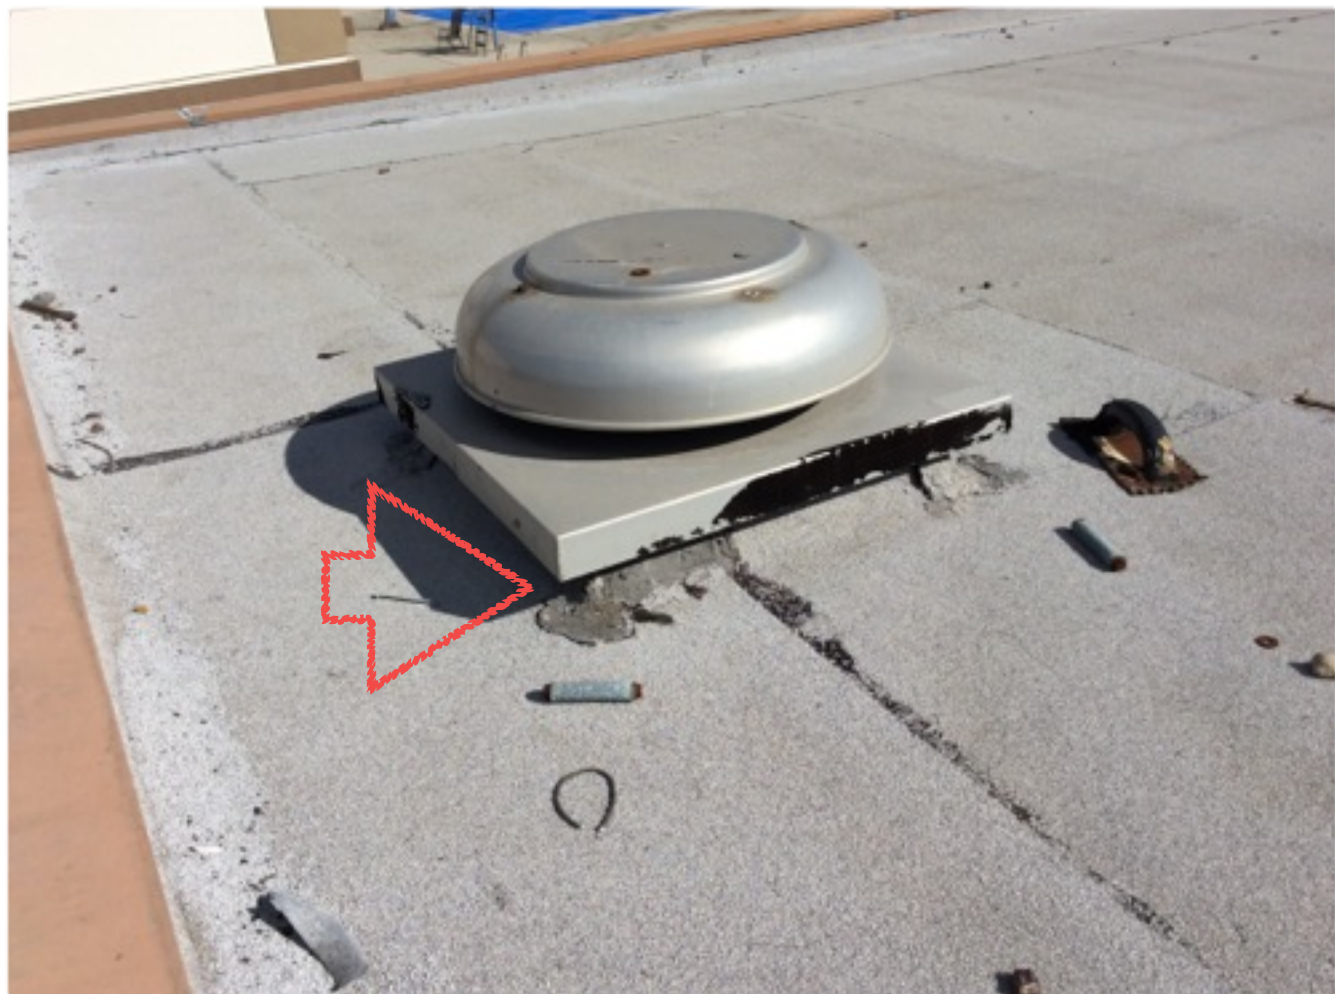
The photo below shows the penetration details in need of repair.

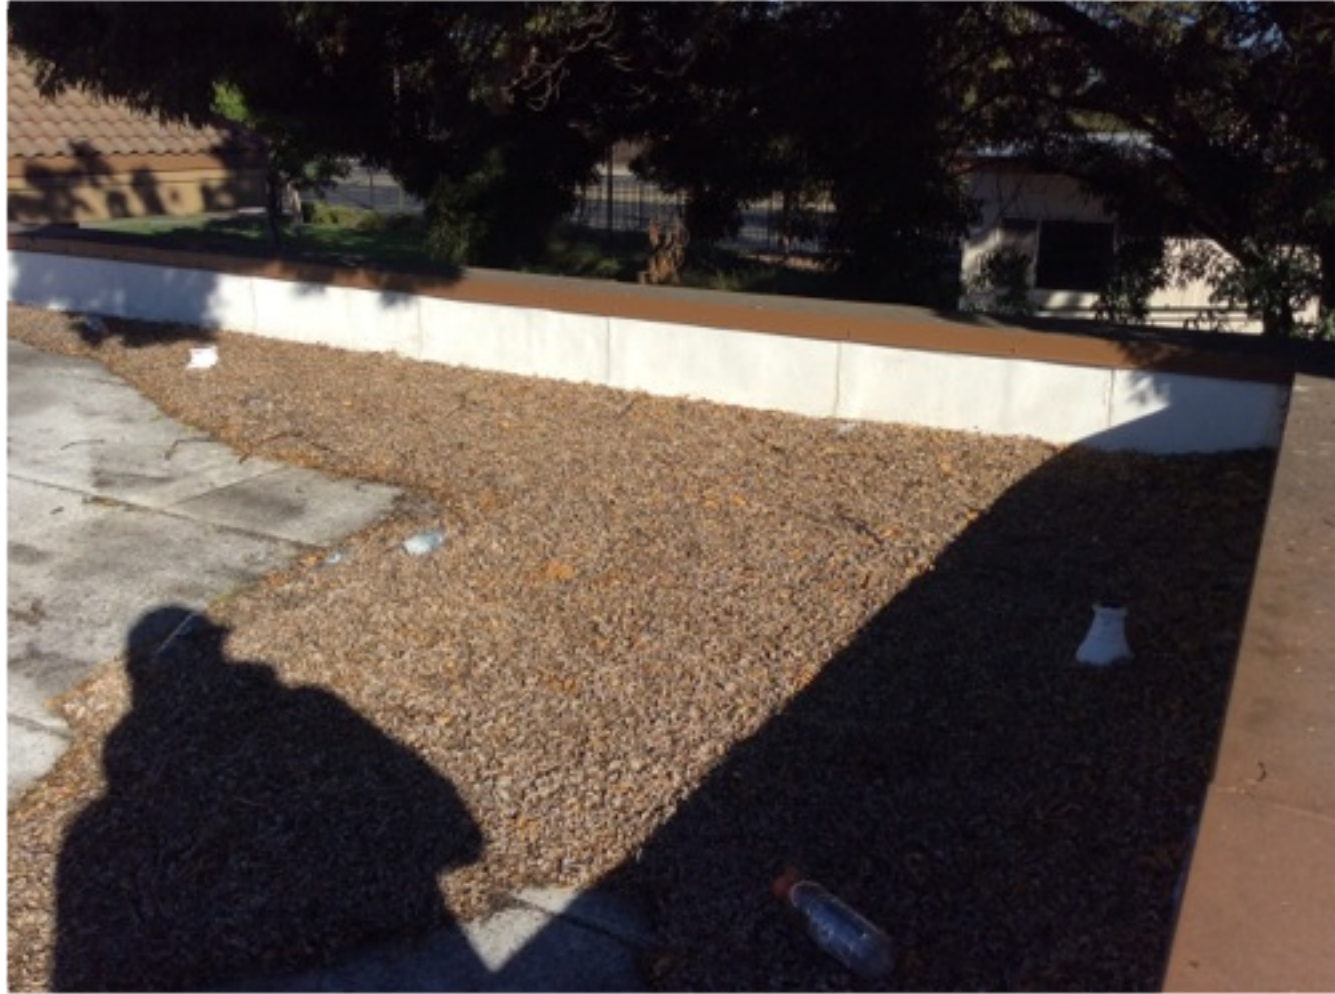
The photo below shows the need to trim trees - this leads to faster roof deterioration.

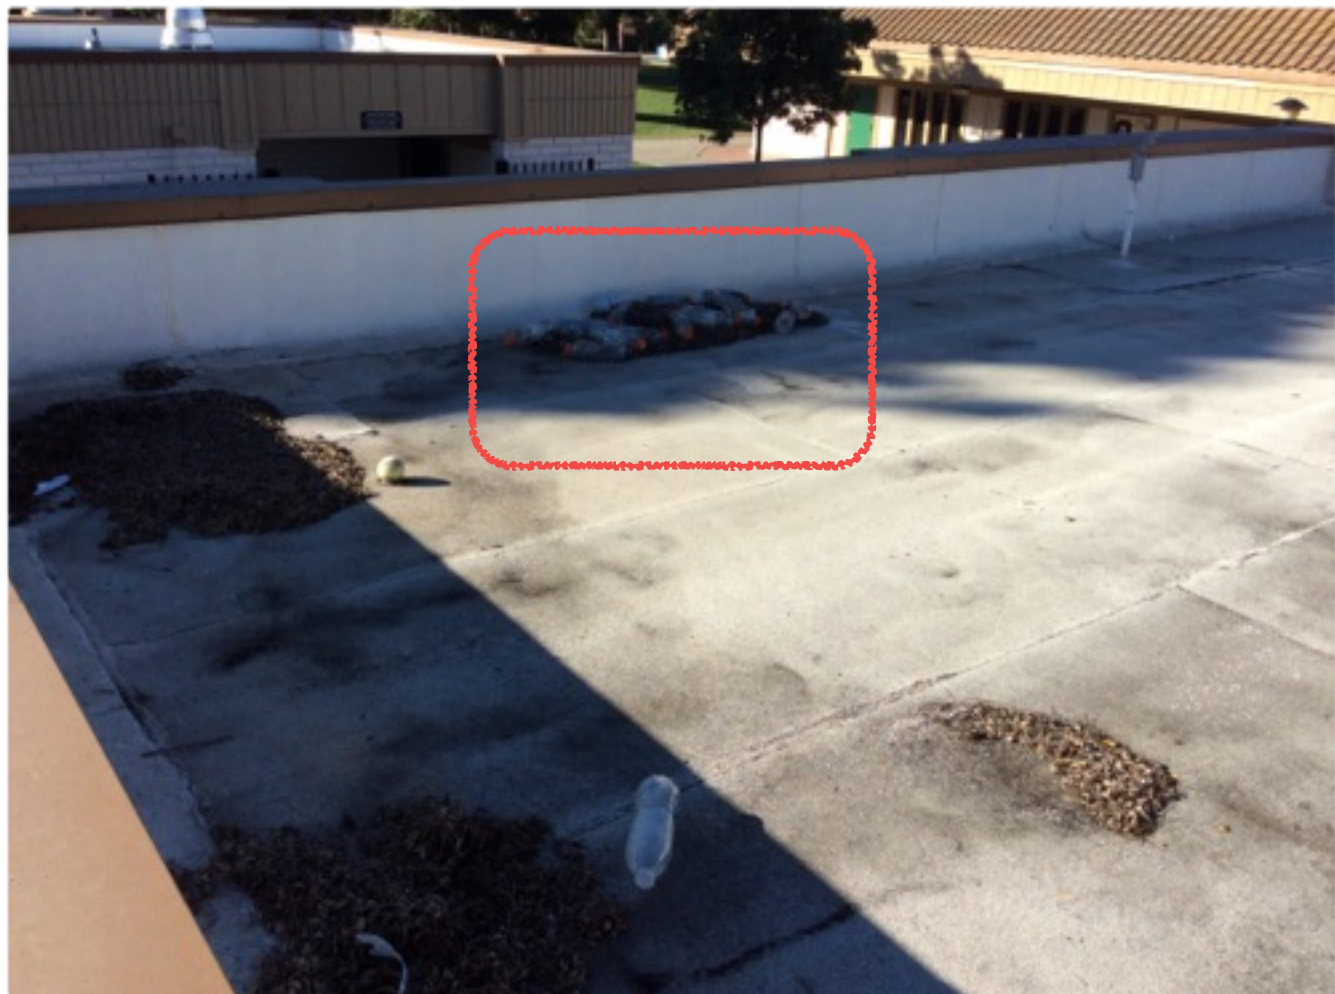
The photo below shows the drains needing to be cleared.
