BUILDING INFORMATION	
FACILITY	Yerba Buena HS
DATE	October 14, 2014
BUILDING	100, 800, 1000, Food Services
ROOF SQ FT	25,000

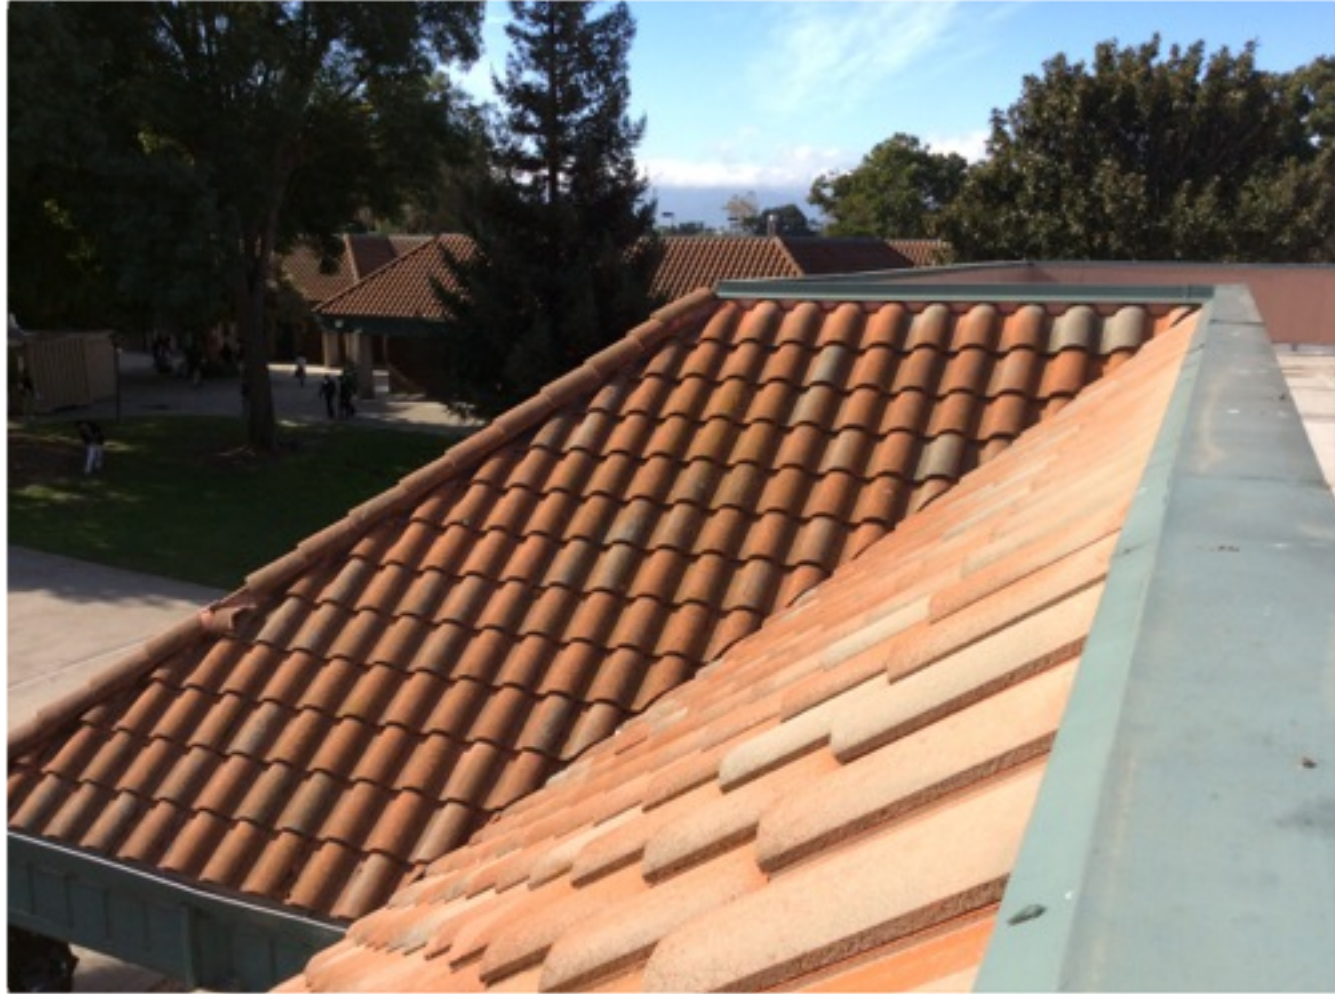
**ADDITIONAL NOTES**  
 SMALL AMOUNT OF BLISTERS FOUND, ONE AREA WHERE FLASHING IS FALLING OFF. MANY BROKEN TILES. TILE AREA APPROXIMATELY 18000SF.

The photo below shows some broken tiles.

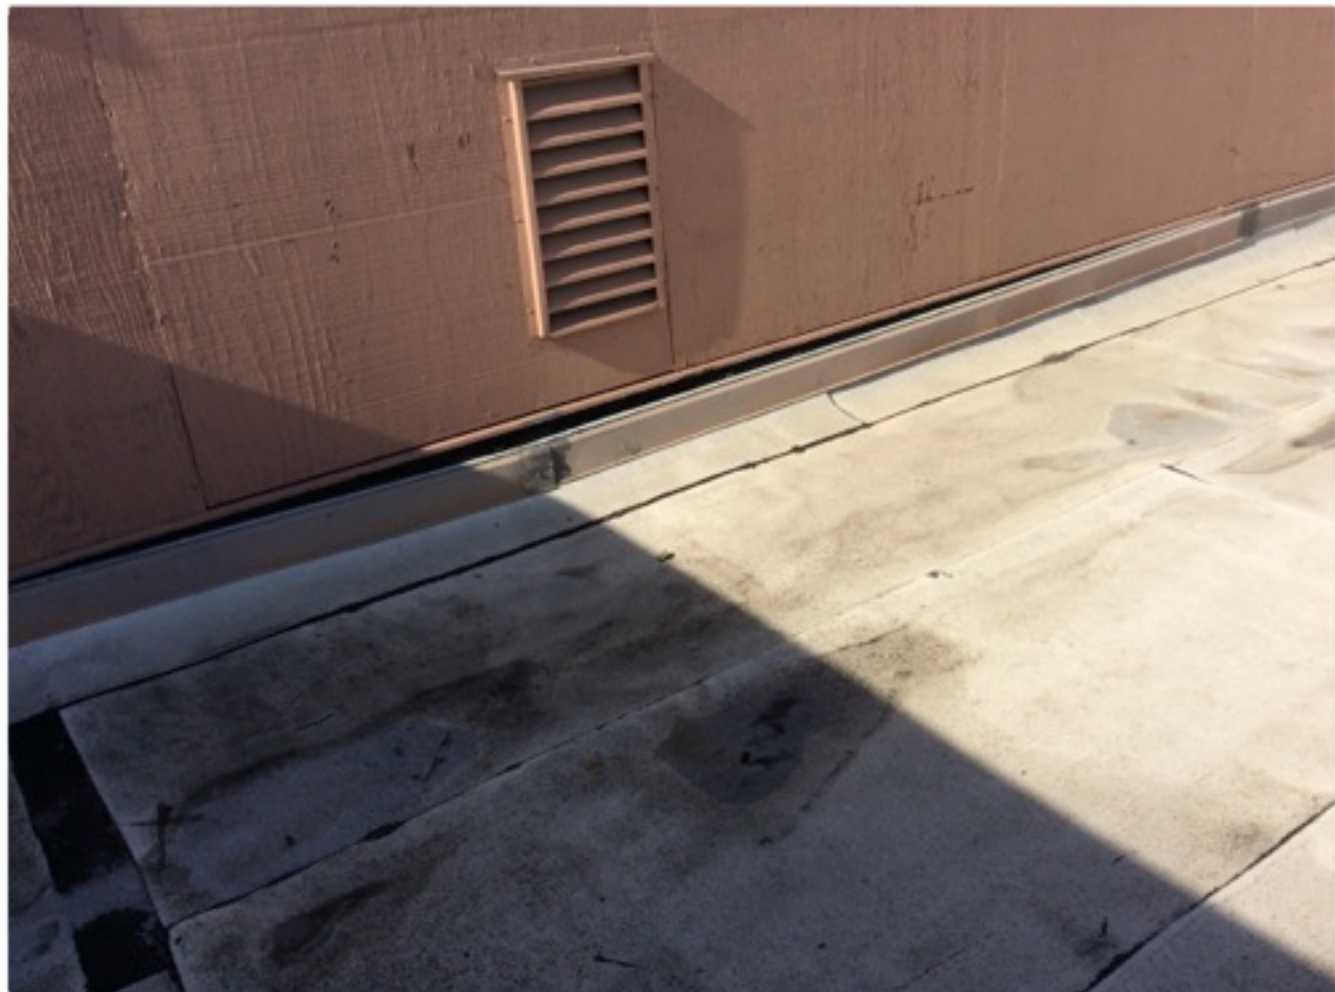
The photo below shows the wall flashing in need of repair.

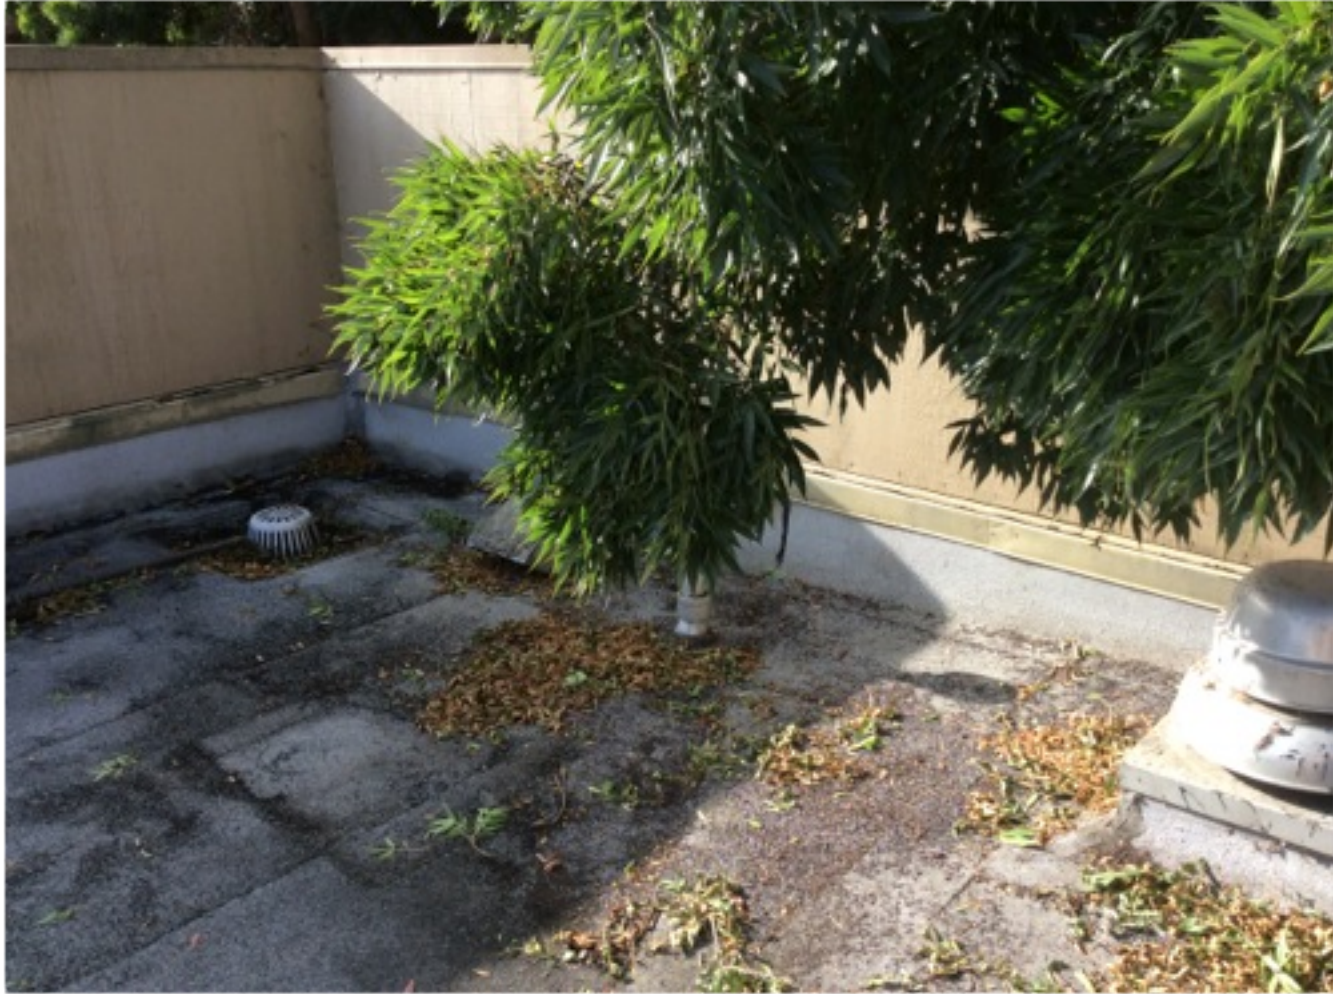
The photo below shows evidence of extreme ponding and the need to trim trees.

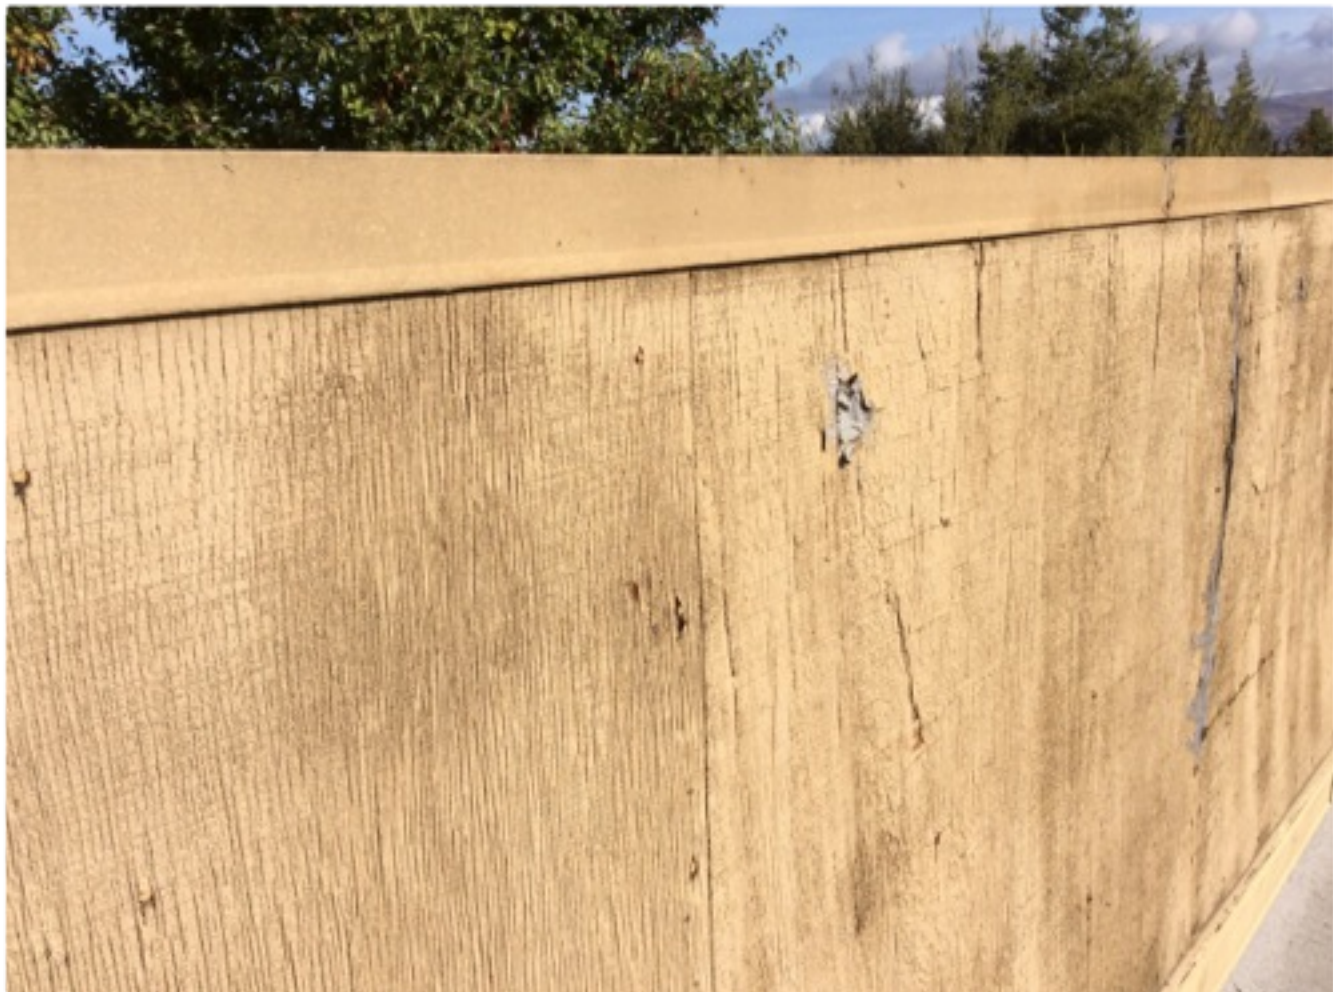
The photo below shows the wall in need of a new coating.

ADDITIONAL NOTES  
BUDGET TO REPLACE IN A YEAR OR TWO.

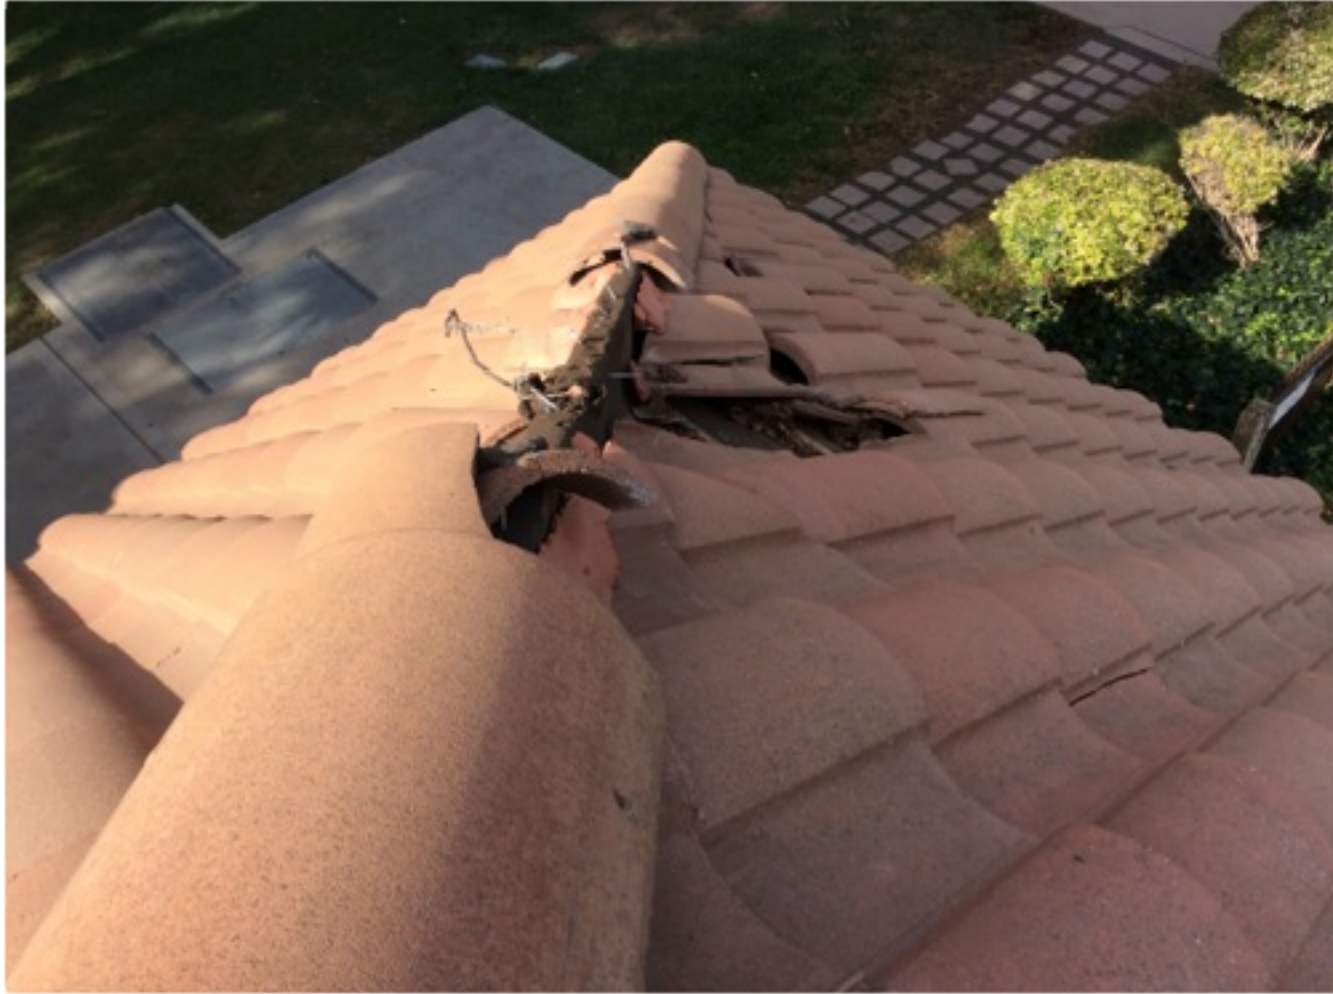
The photo below shows some broken tiles.

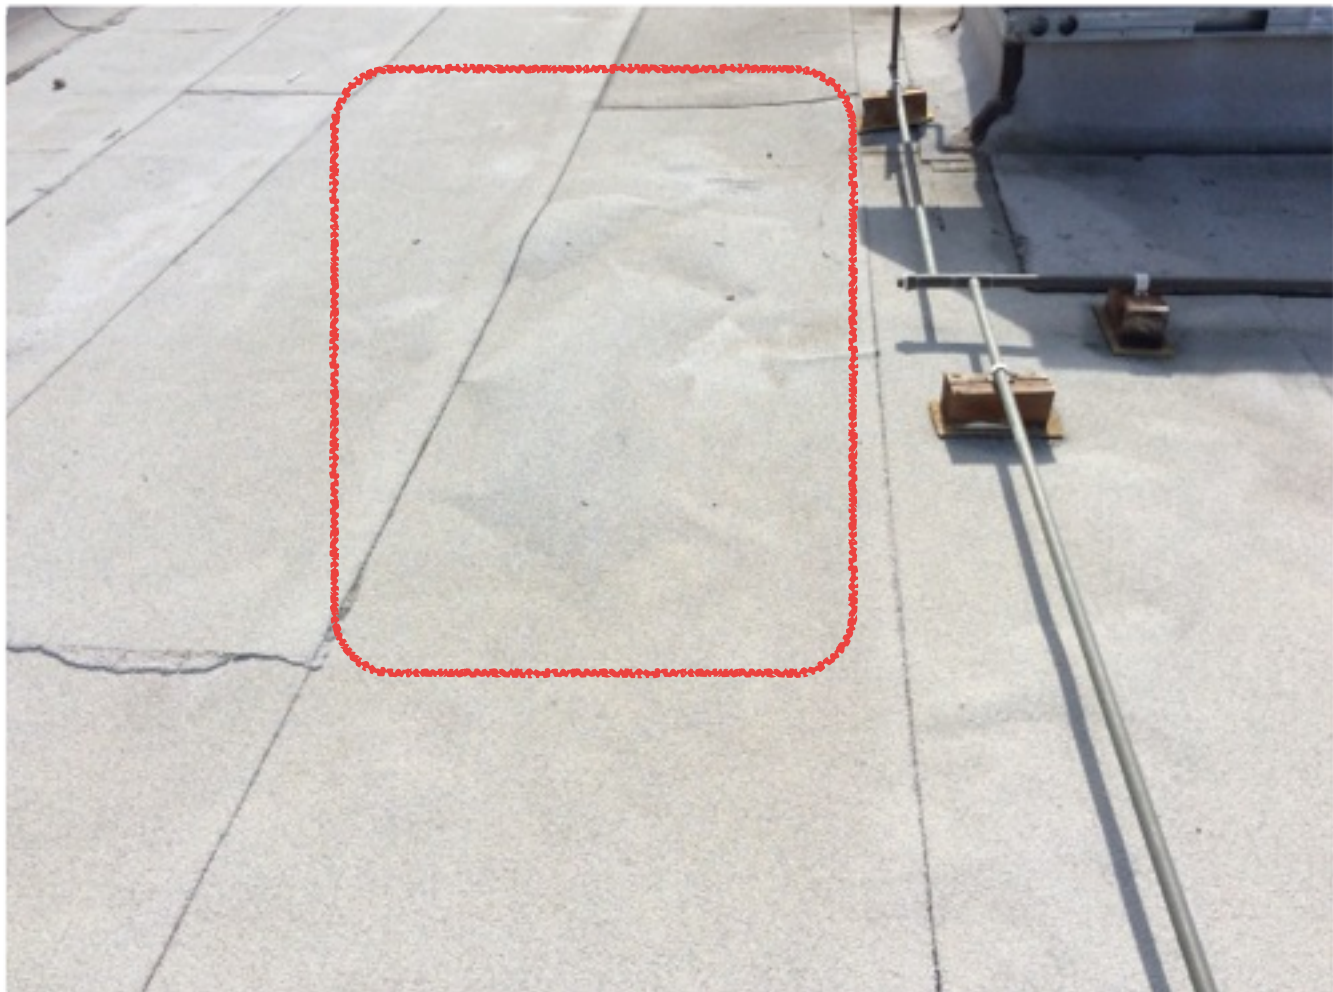
ADDITIONAL NOTES  
 WITH OVERALL REPAIRS THIS ROOF MAY LAST ANOTHER FIVE YEARS. MANY BLISTERS.

The photo below shows many blisters in need of repair.

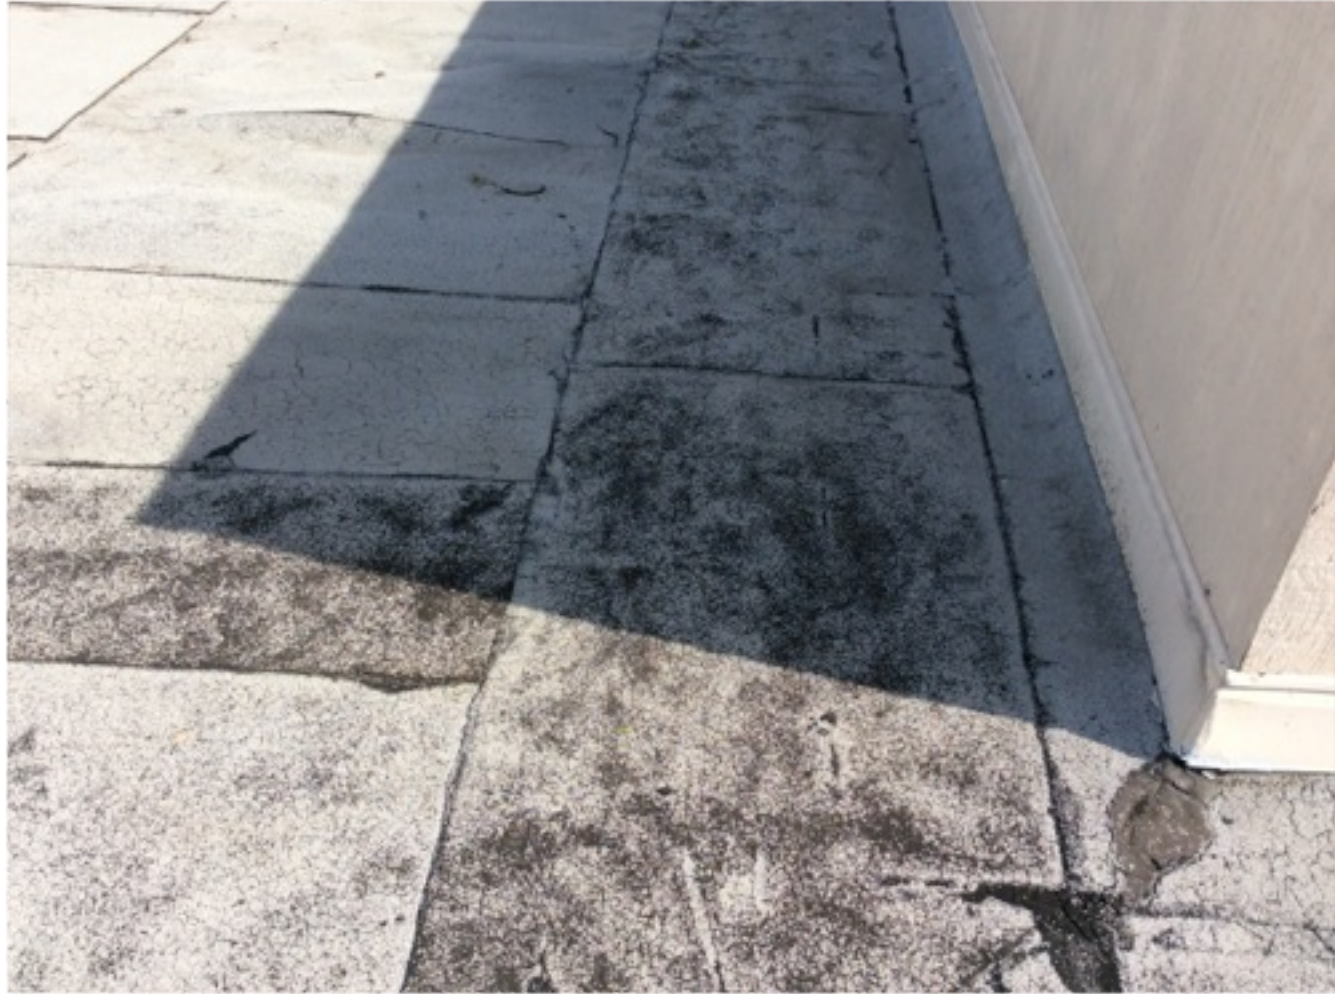
The photo below shows excessive membrane wear.

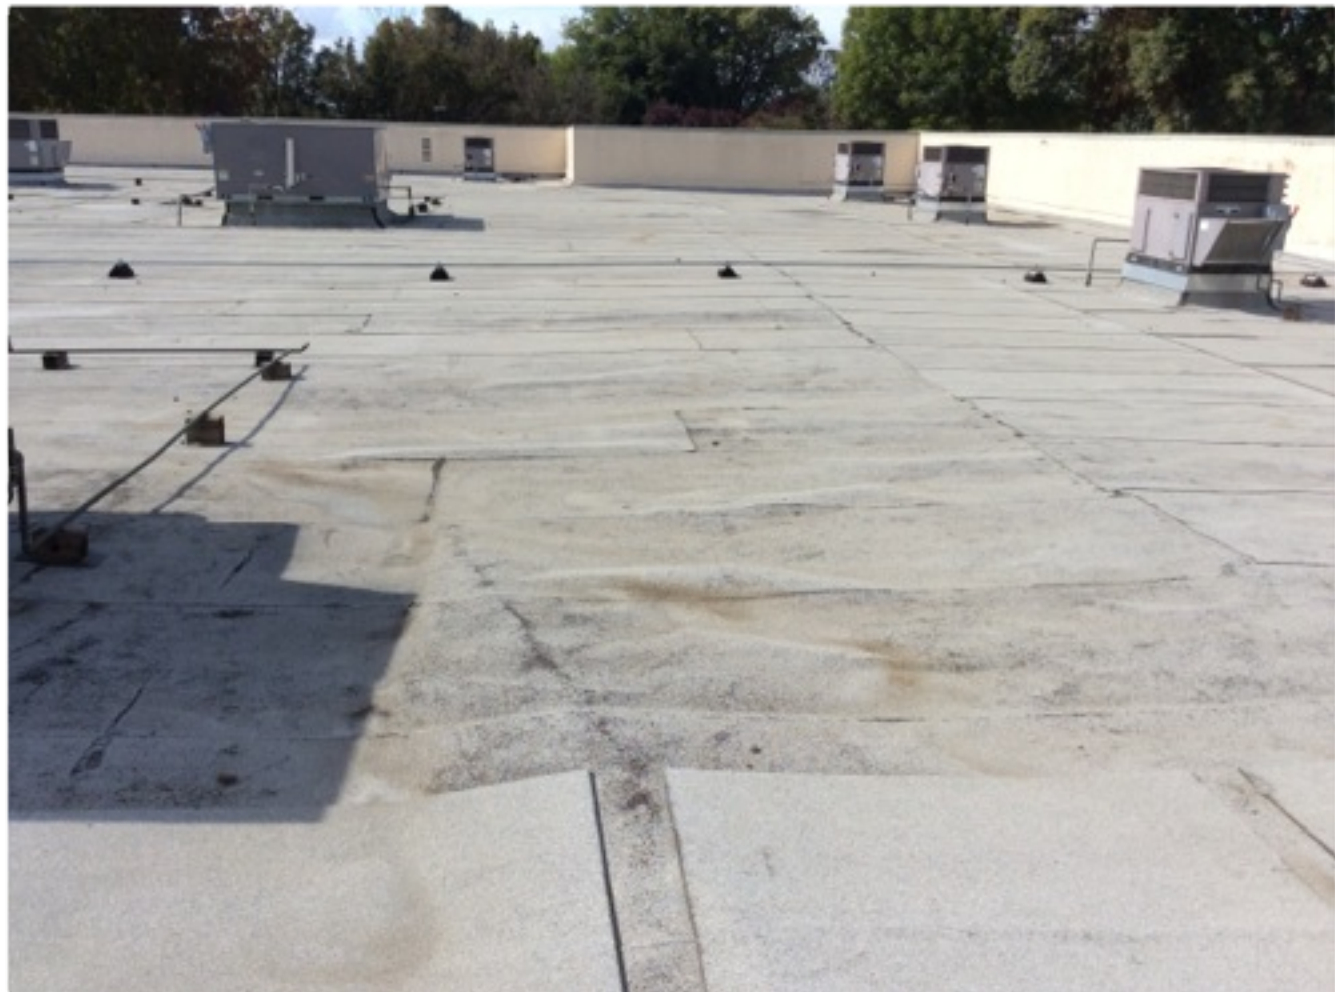
ADDITIONAL NOTES  
 SO MANY BLISTERS AND SO MUCH RIDGING THAT THIS ROOF MAY FAIL AT ANY TIME.

The photo below shows excessive blistering and ridging - beyond repair.

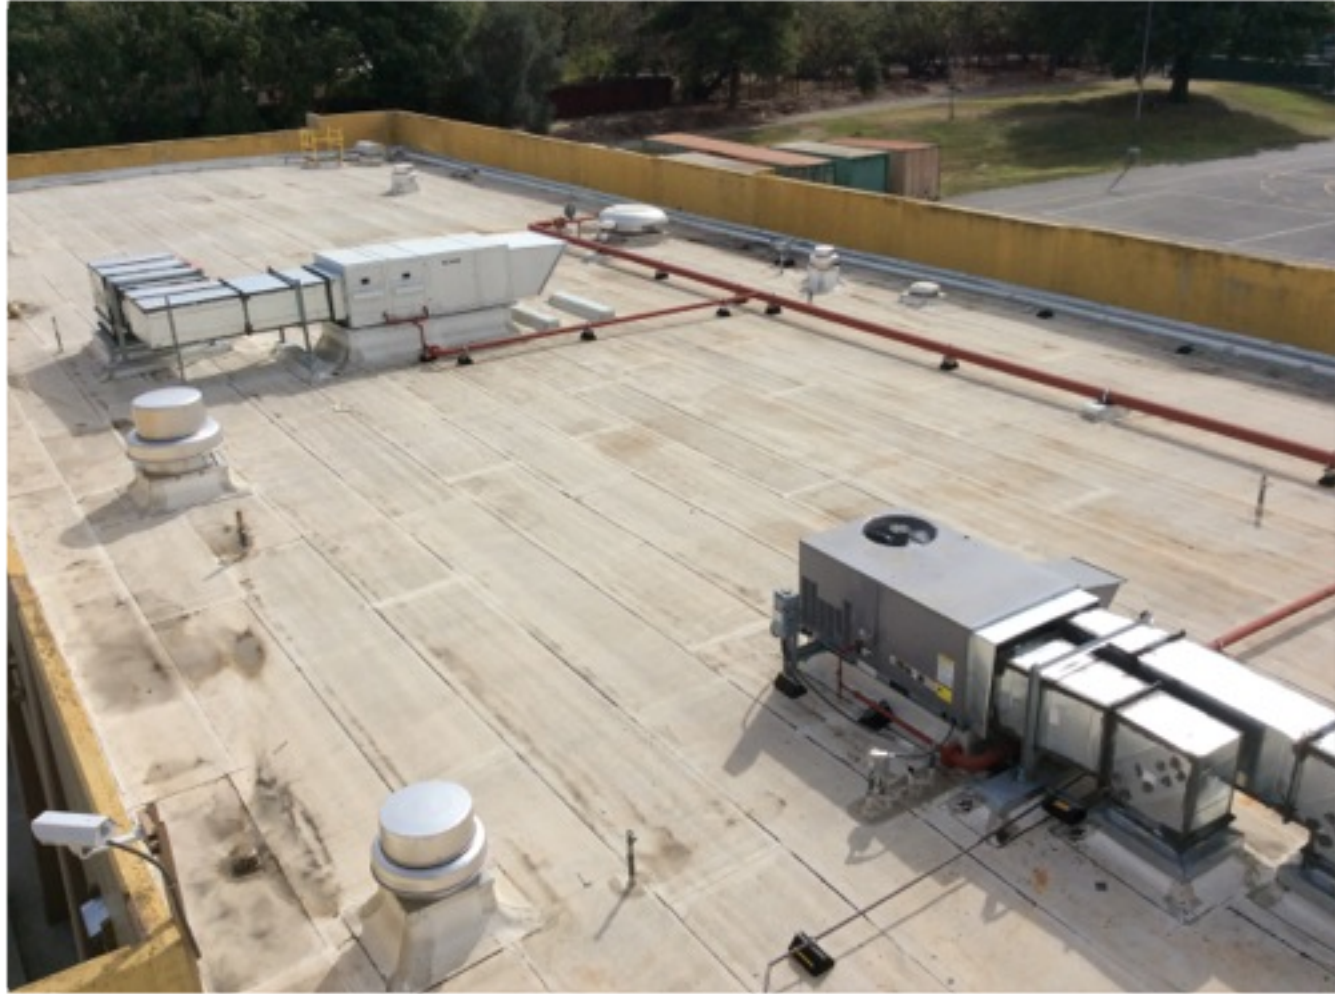
ADDITIONAL NOTES  
 ROOF IS IN GREAT CONDITION.

The photo below shows the system in good shape.

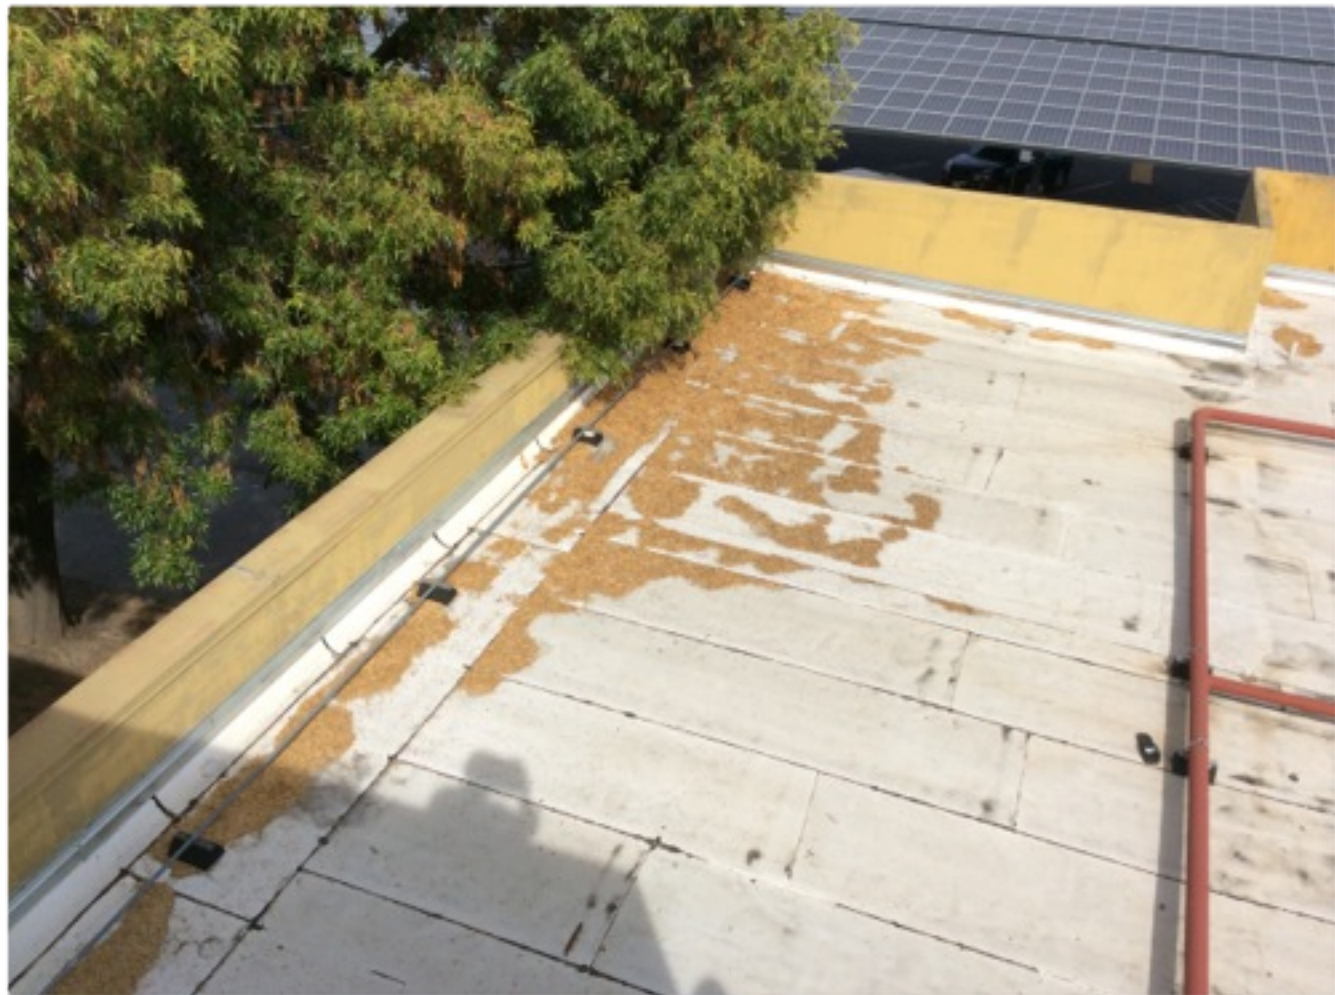
The photo below shows the need for trimming the trees.

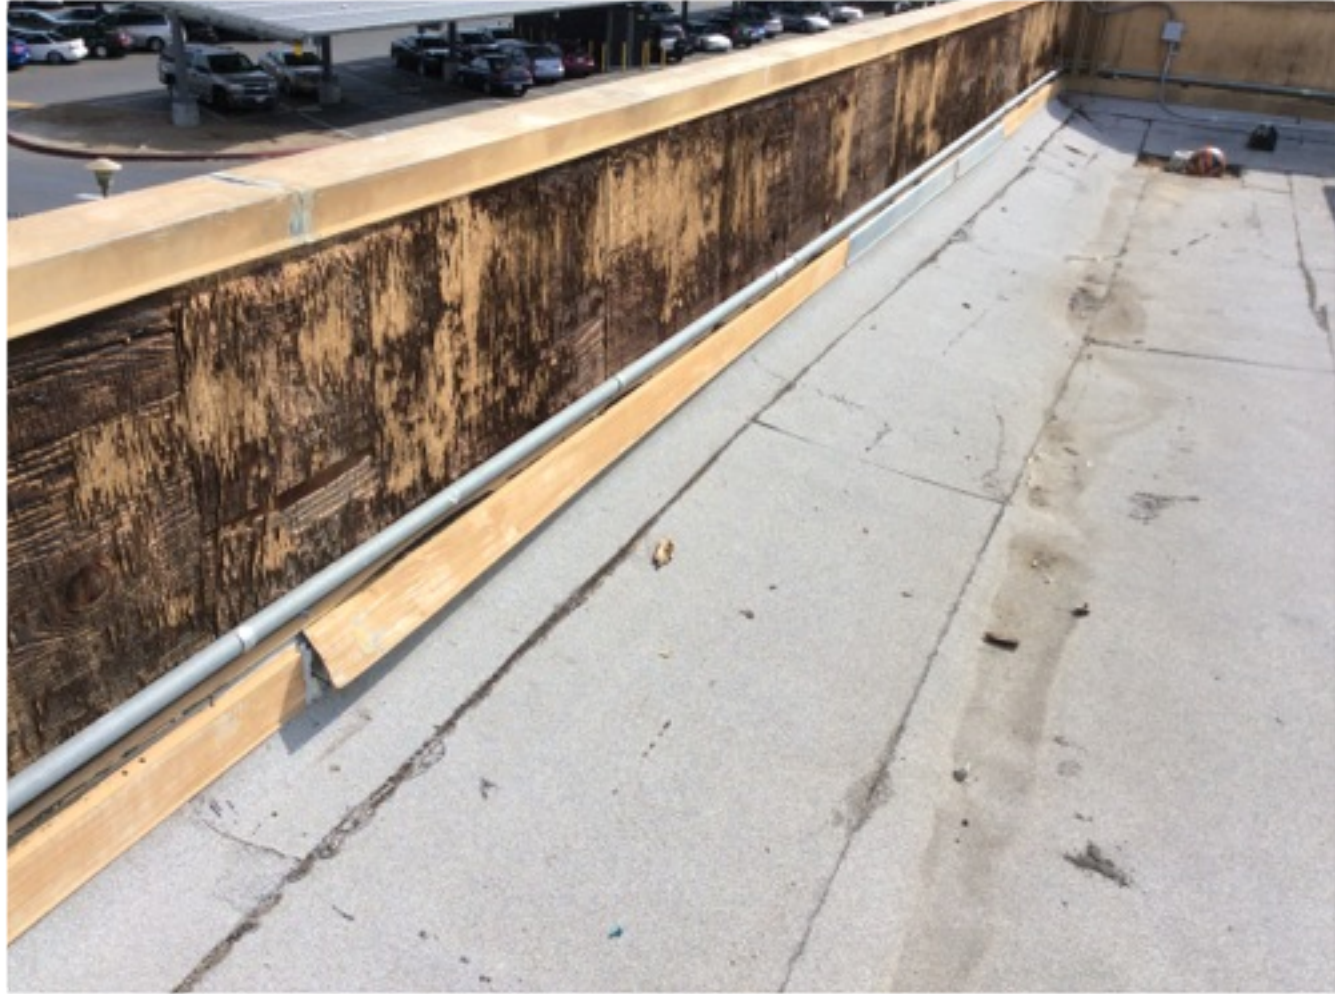
**ADDITIONAL NOTES**  
 THIS ROOF HAS AGED WELL - WITH SOME OVERALL SYSTEM REPAIR THE ROOF MAY LAST A FEW MORE YEARS. THE WALLS AND WALL FLASHINGS ARE IN BAD SHAPE HOWEVER.

The photo below shows excessive wear on the walls - some plywood replacement needed.

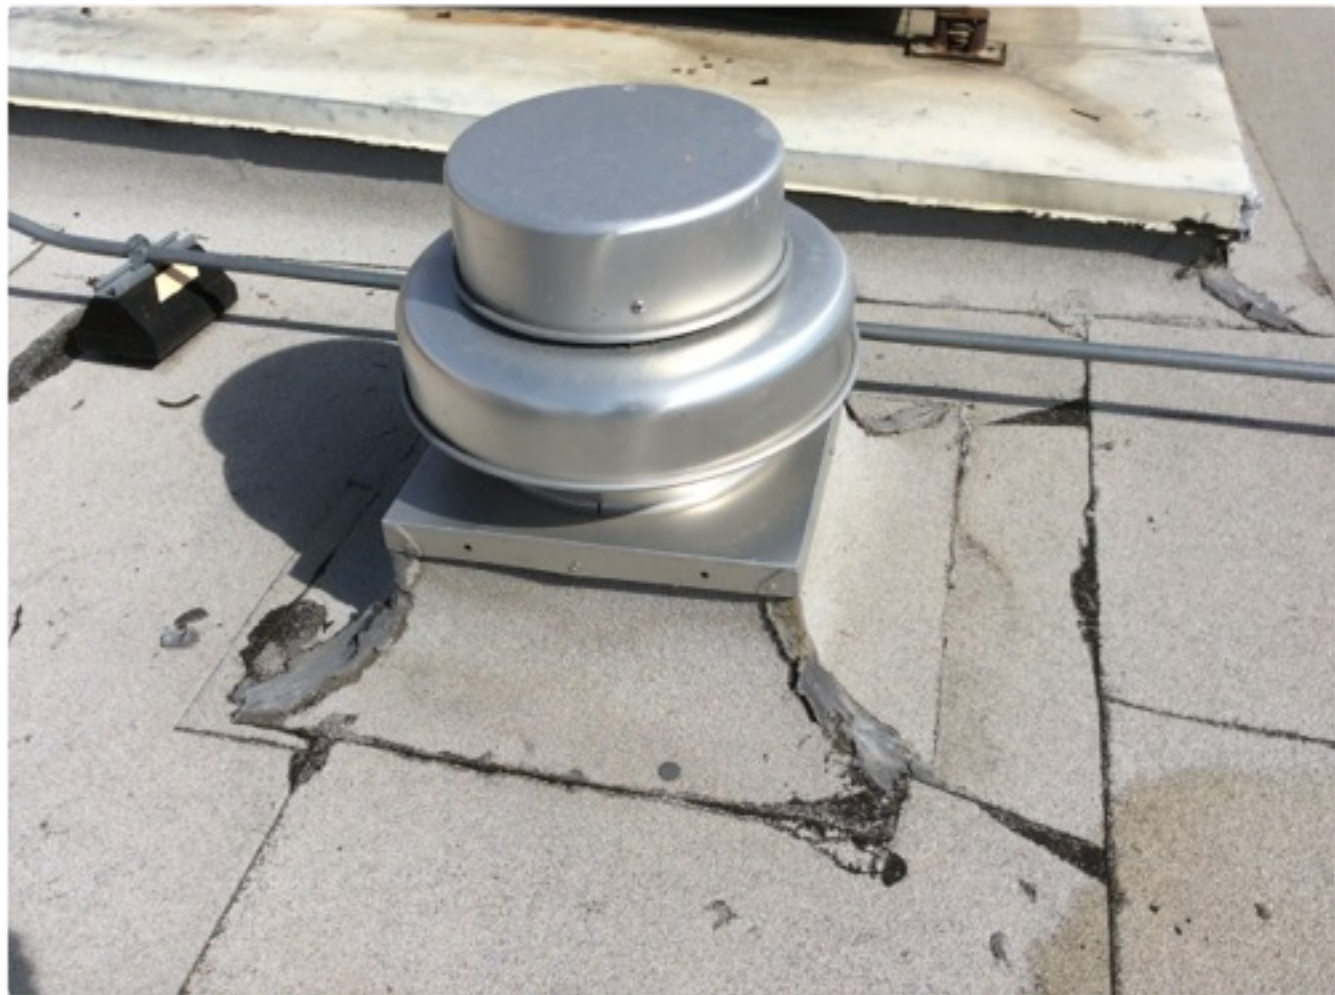
The photo below shows penetration corner sealant is needed.

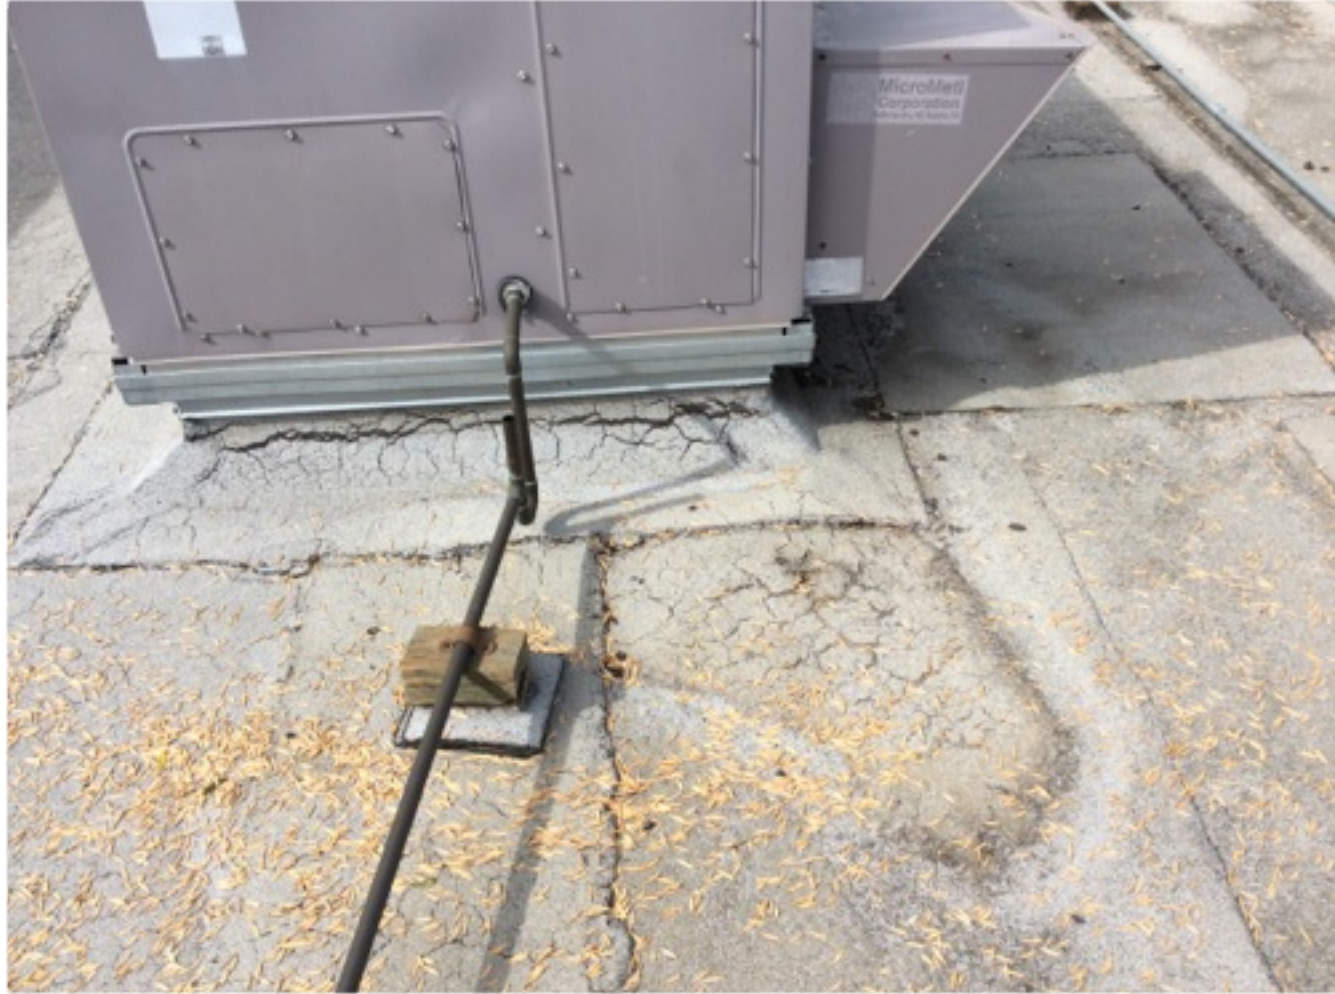
The photo below shows a large blister - this roof has many.

ADDITIONAL NOTES  
 TOO MUCH TO REPAIR. BUDGET TO REPLACE IN A YEAR OR TWO.

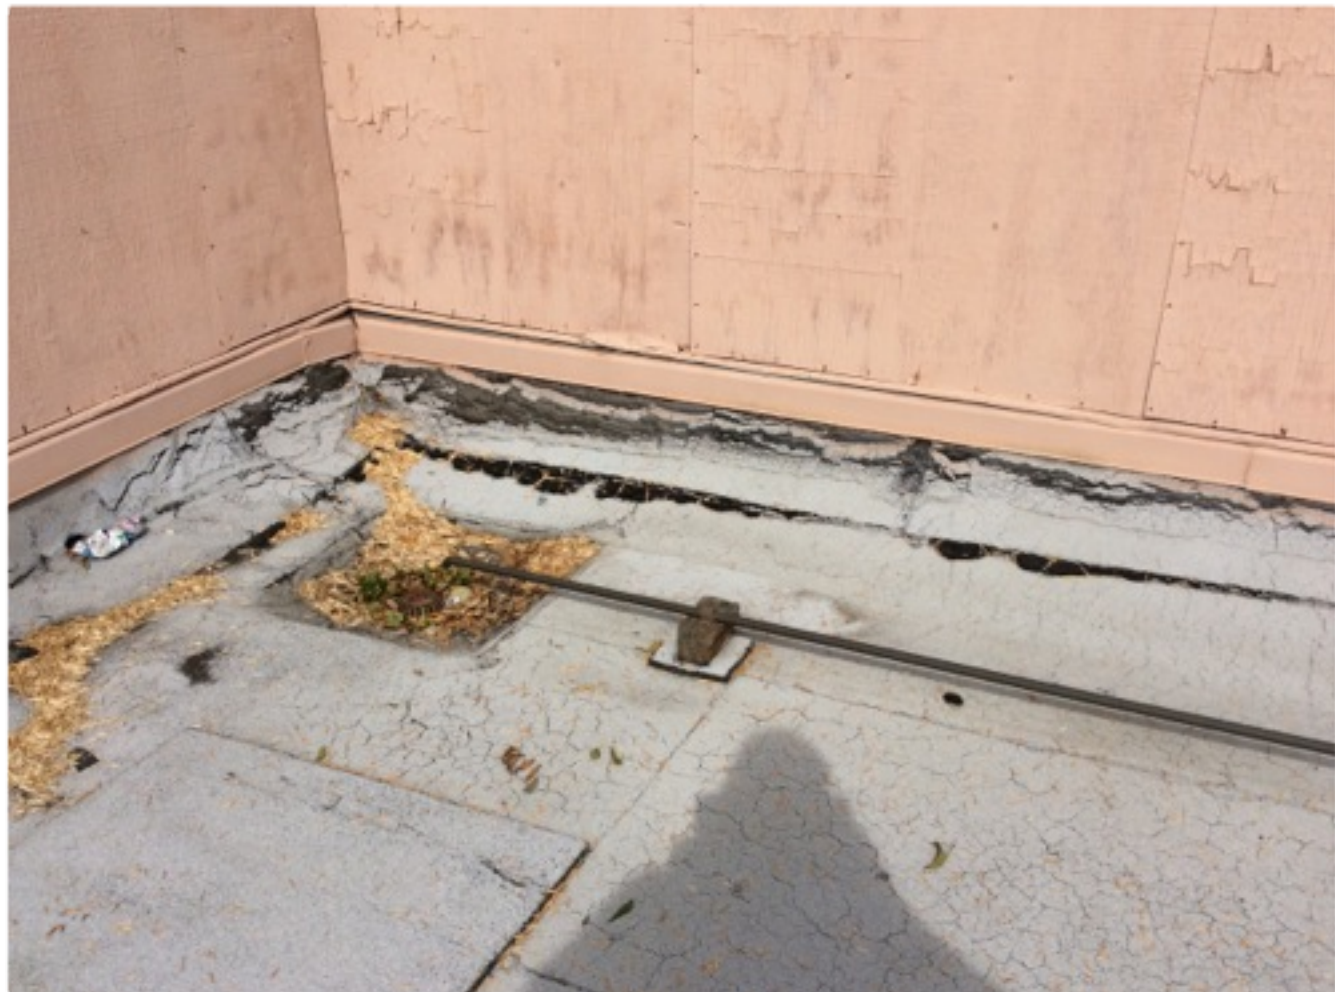
The photo below shows the base flashing failing.

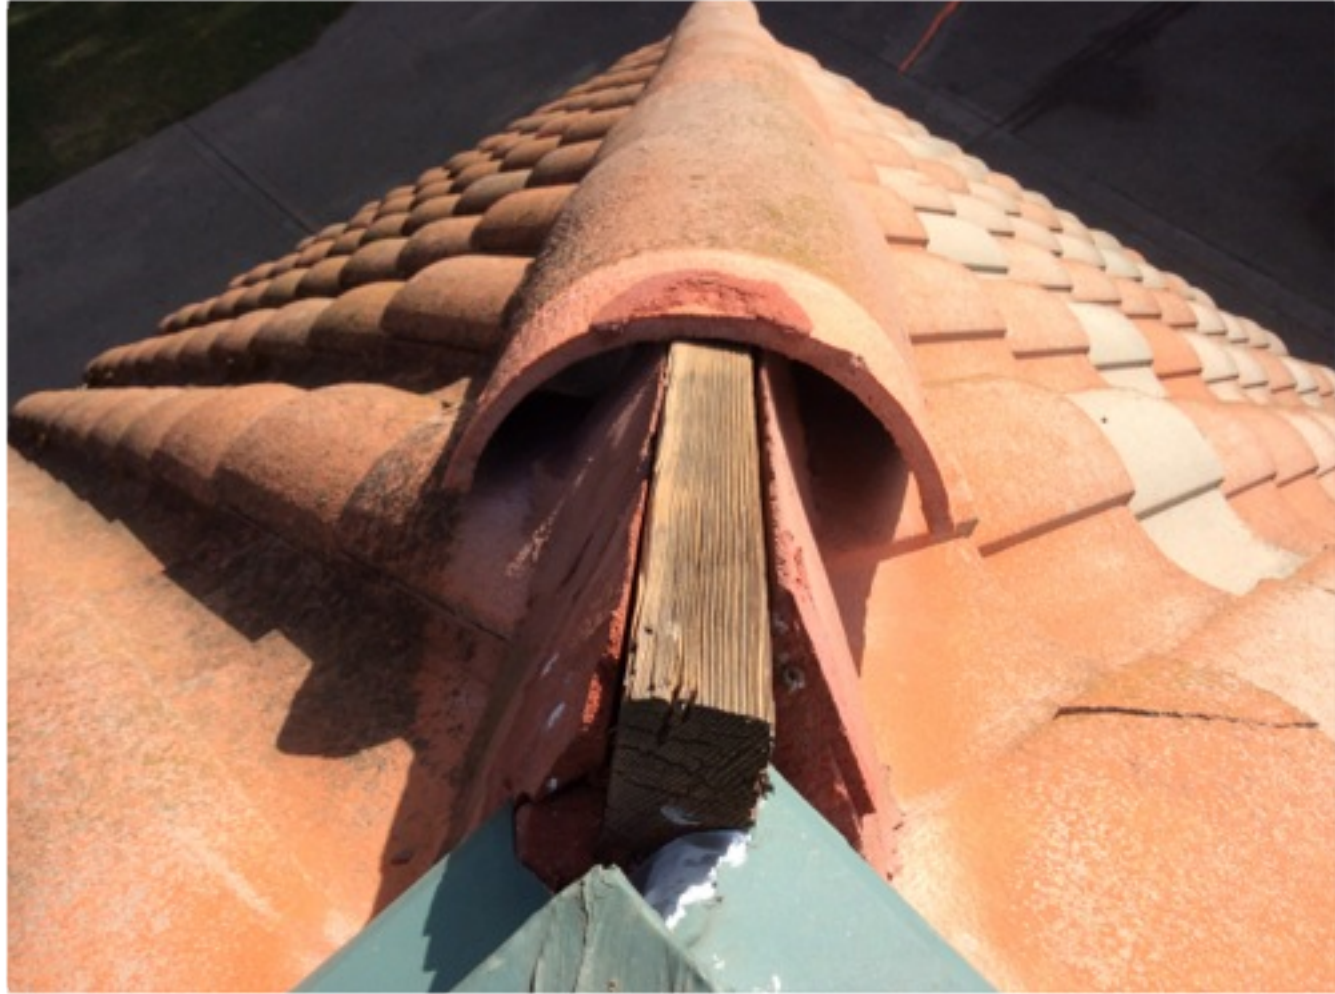
ADDITIONAL NOTES  
TILE CORNER/RIDGE TOP TILE MISSING ON ALL CORNERS - FRAME DETERIORATION PRESENT.

The photo below shows some missing tiles.

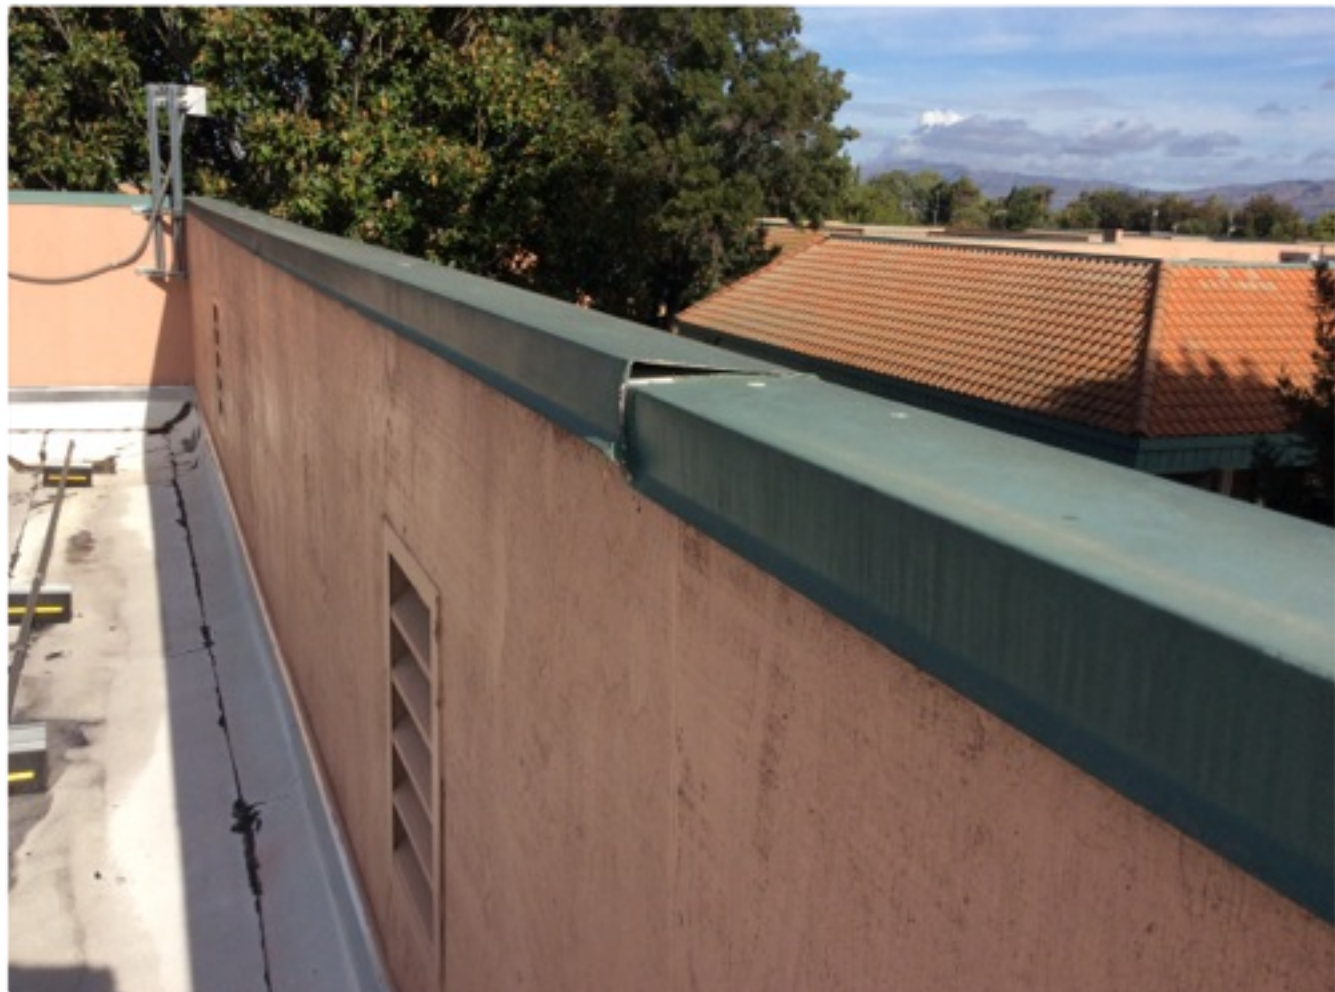
The photo below shows the wall cap flashing in need of repair.

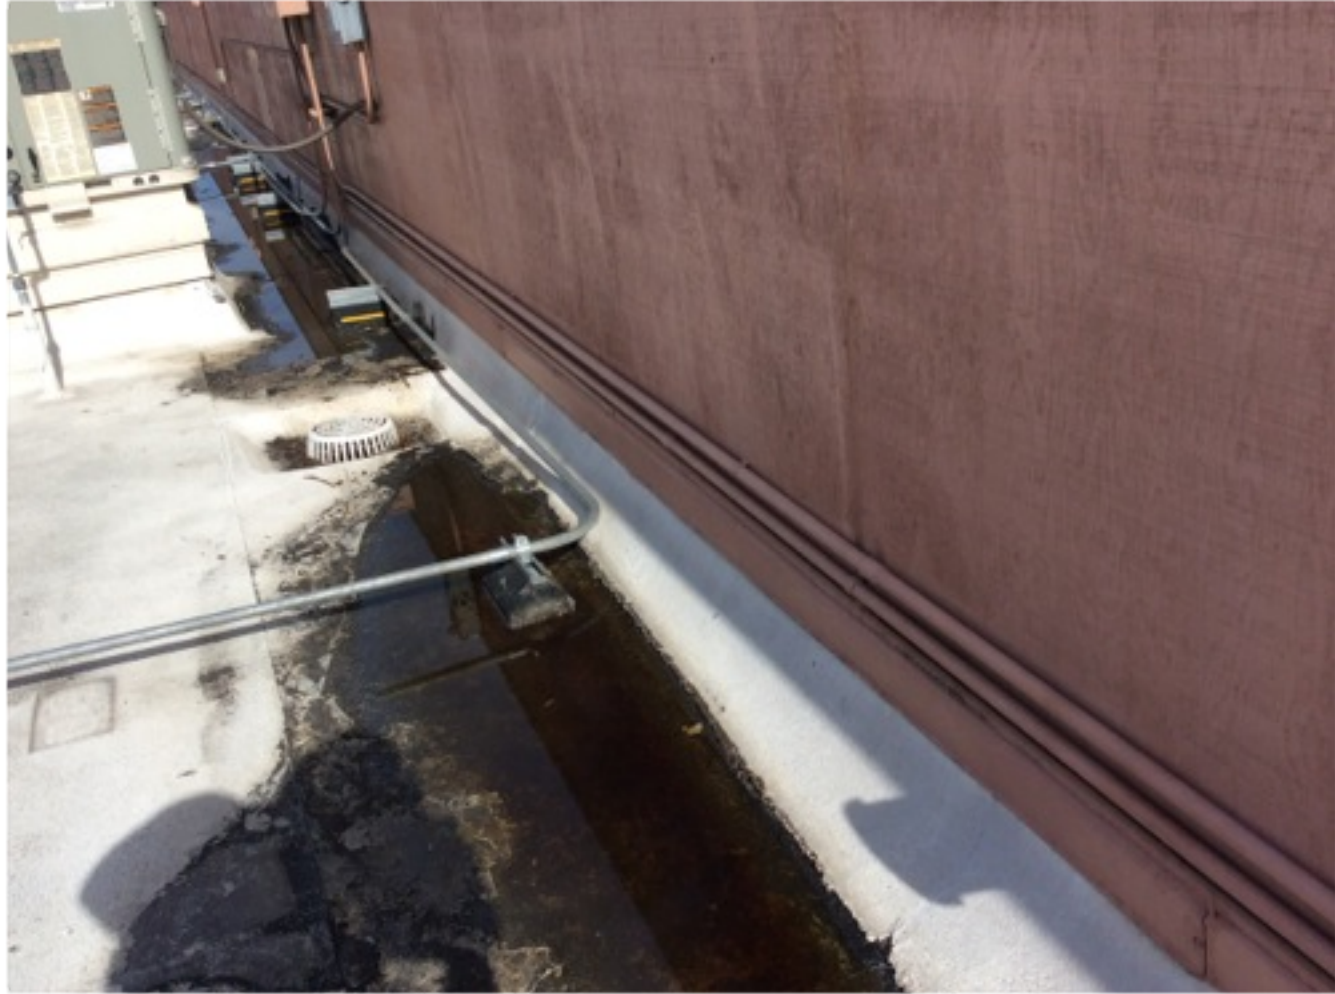
ADDITIONAL NOTES  
TILE SYSTEM IS IN GOOD SHAPE. INADEQUATE CRICKETS HAS LED TO EXTENSIVE PONDING.

The photo below shows extensive ponding.
