BUILDING INFORMATION	
FACILITY	Yerba Buena HS
DATE	October 14, 2014
BUILDING	100, 800, 1000, Food Services
ROOF SQ FT	25,000

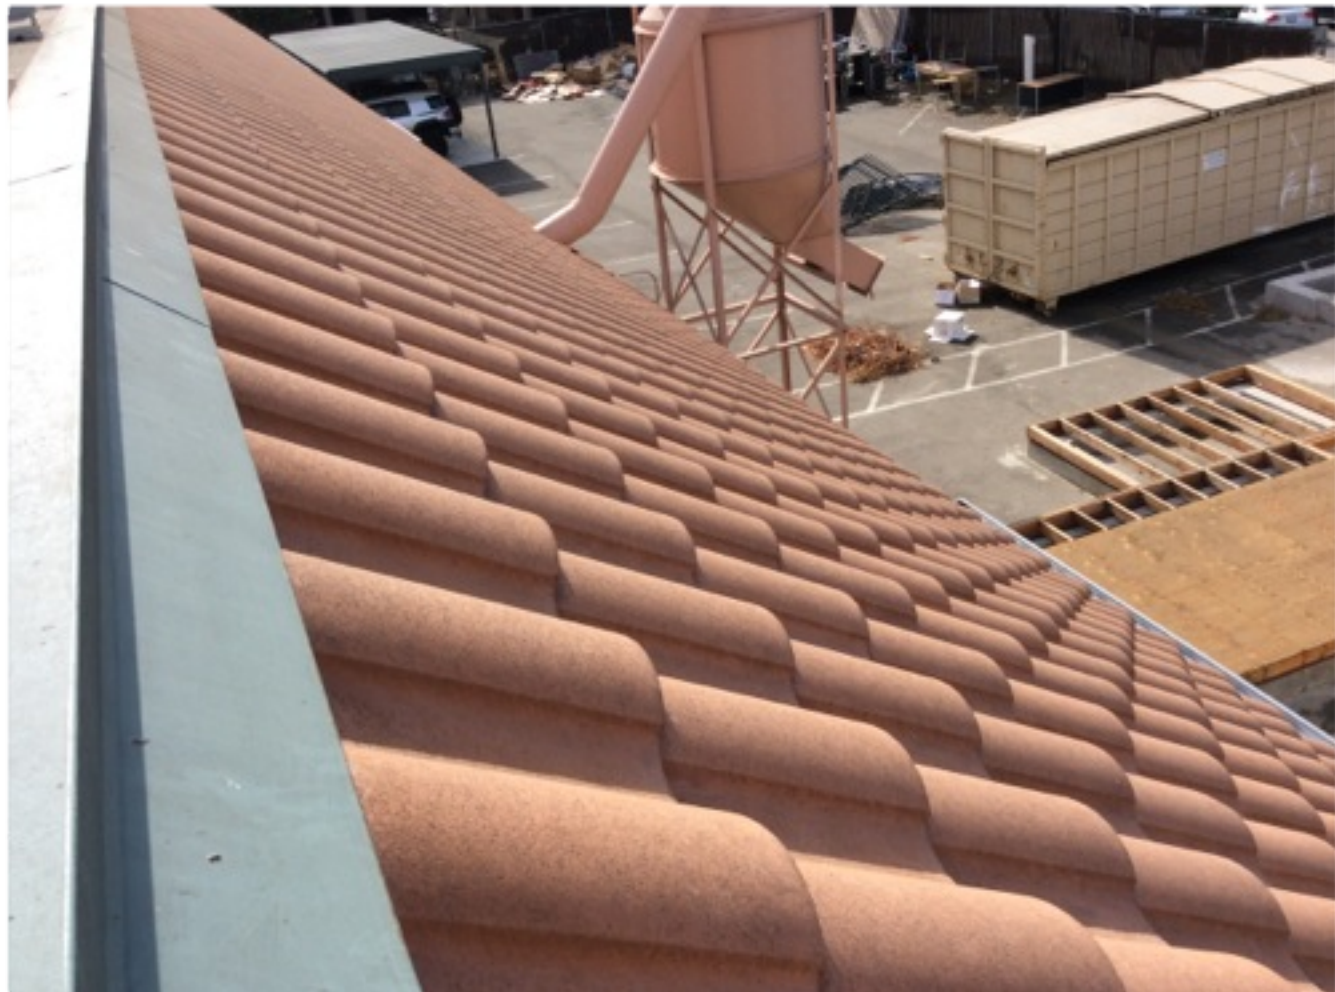
The photo below shows the tile system in good shape.

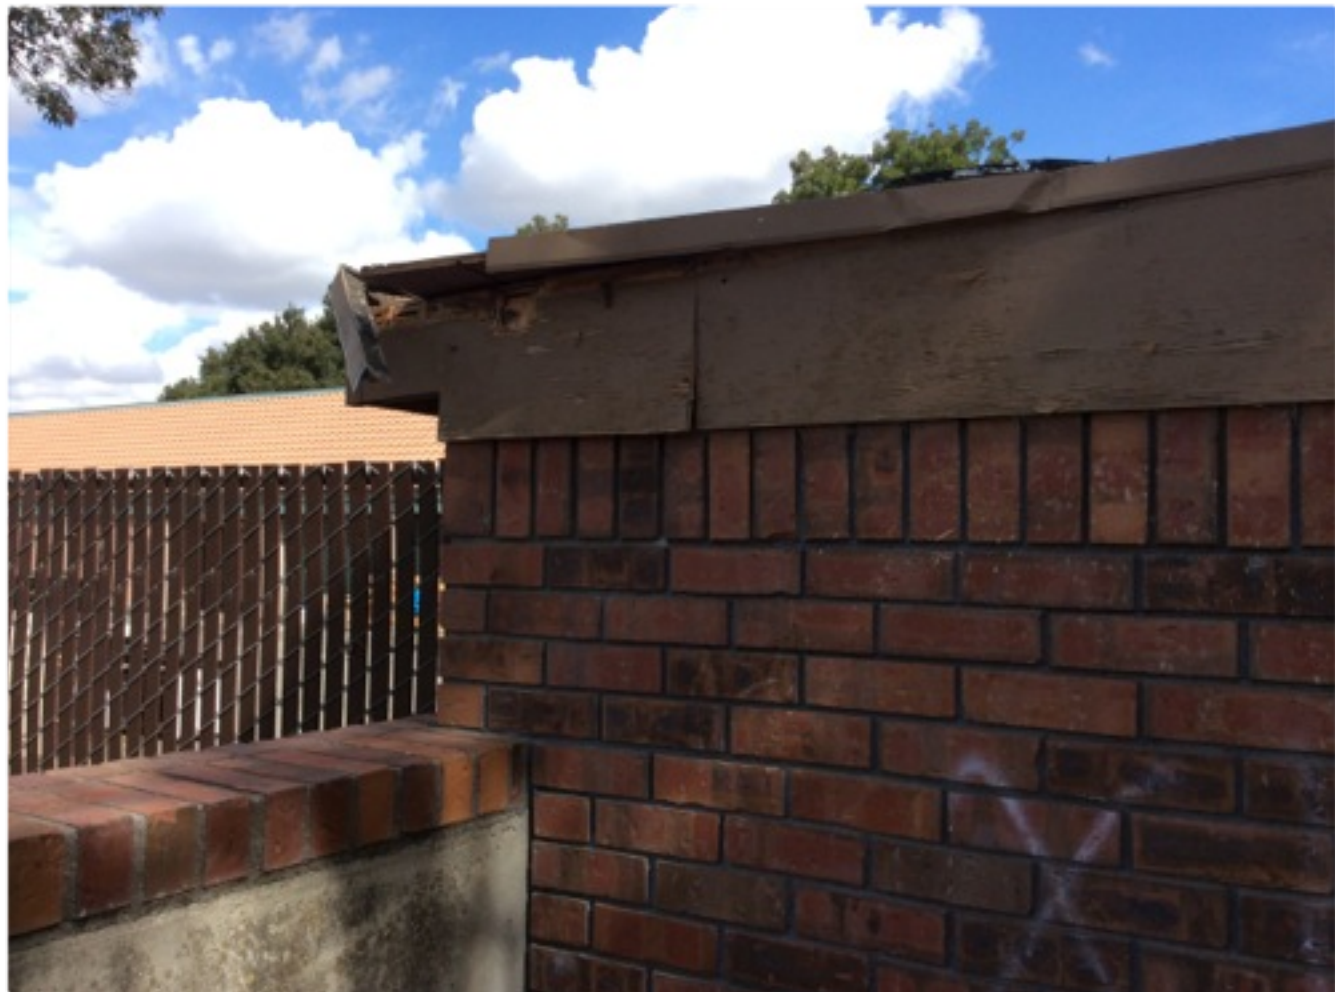
The large hole has simply been covered with a piece of plywood.

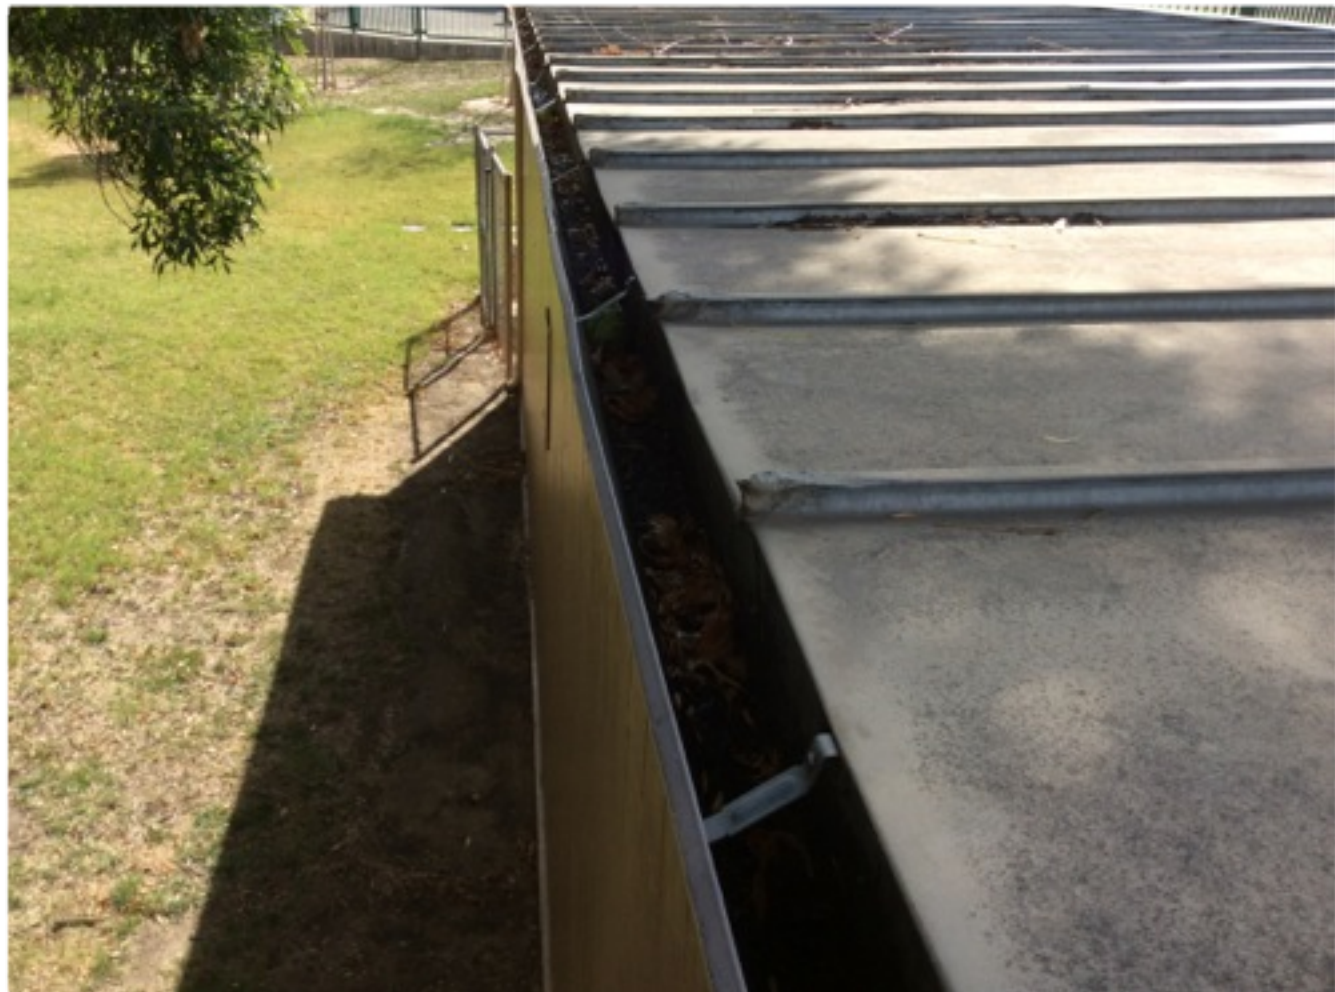
The photo below shows the need to keep the gutters clean and clear.

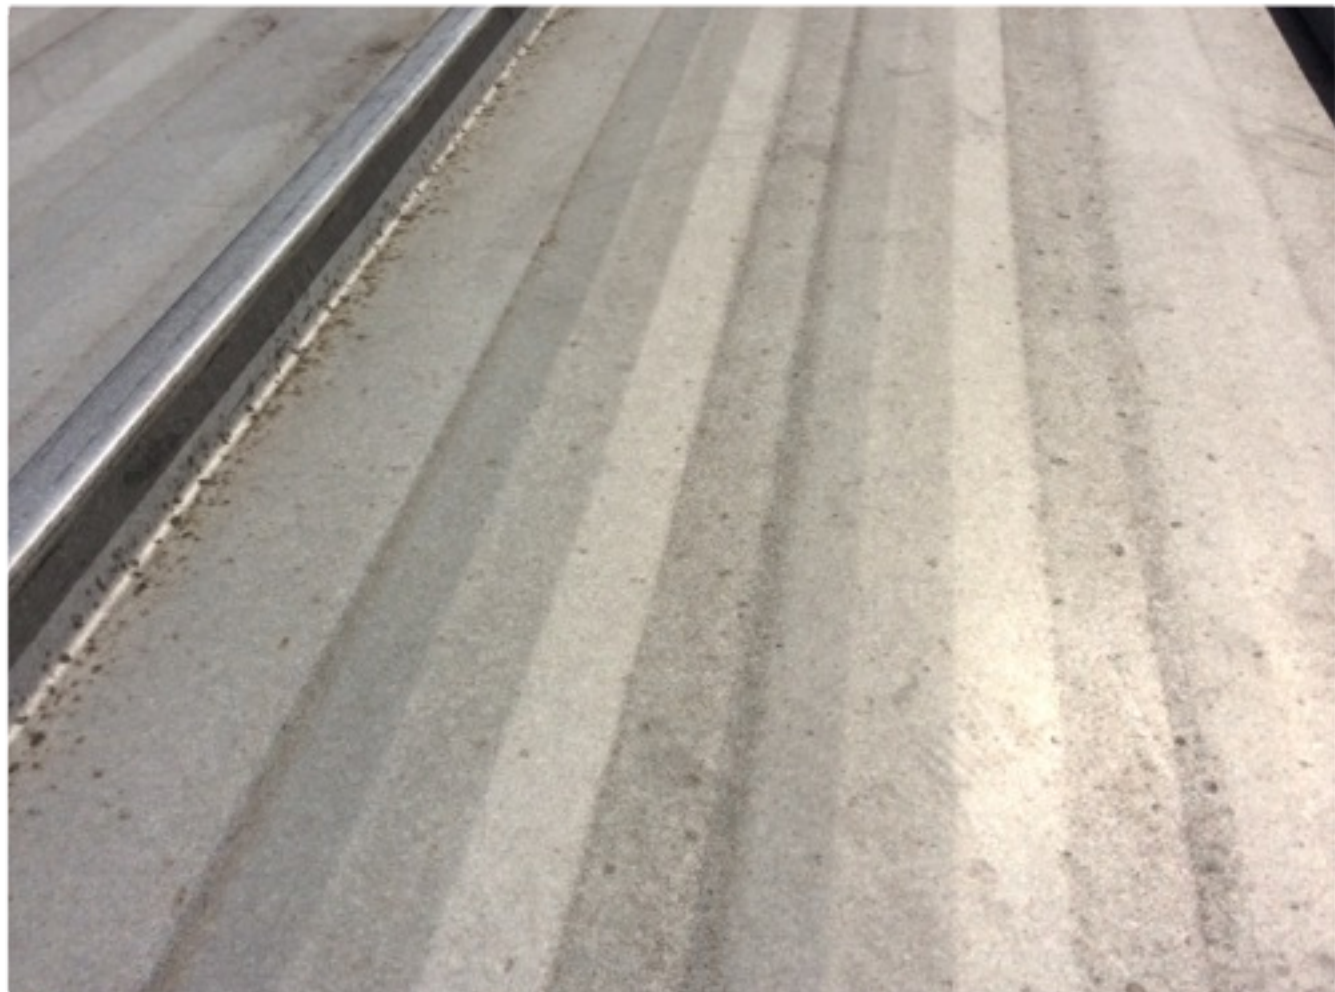
The photo below shows the surface in good shape - no signs of rust.

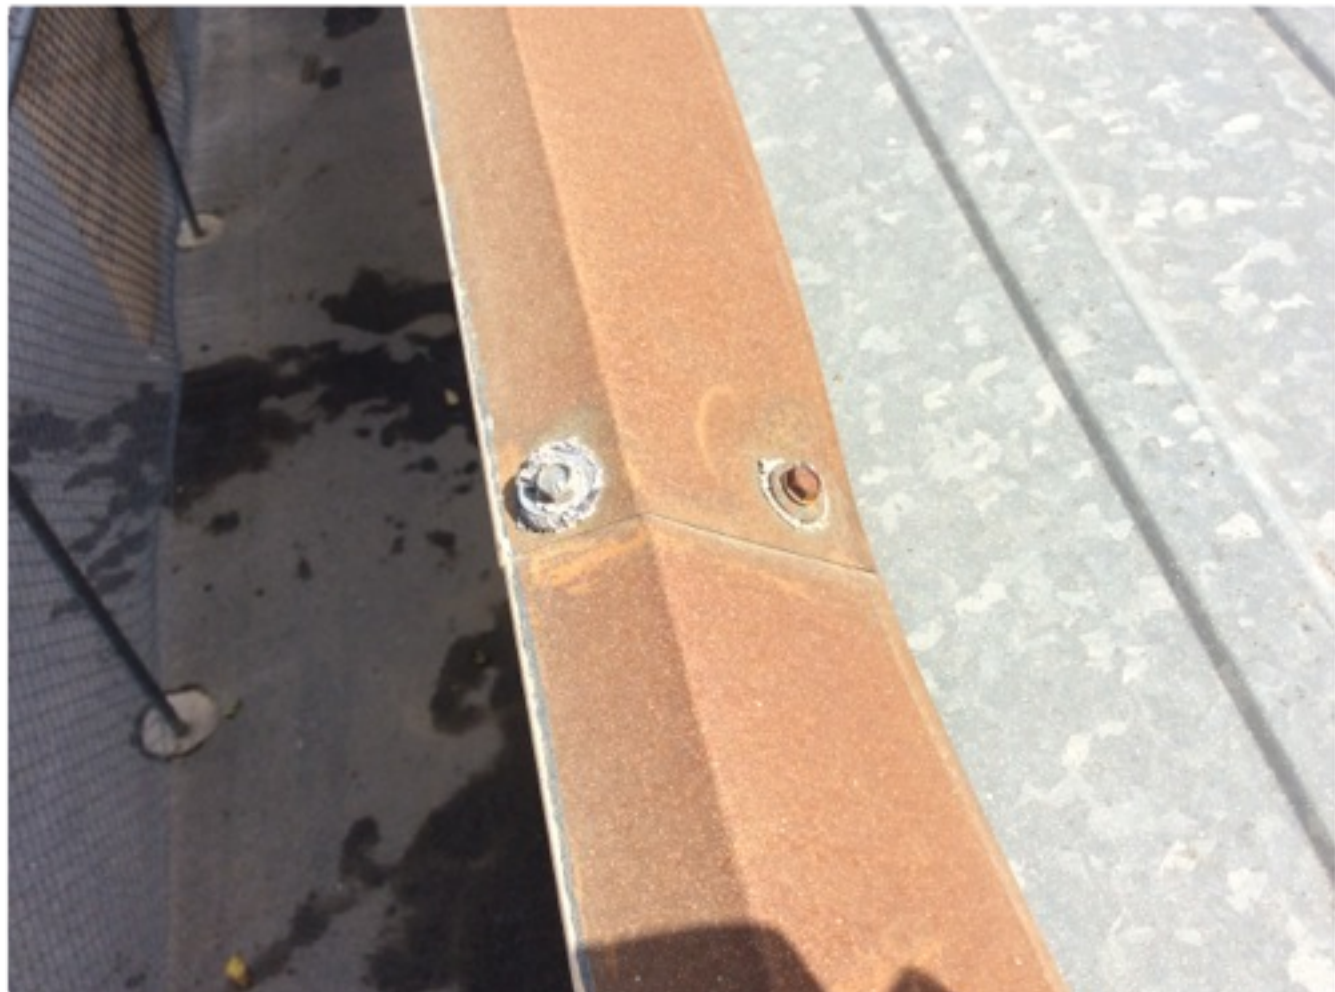
The photo below shows the fasteners failing and the flashing rusting.
