BUILDING INFORMATION	
FACILITY	Mt. Pleasant HS
DATE	August 26, 2014
BUILDING	100 Admin, 900 Library, Central Canopy
ROOF SQ FT	30,000

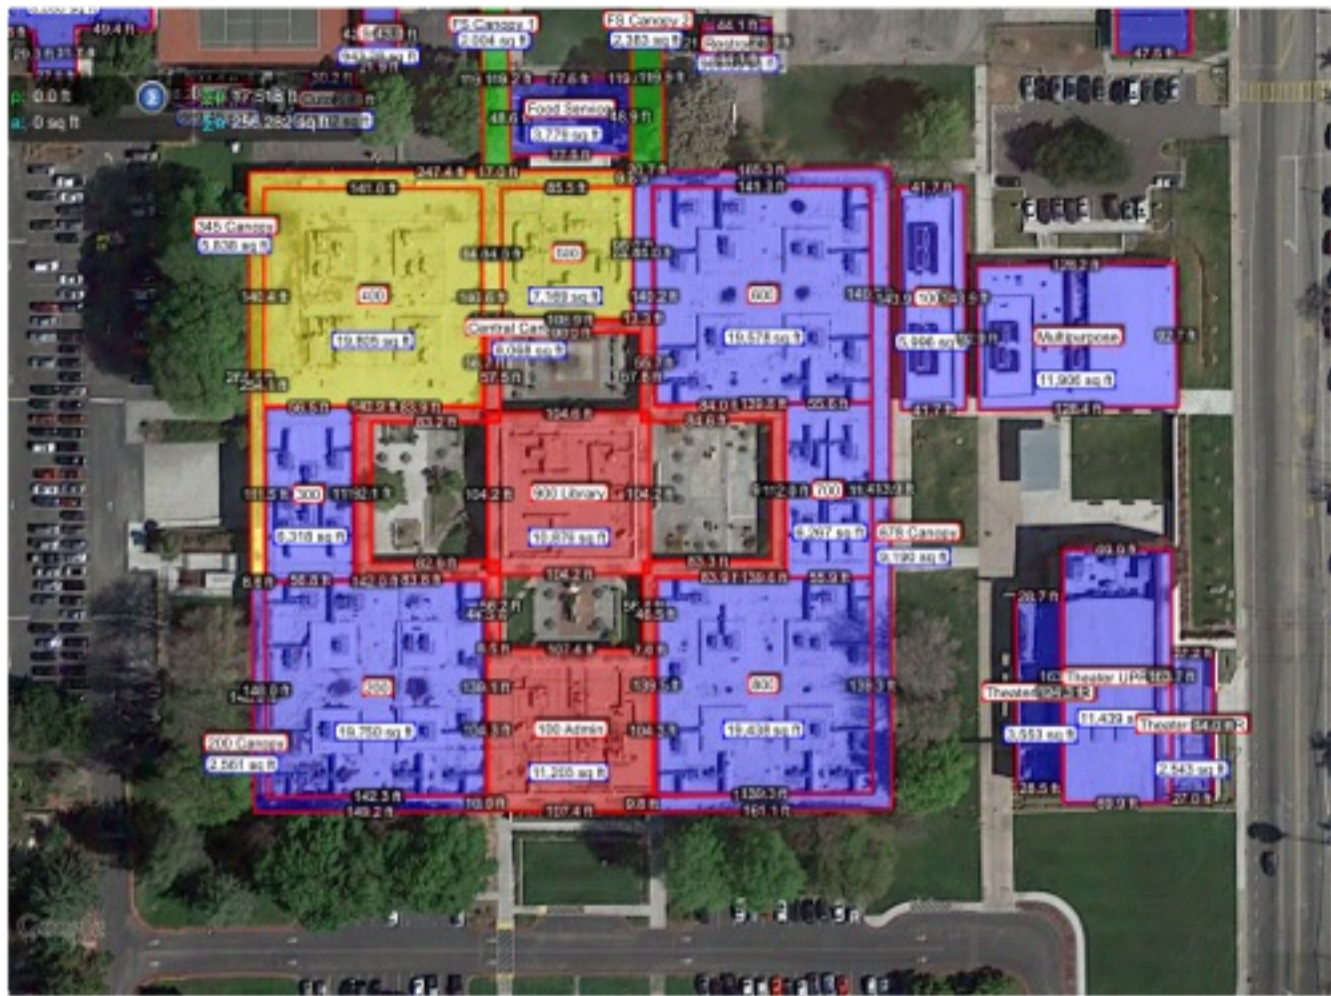
An aerial view of the building - this report for the areas in red.

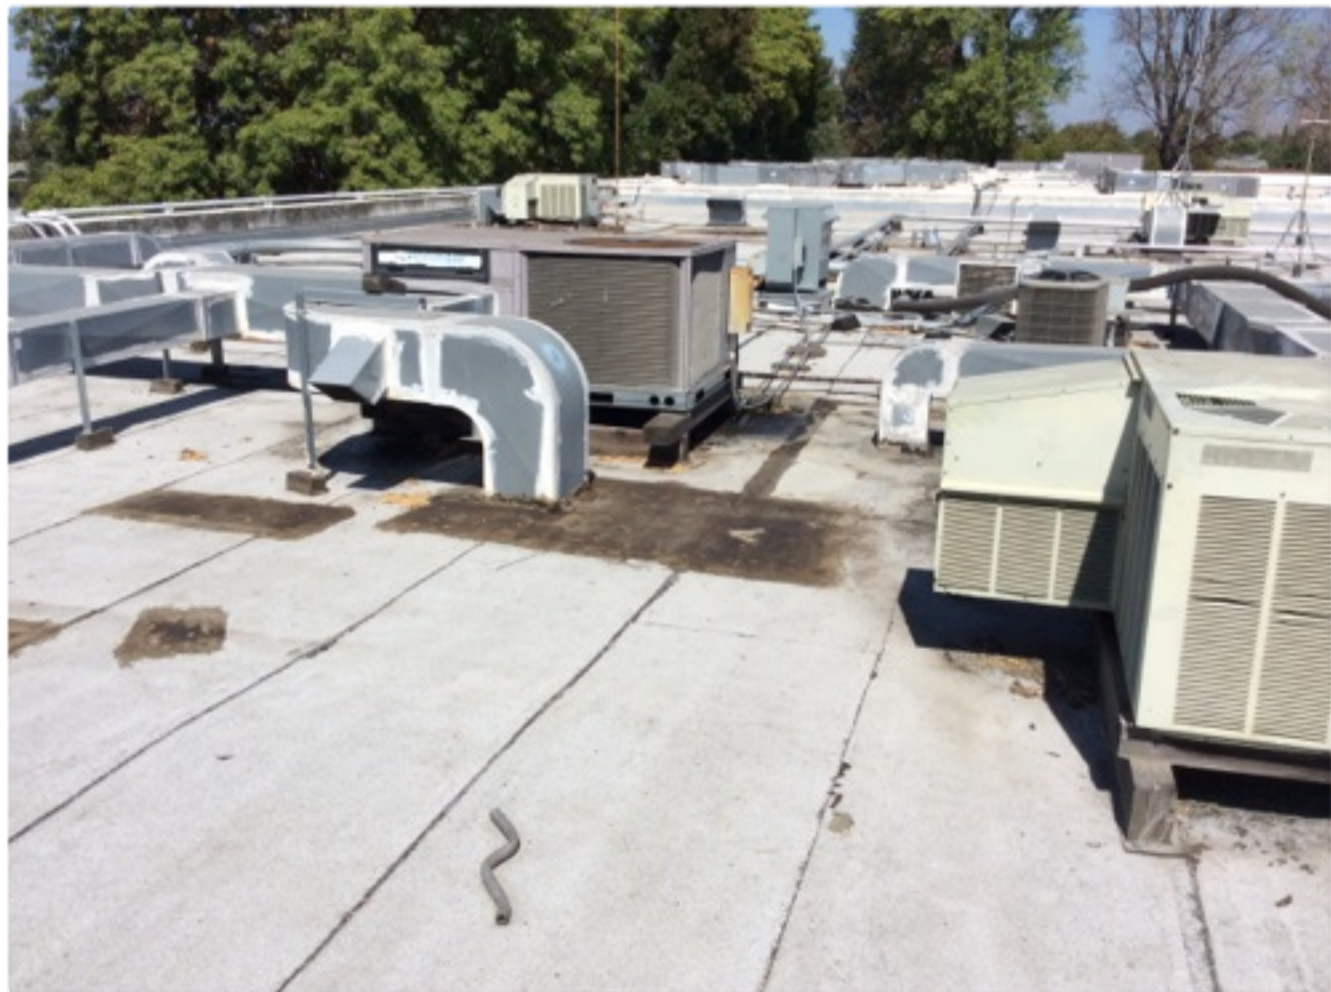
ADDITIONAL NOTES  
 ROOFS ARE IN BAD SHAPE. IF CHOOSING, THE ADMIN BUILDING IS THE FIRST CHOICE TO REPLACE. NO INSULATION ON THE CANOPIES.

An overview photo from the roof level.

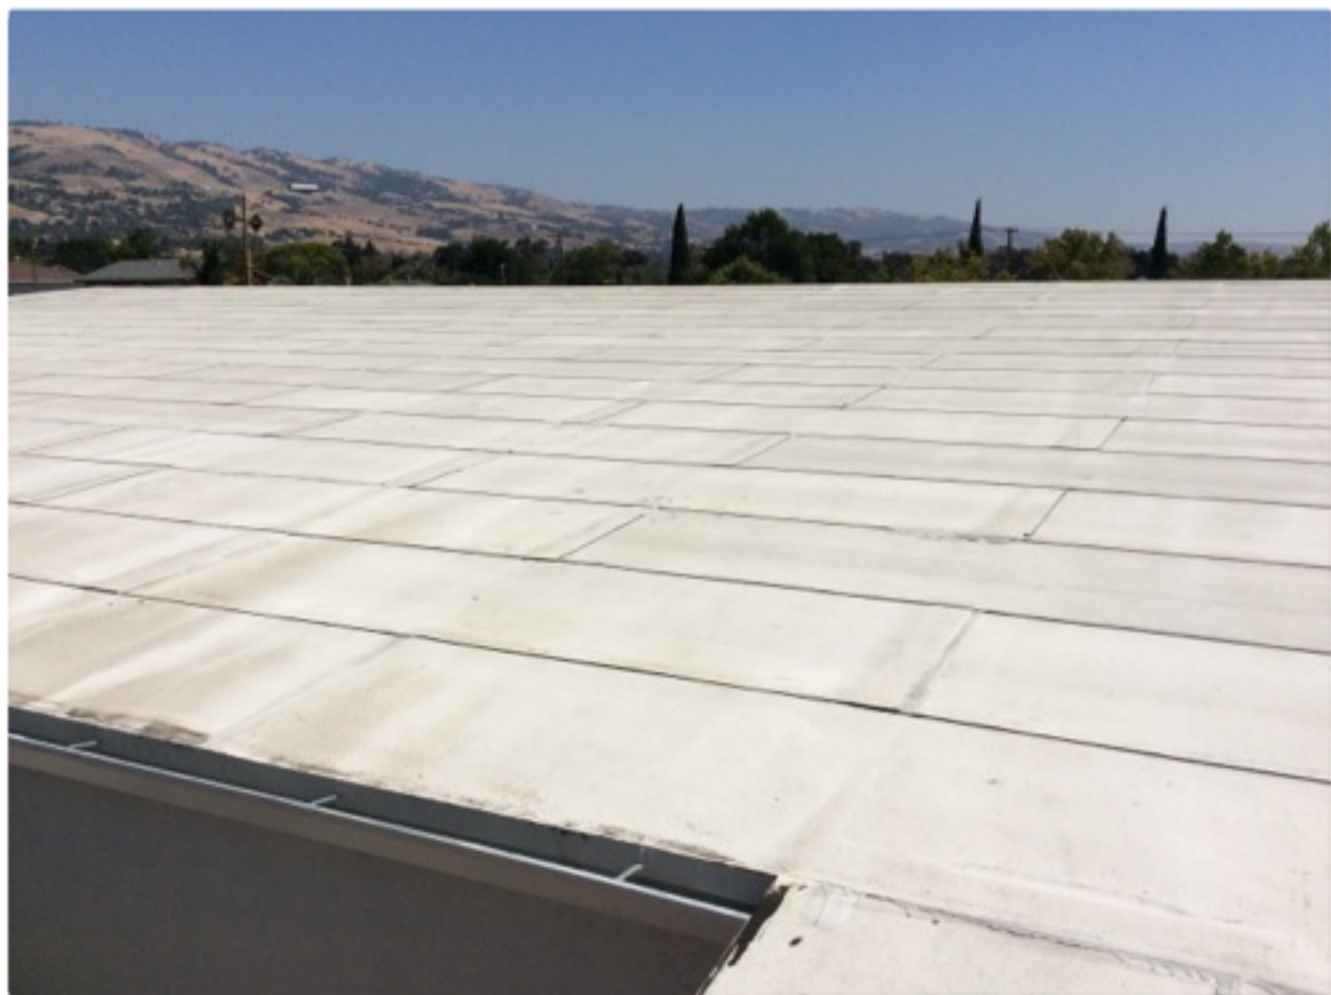
ADDITIONAL NOTES  
 CLEAR SLOW MOVING DRAINS IN ORDER TO PREVENT PONDING AND PREMATURE ROOF DETERIORATION.

An overview photo from the roof level.

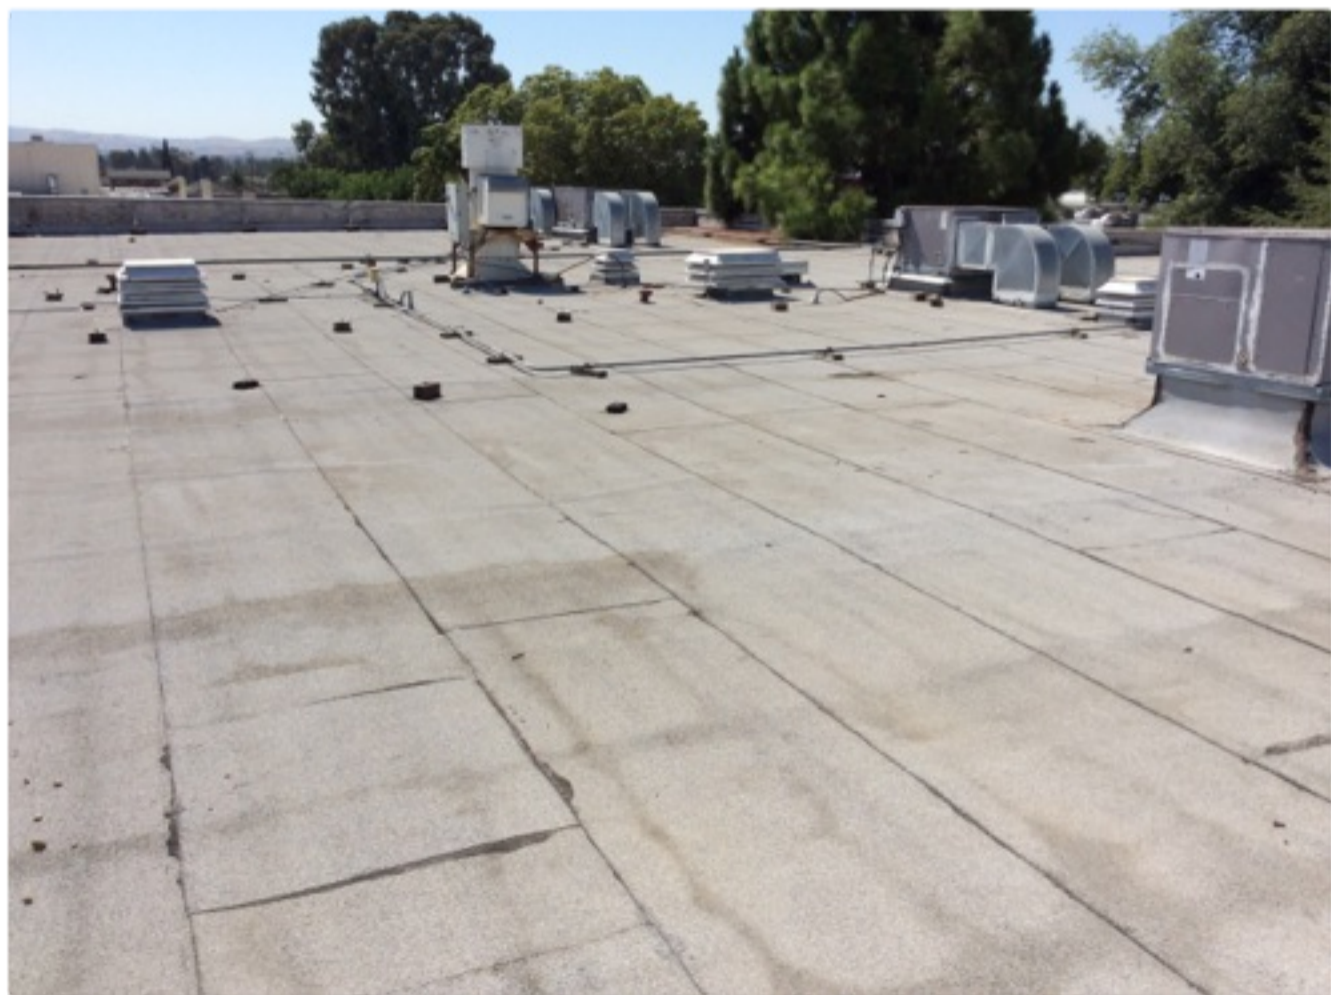
**ADDITIONAL NOTES**  
 ROOF IS IN BAD SHAPE. WALLS AND WALL FLASHING NEEDS TO BE REDESIGNED. A GOOD CHOICE TO BE REPLACED - ARGUABLY IN THE WORST SHAPE ON CAMPUS.

An overview photo from the roof level.

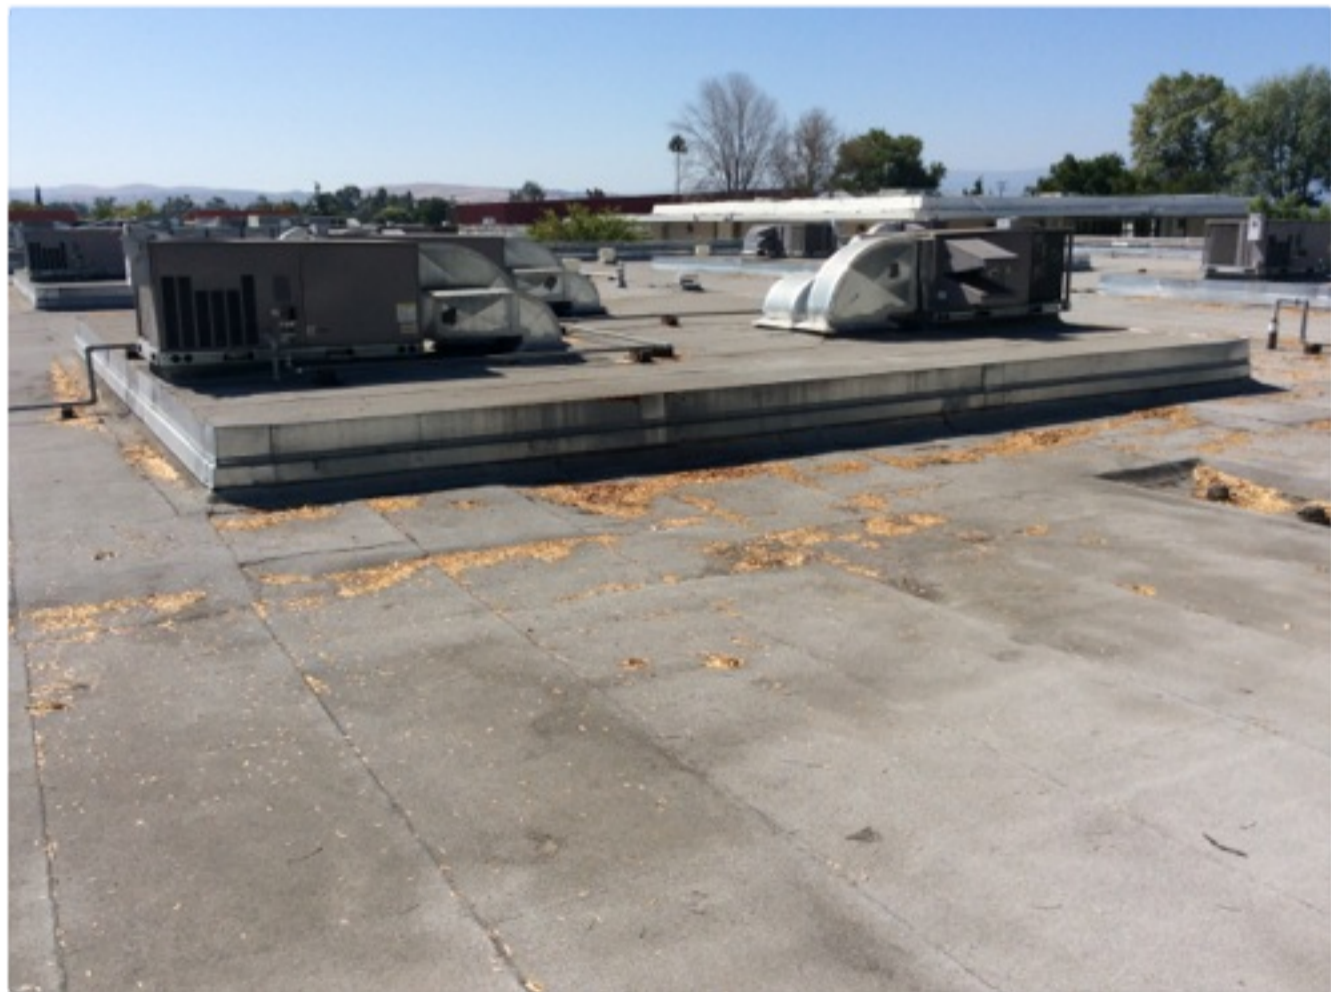
**ADDITIONAL NOTES**  
 ROOFS ARE IN POOR SHAPE. TOO MUCH RIDGING TO REPAIR. ONCE THE RIDGES CRACK, THE ROOF WILL FAIL. NO INSULATION ON THE CANOPIES.

An overview photo from the roof level.

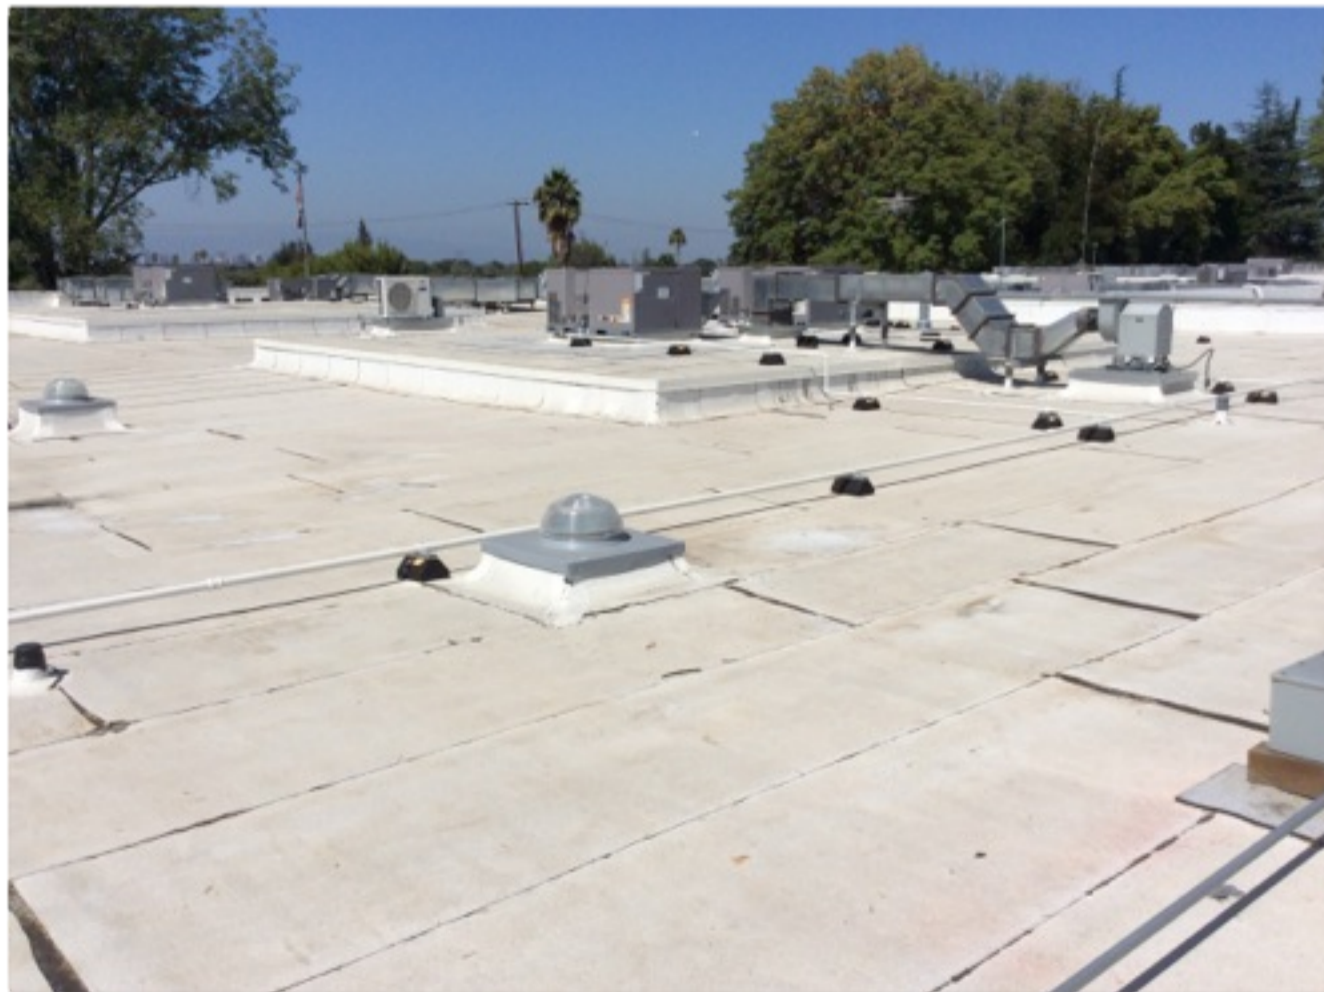
**ADDITIONAL NOTES**  
 REPAIR ALL BLISTERS AND EDGE FLASHING CLOSE TO THE BLISTERS (WORST ON 200). CLEAR DRAINS TO PREVENT EXCESSIVE PONDING AND SUBSEQUENT PREMATURE DETERIORATION OF THE ROOF MEMBRANE.

An overview photo from the roof level.

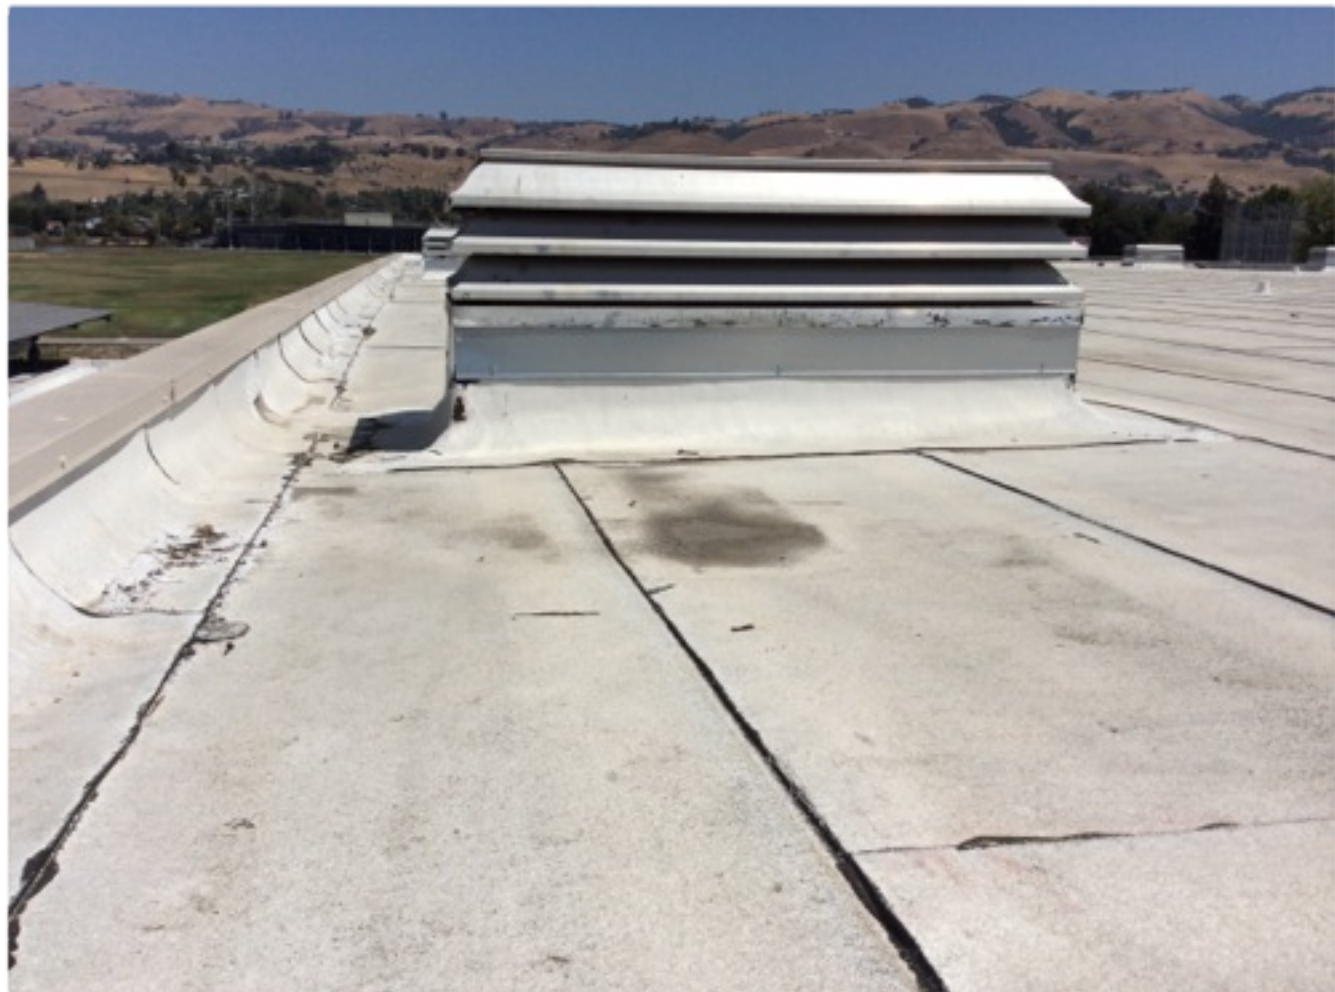
The photo below shows the penetration details in great shape.

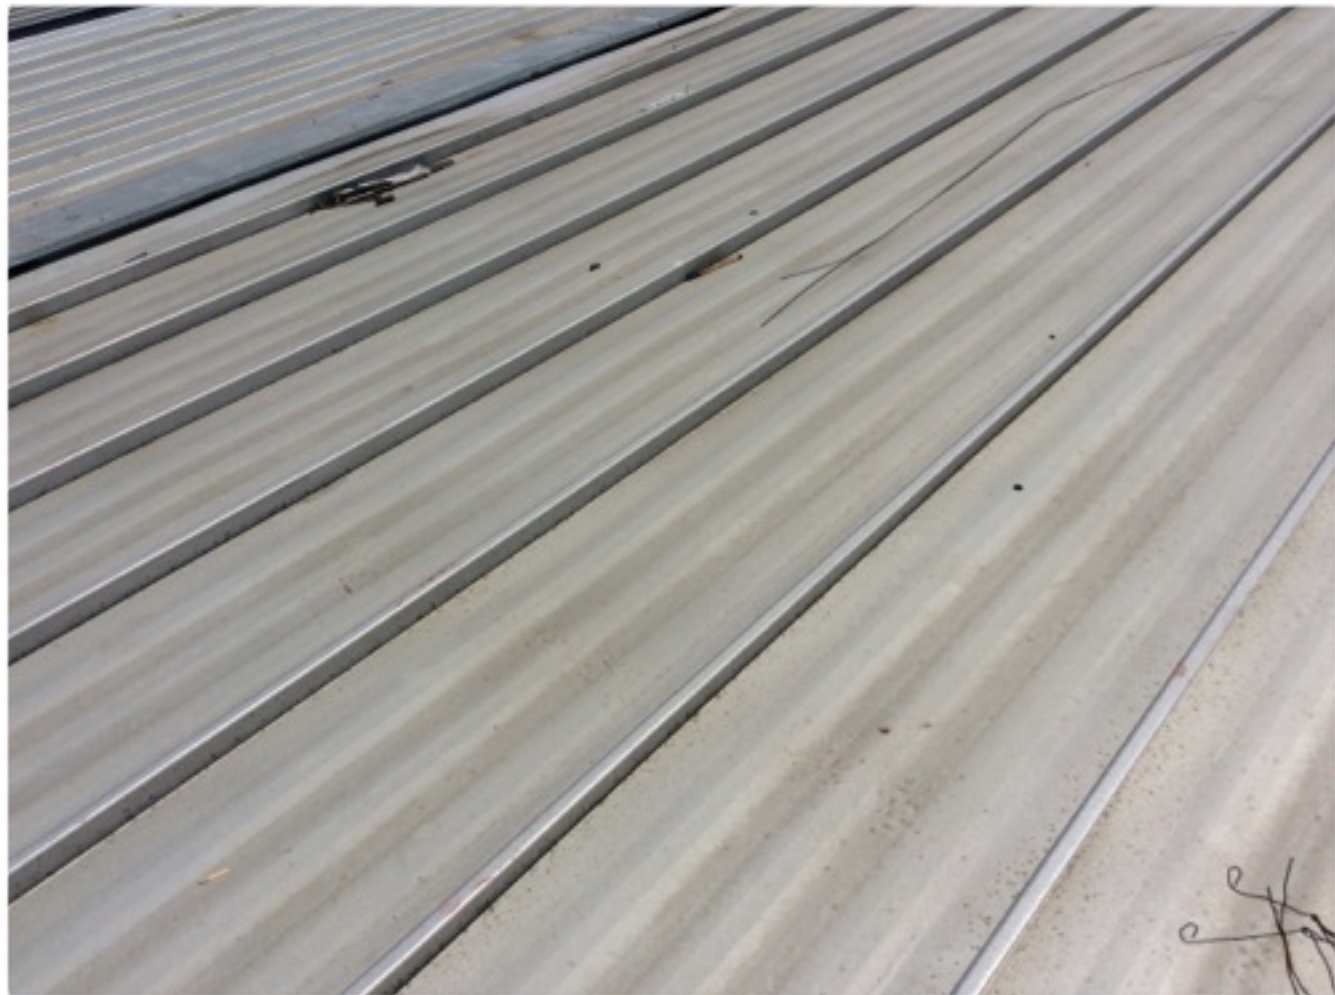
The photo below shows a close up of the panels.
