BUILDING INFORMATION	
FACILITY	Oak Grove HS
DATE	October 23, 2014
BUILDING	A Admin, H1, H2
ROOF SQ FT	25,000

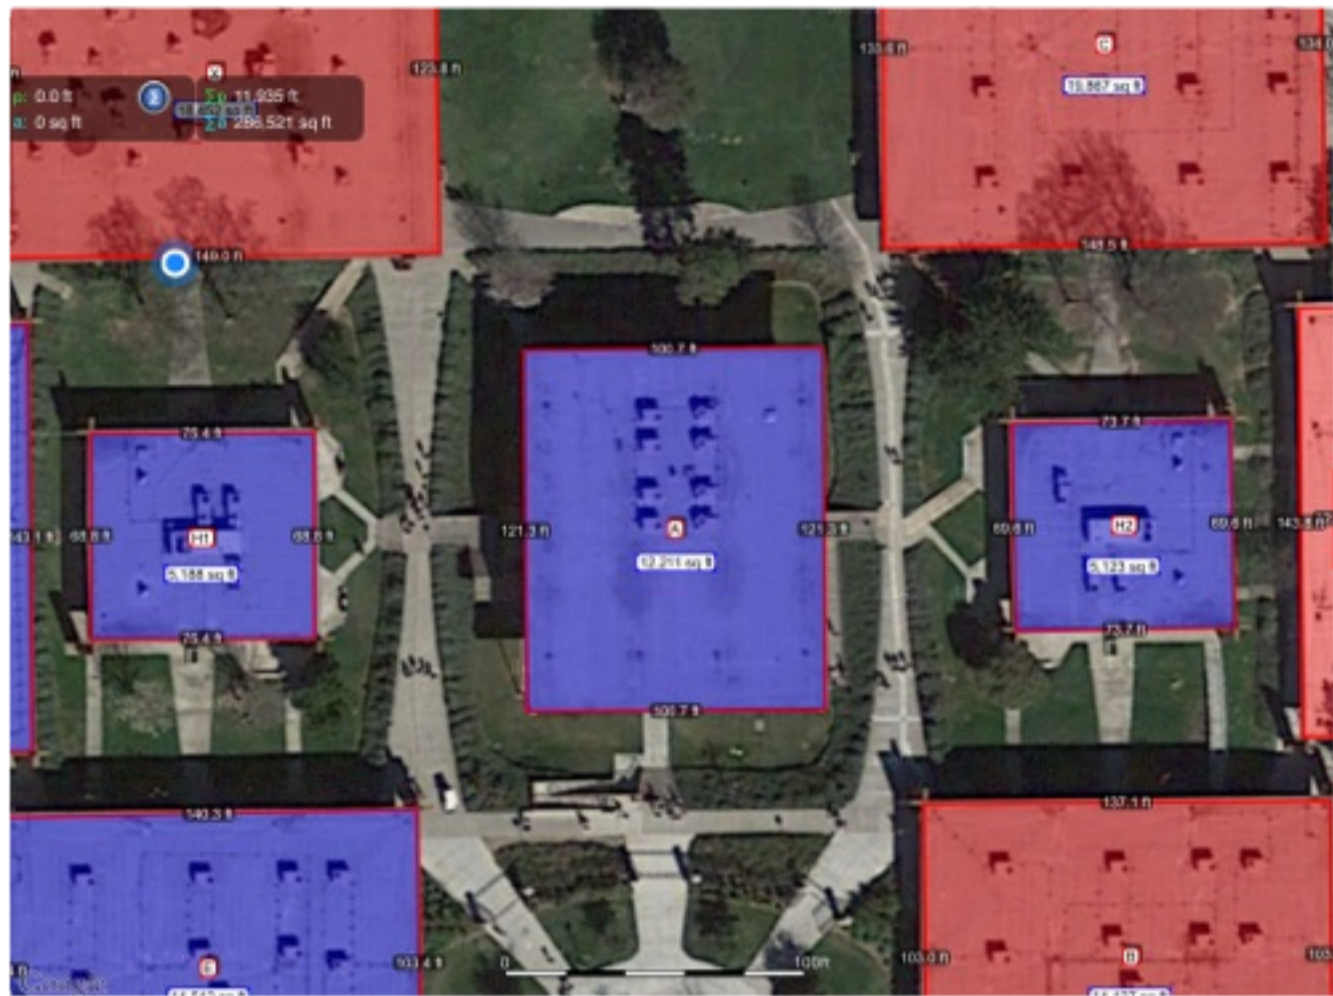
ADDITIONAL NOTES
 ROOFS ARE AGING WELL. MANAGE FOR ANOTHER FIVE YEARS OF LIFE. H1 and H2 DO NEED REPAIRS TO PENETRATIONS. A DOES NOT.

An aerial view of the building.

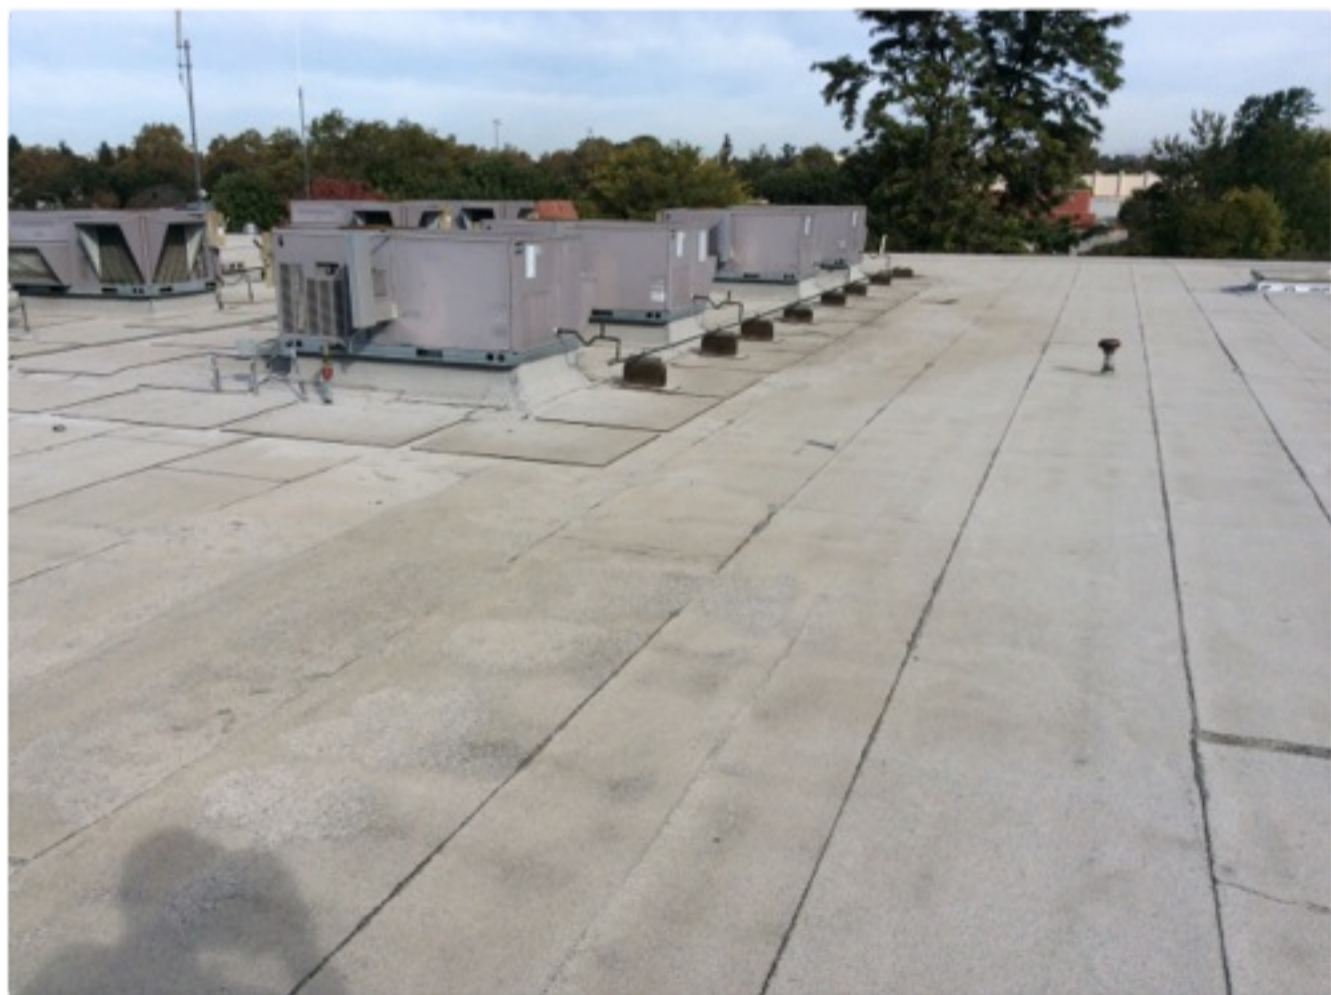
An overview photo from the roof level.

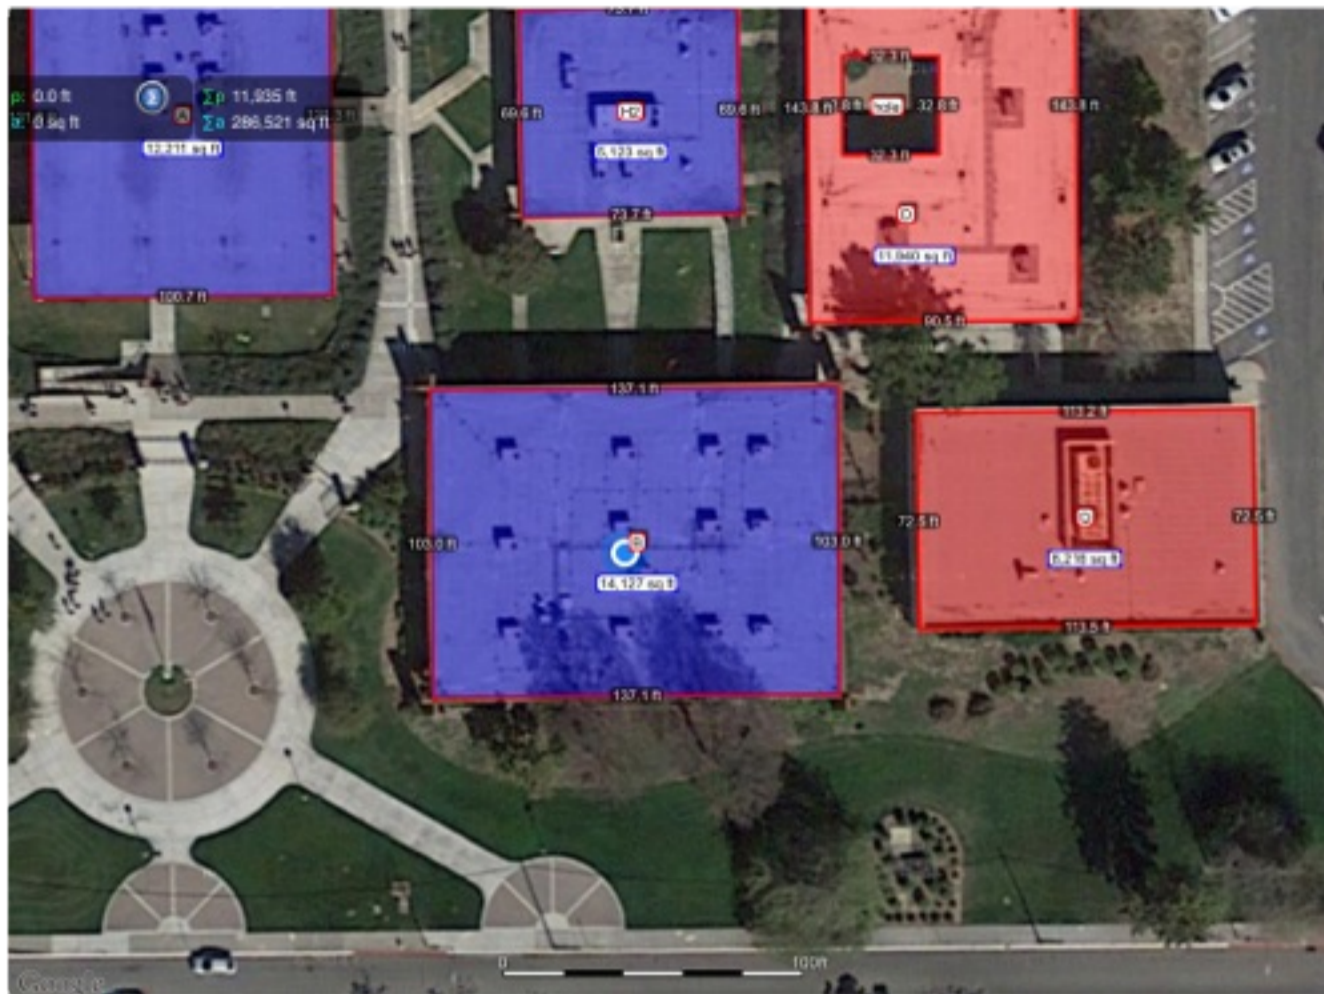
An aerial view of the building.

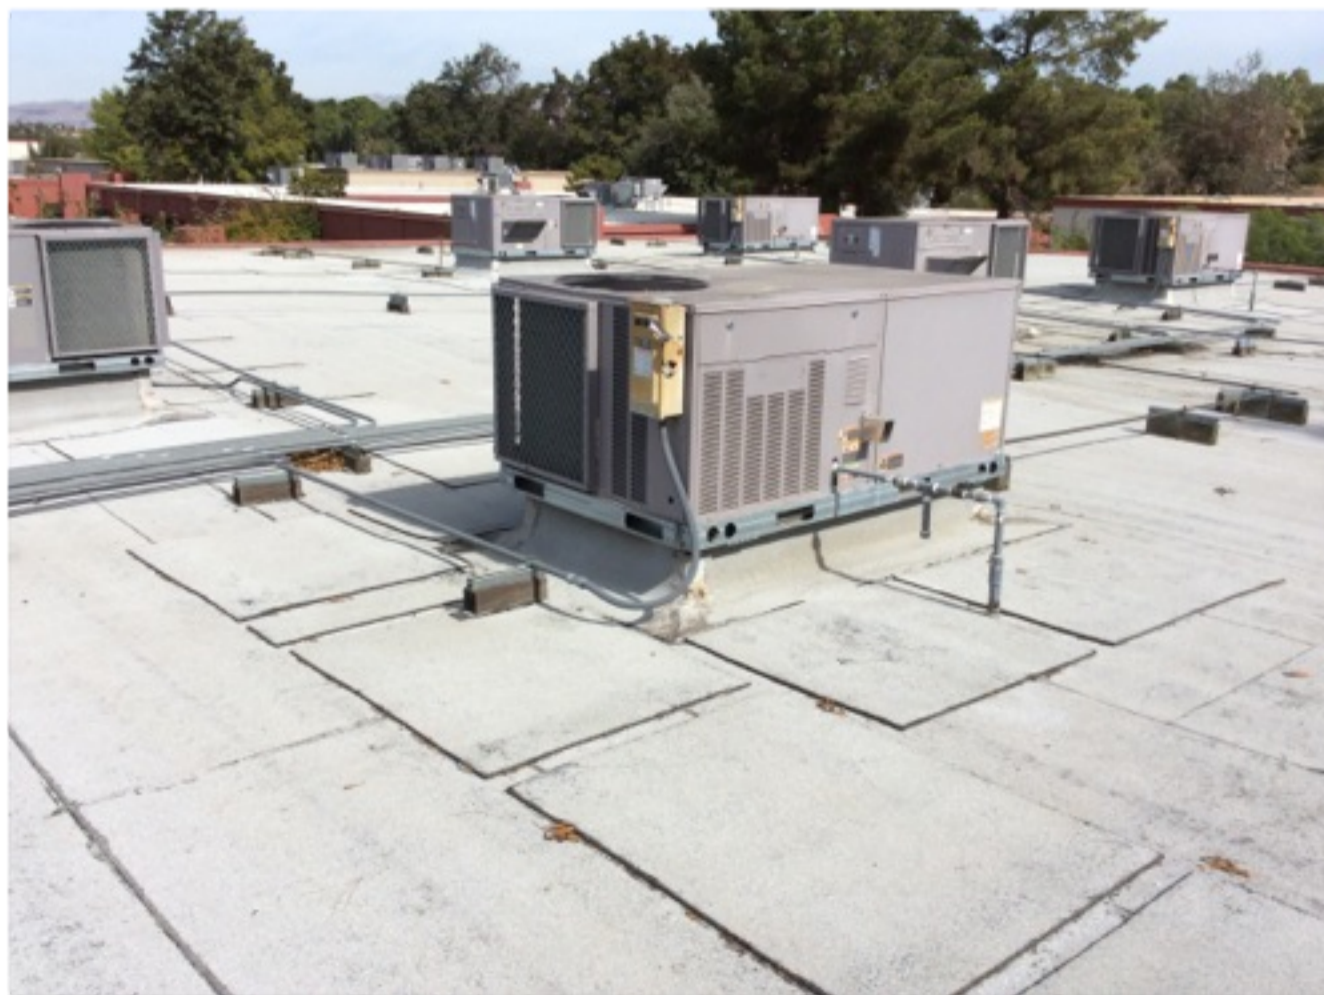
An overview photo from the roof level.

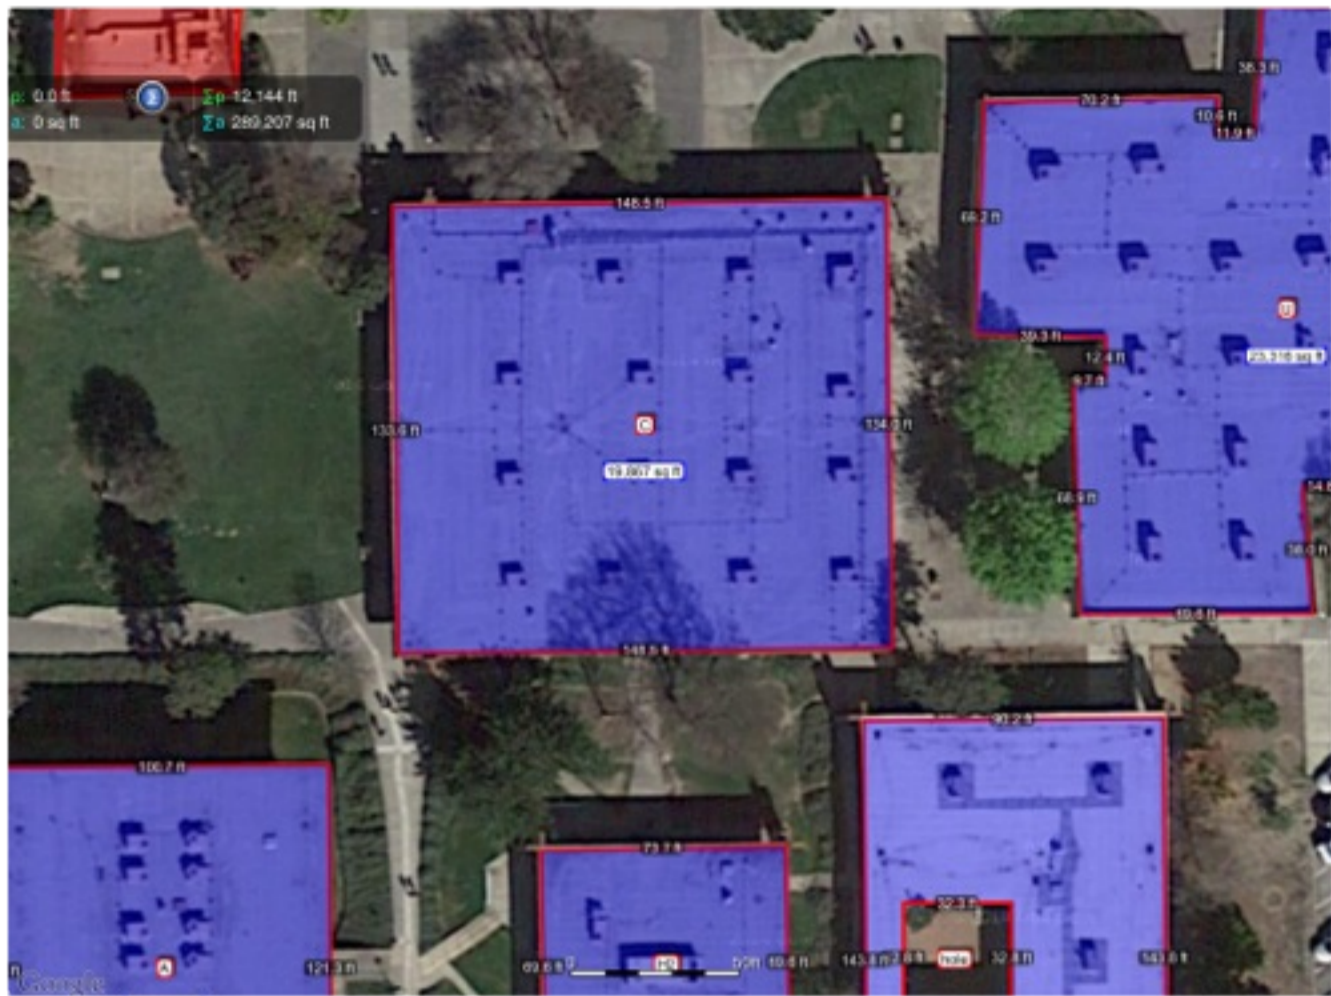
An aerial view of the building.

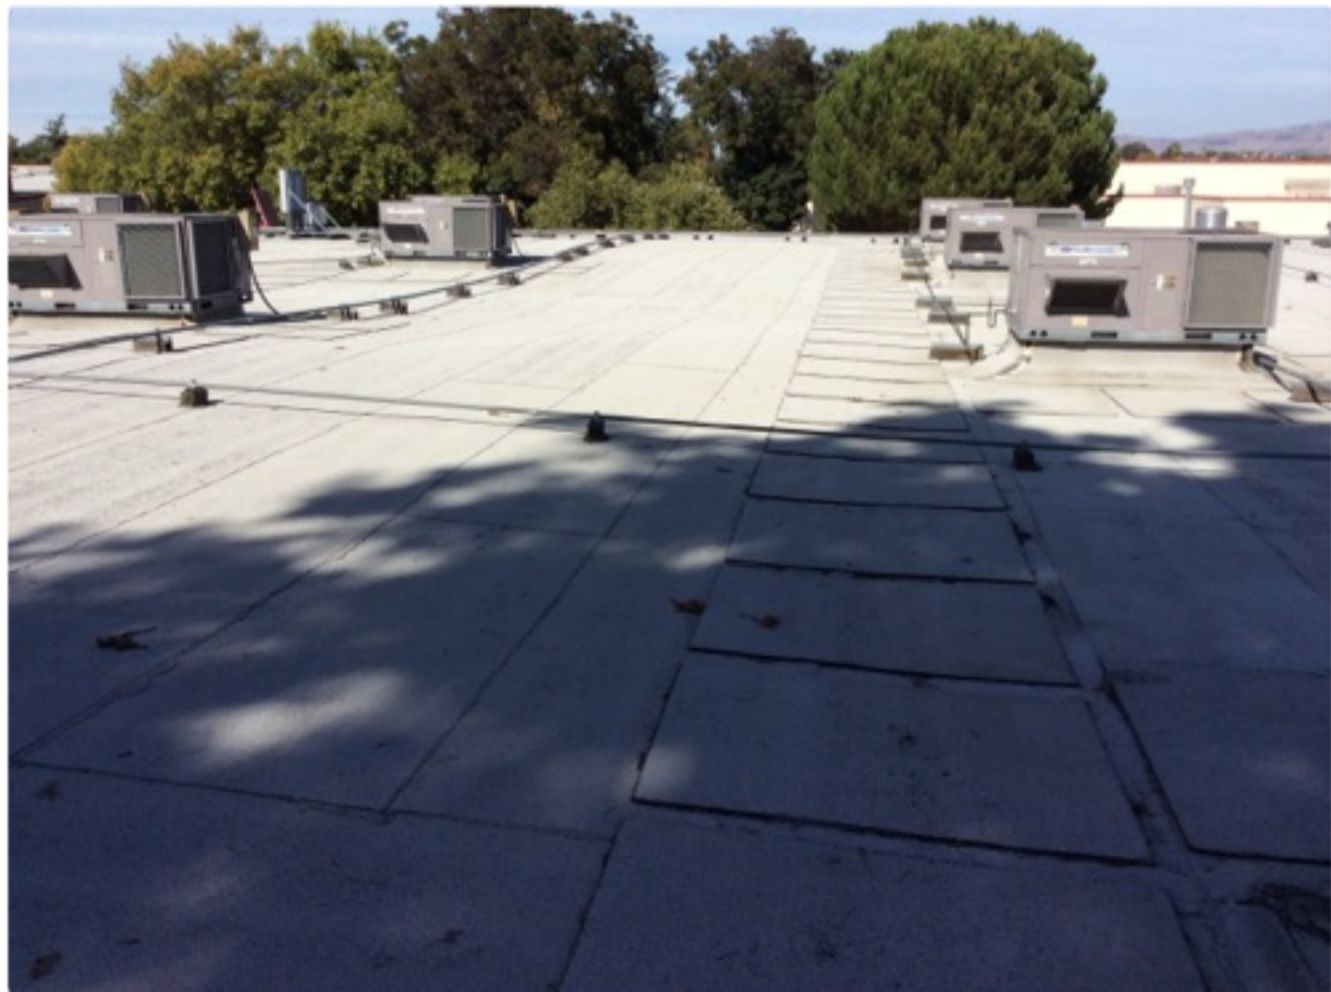
An overview photo from the roof level.

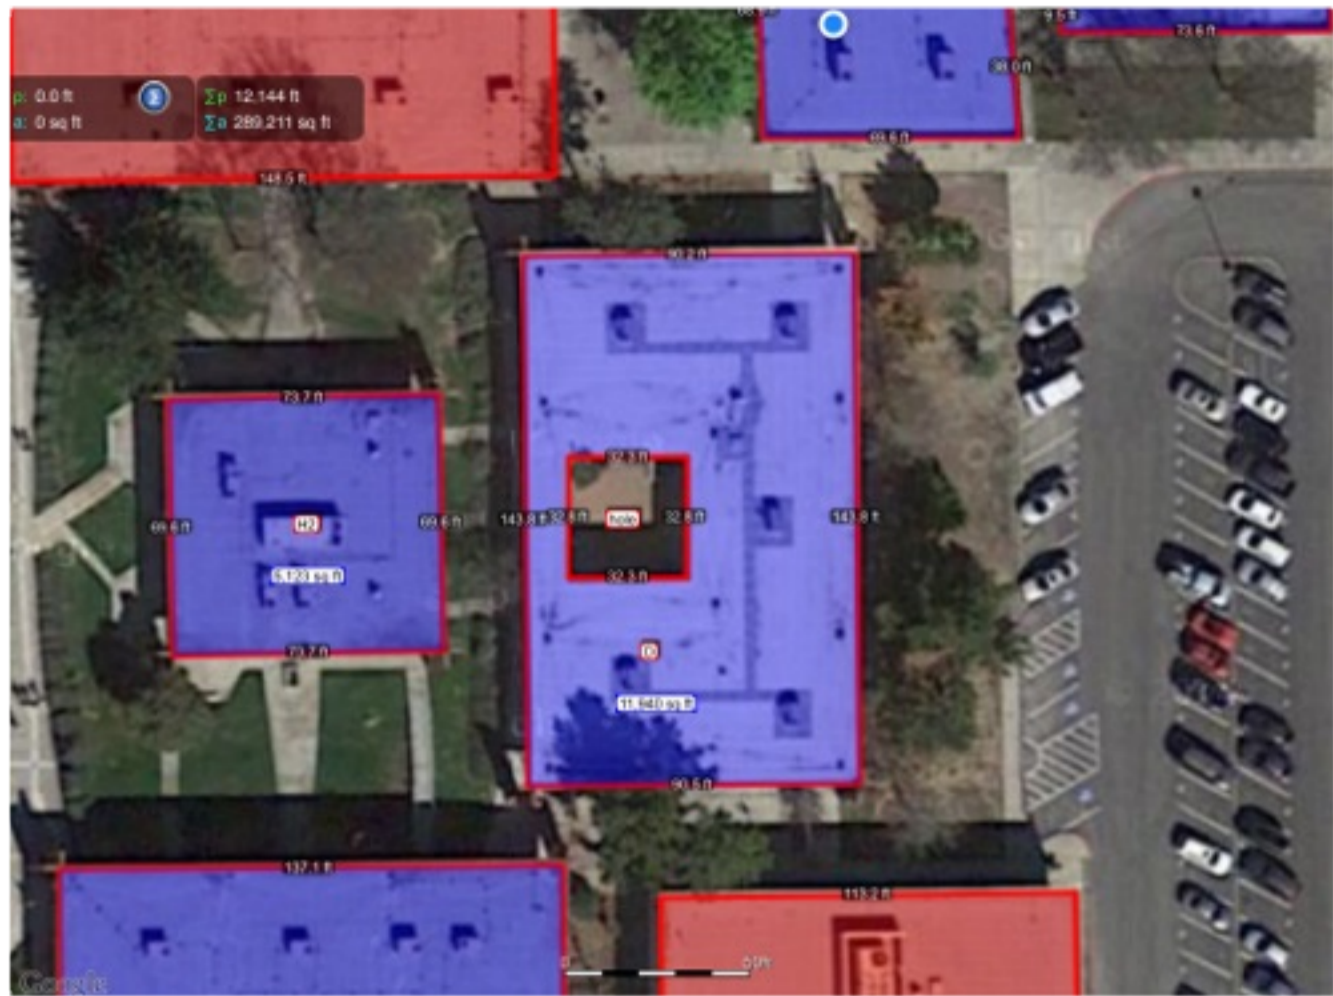
ADDITIONAL NOTES
 ROOF IS NEW HOWEVER SOME OF THE PENETRATION SEAMS ARE FAILING. HAVE CONTRACTOR REPAIR UNDER WARRANTY. BLISTERS TOO SMALL TO REPAIR - INSPECT PERIODICALLY AND ESPECIALLY BEFORE THE CONTRACTORS WARRANTY IS UP.

An aerial view of the building.

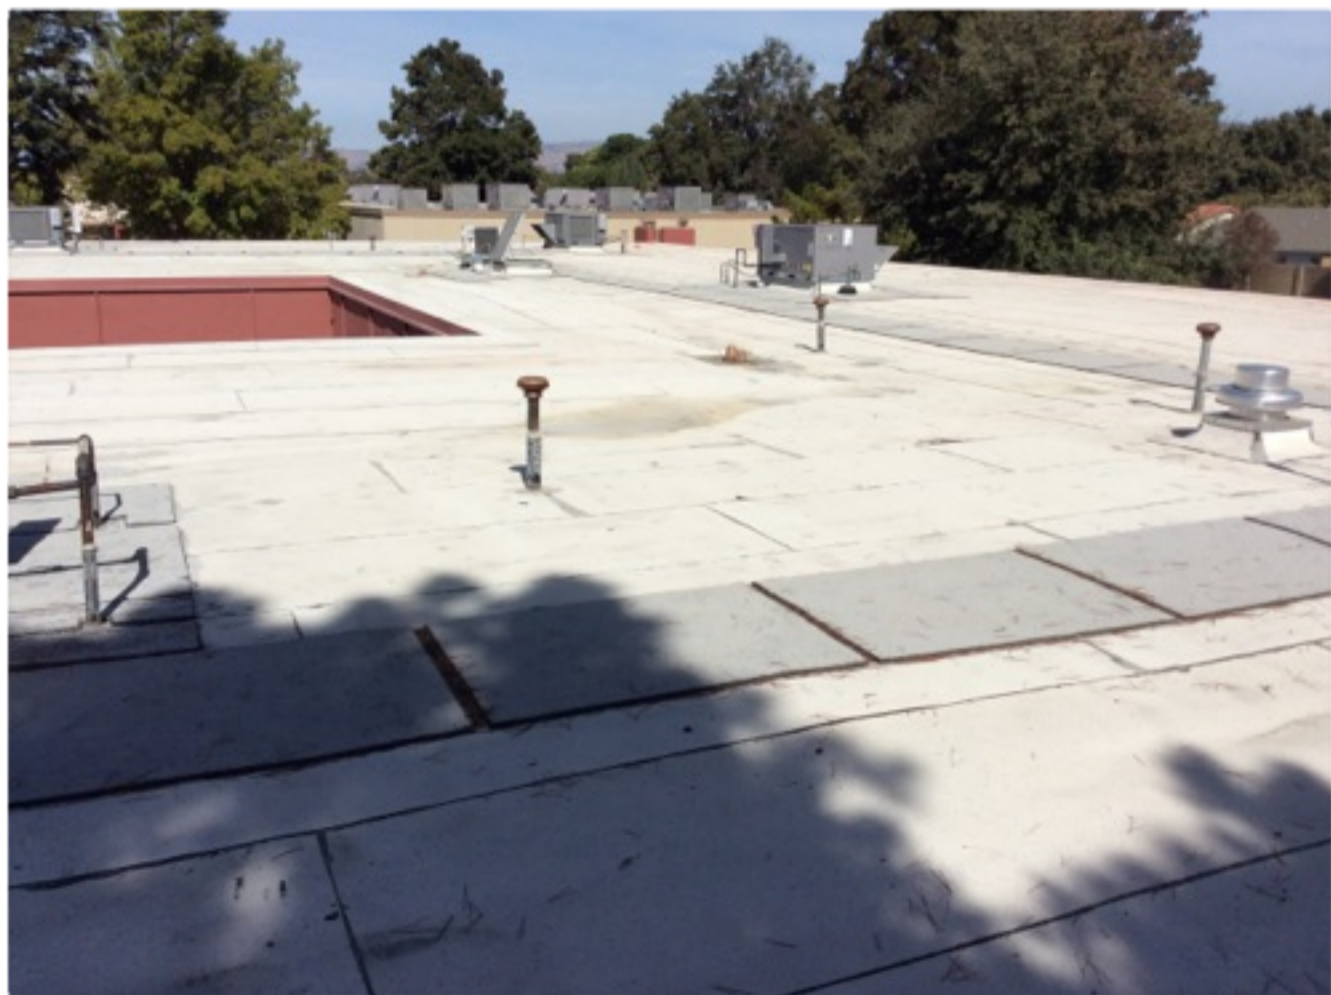
An overview photo from the roof level.

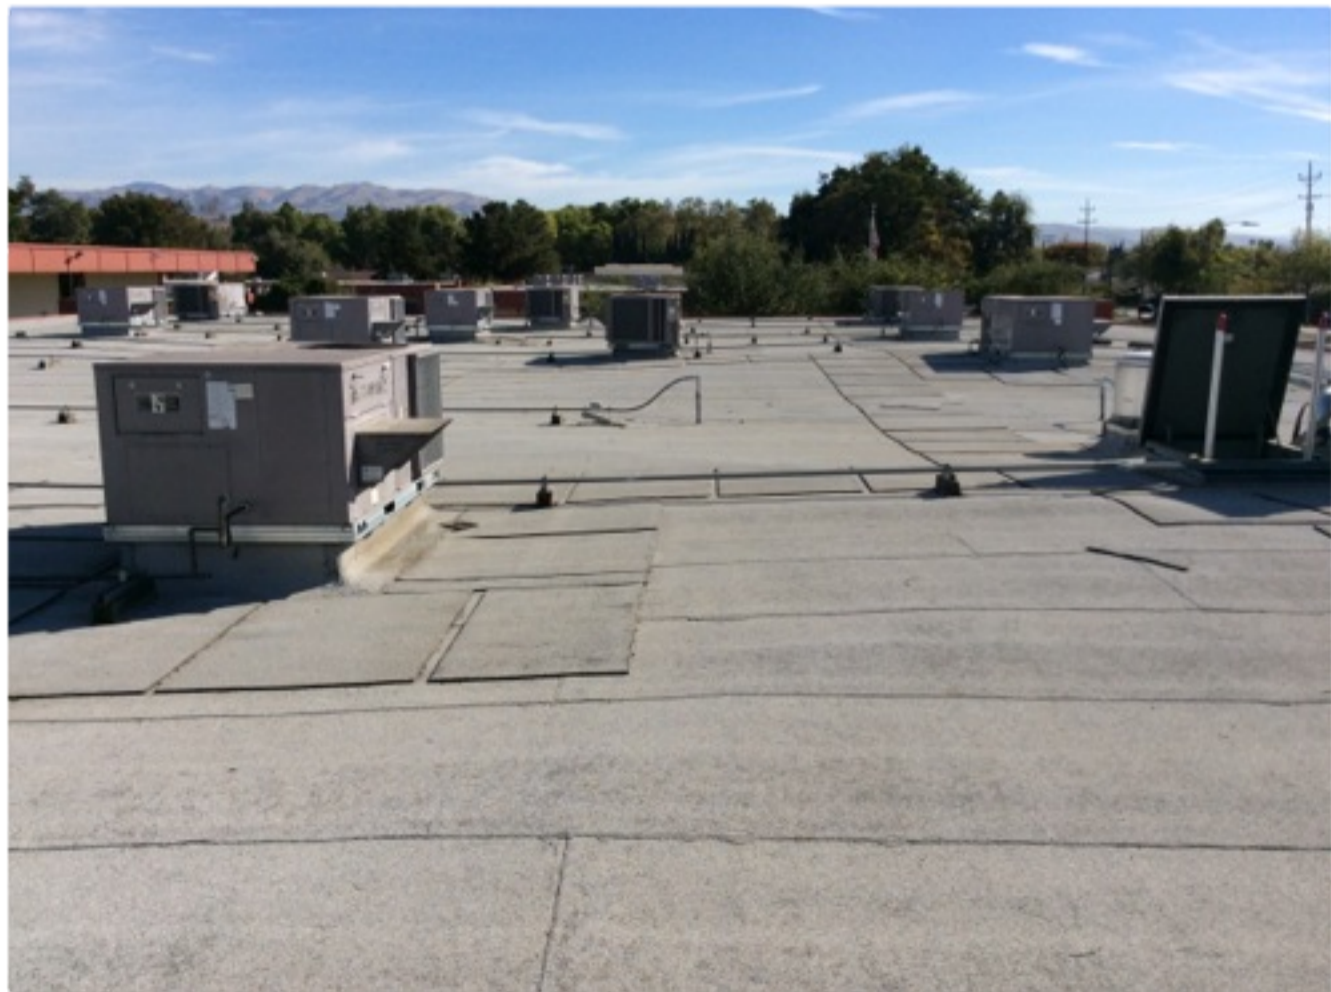
An overview photo from the roof level.

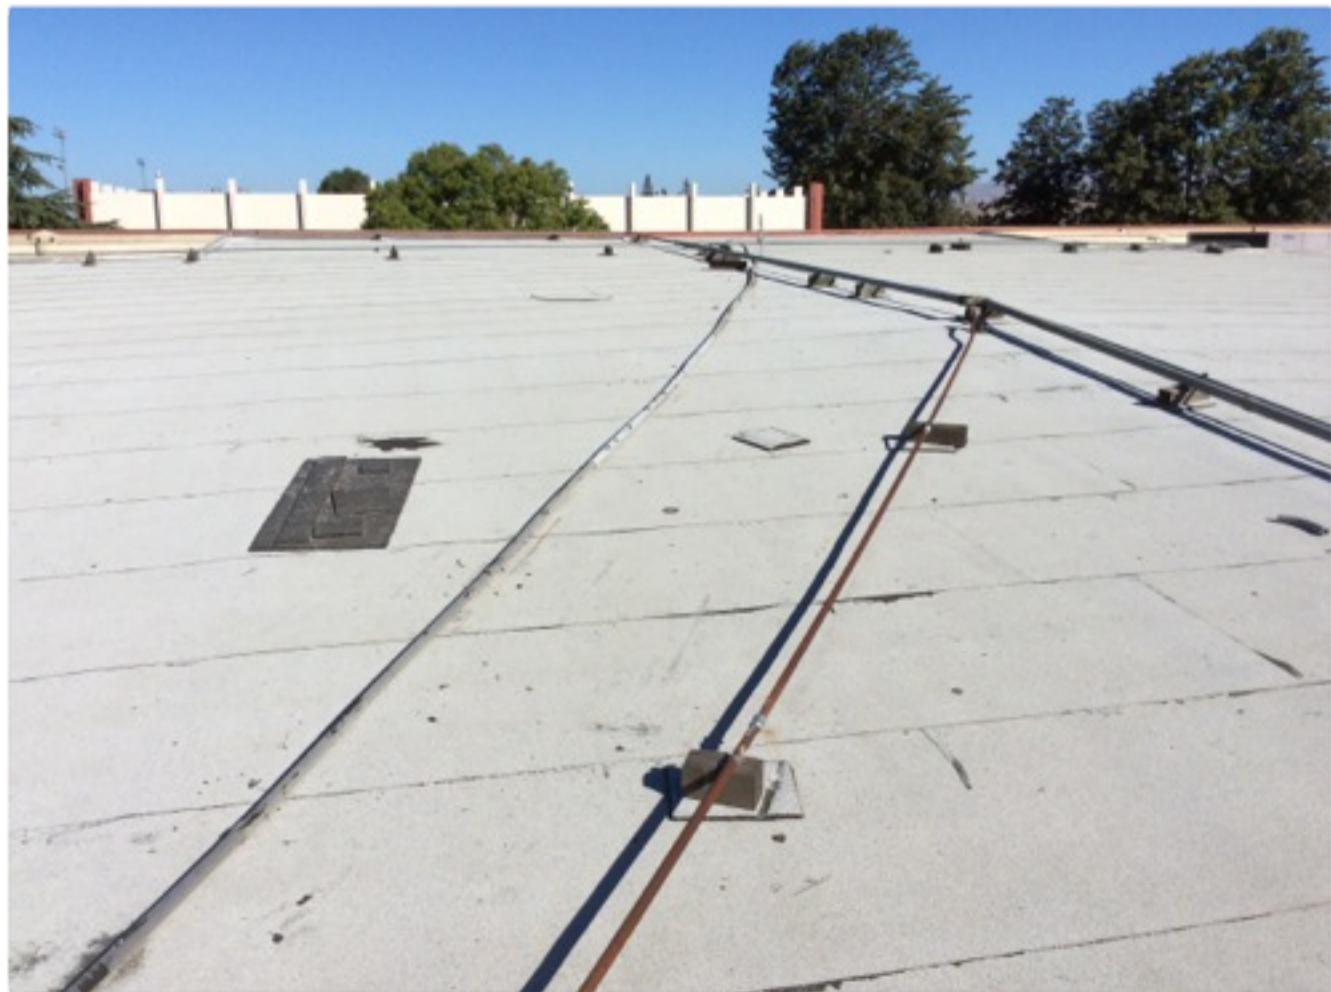
An overview photo from the roof level.

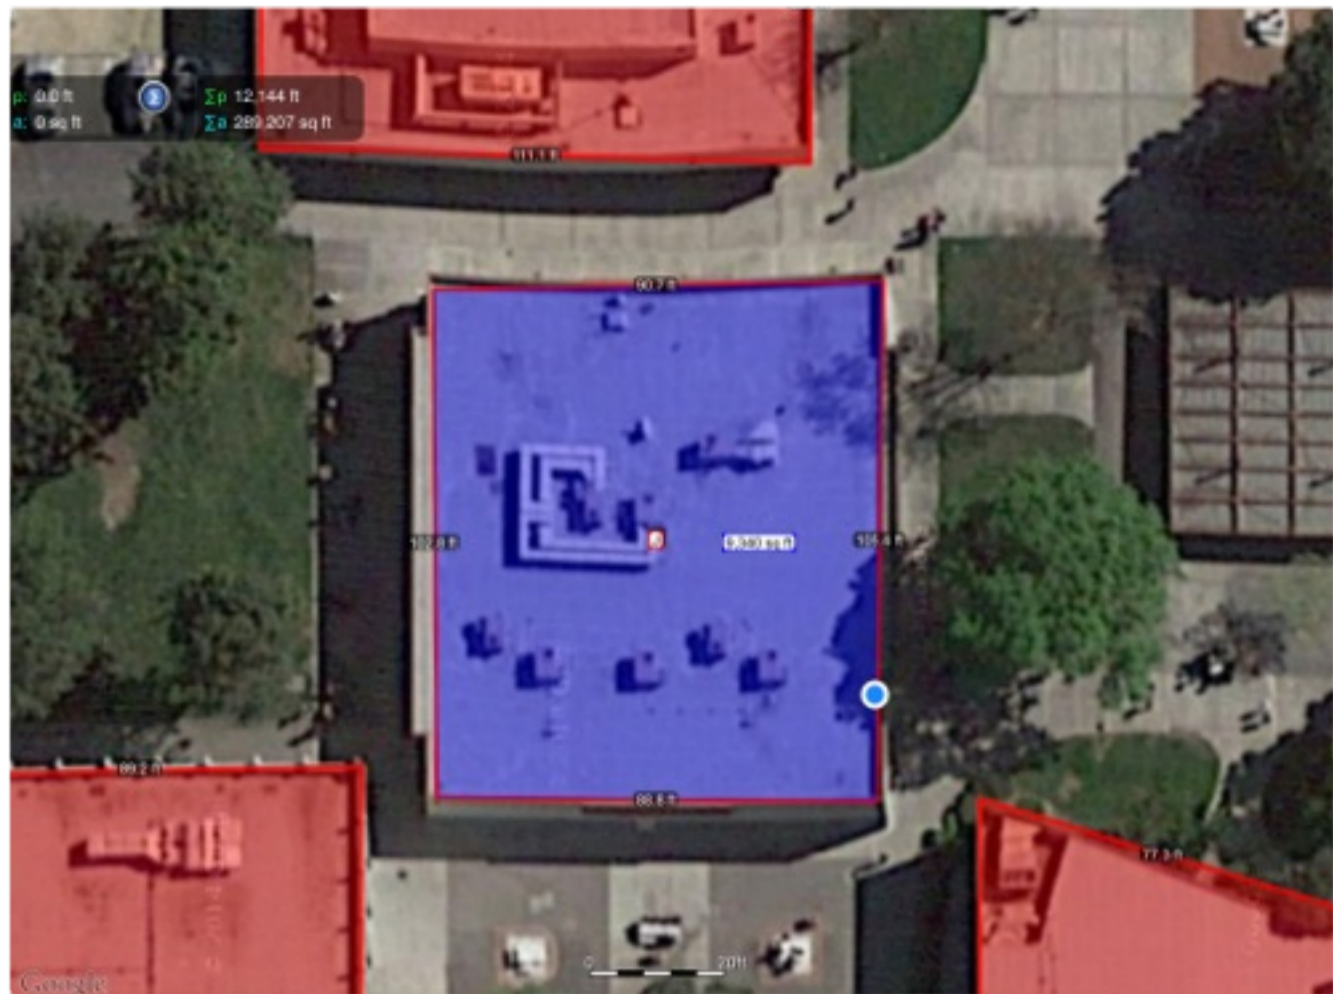
An aerial view of the building.

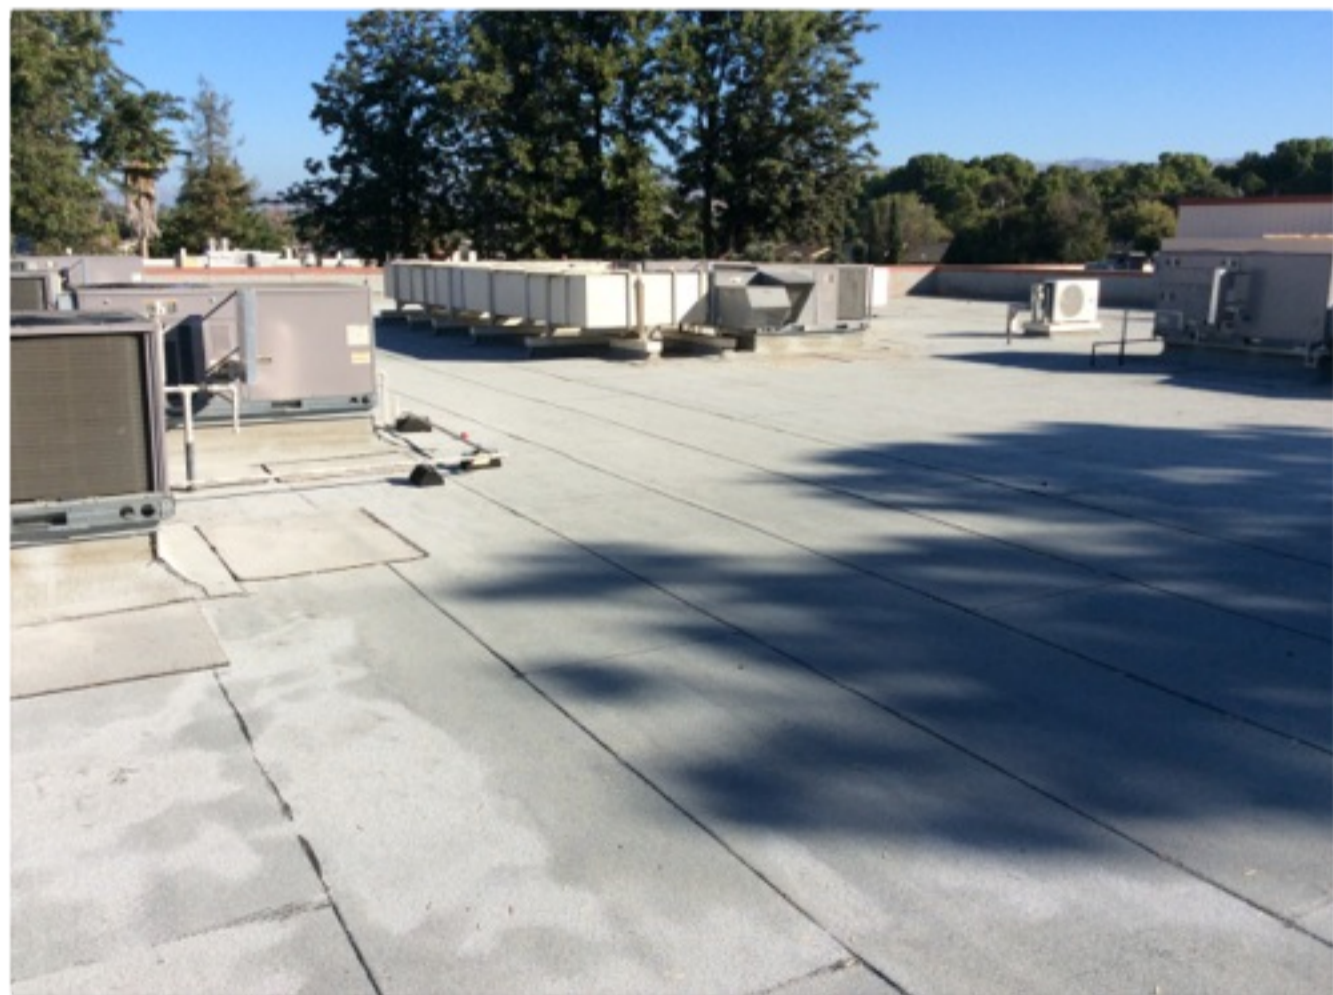
An overview photo from the roof level.

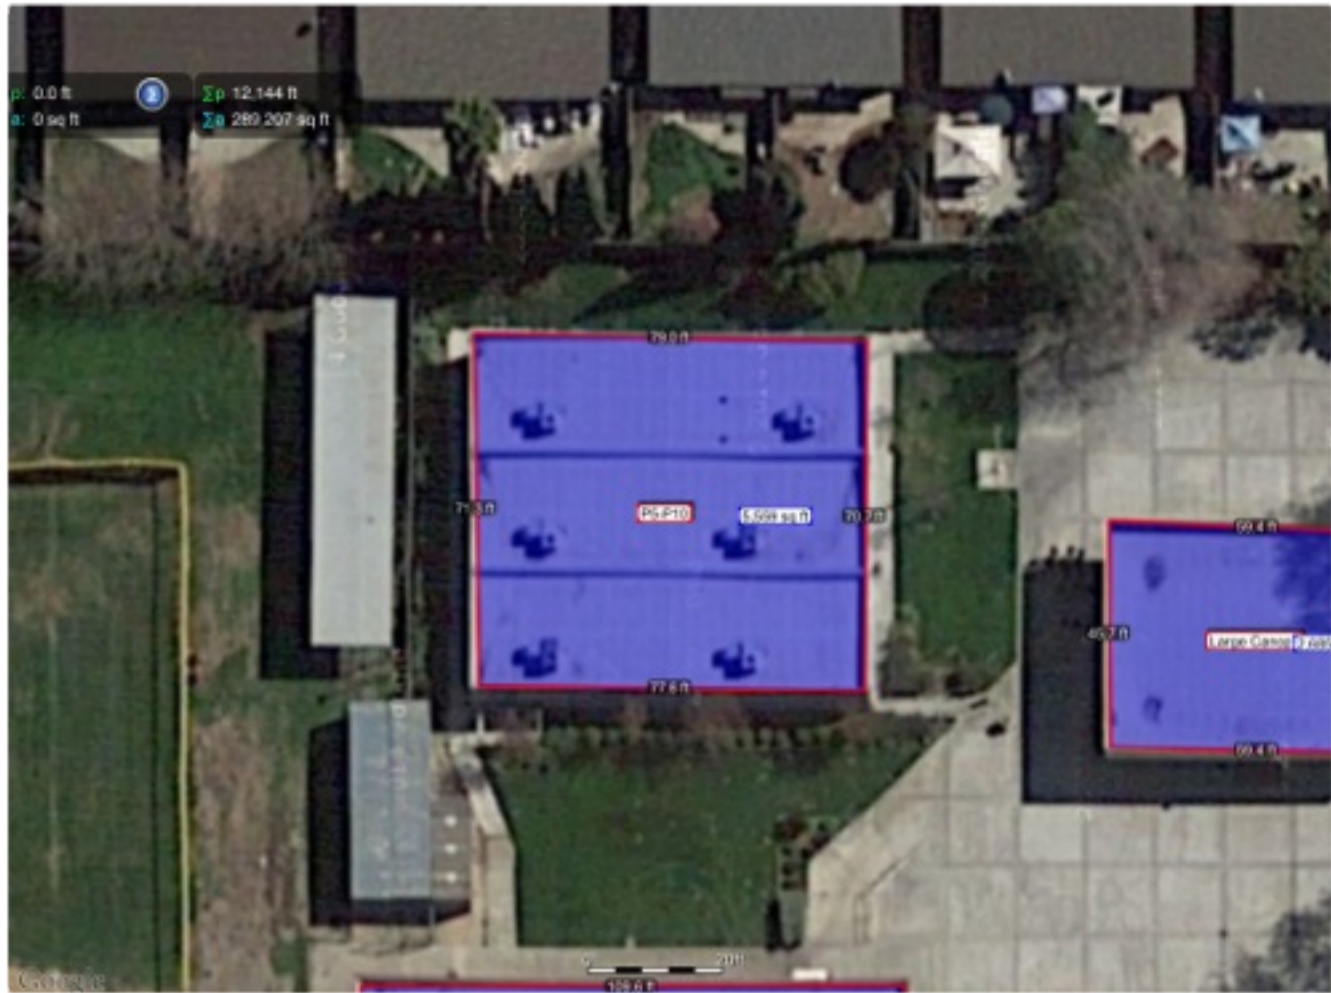
ADDITIONAL NOTES
 ROOF IS AGING. SPOT REPAIR ONLY - DOES NOT WARRANT A FULL SYSTEM REPAIR.

An aerial view of the building.

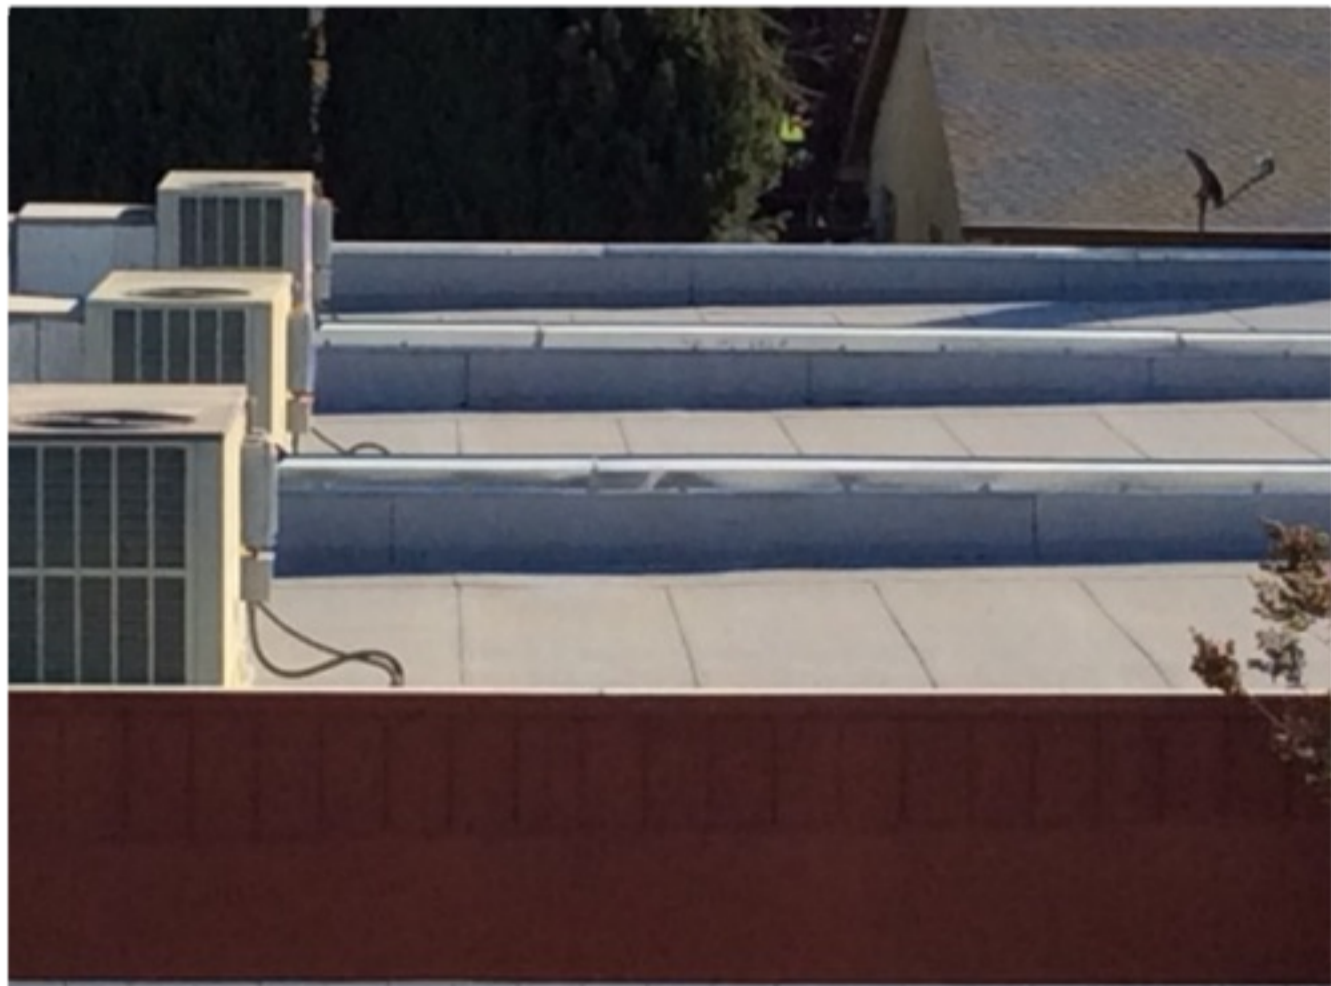
An overview photo from the roof level.

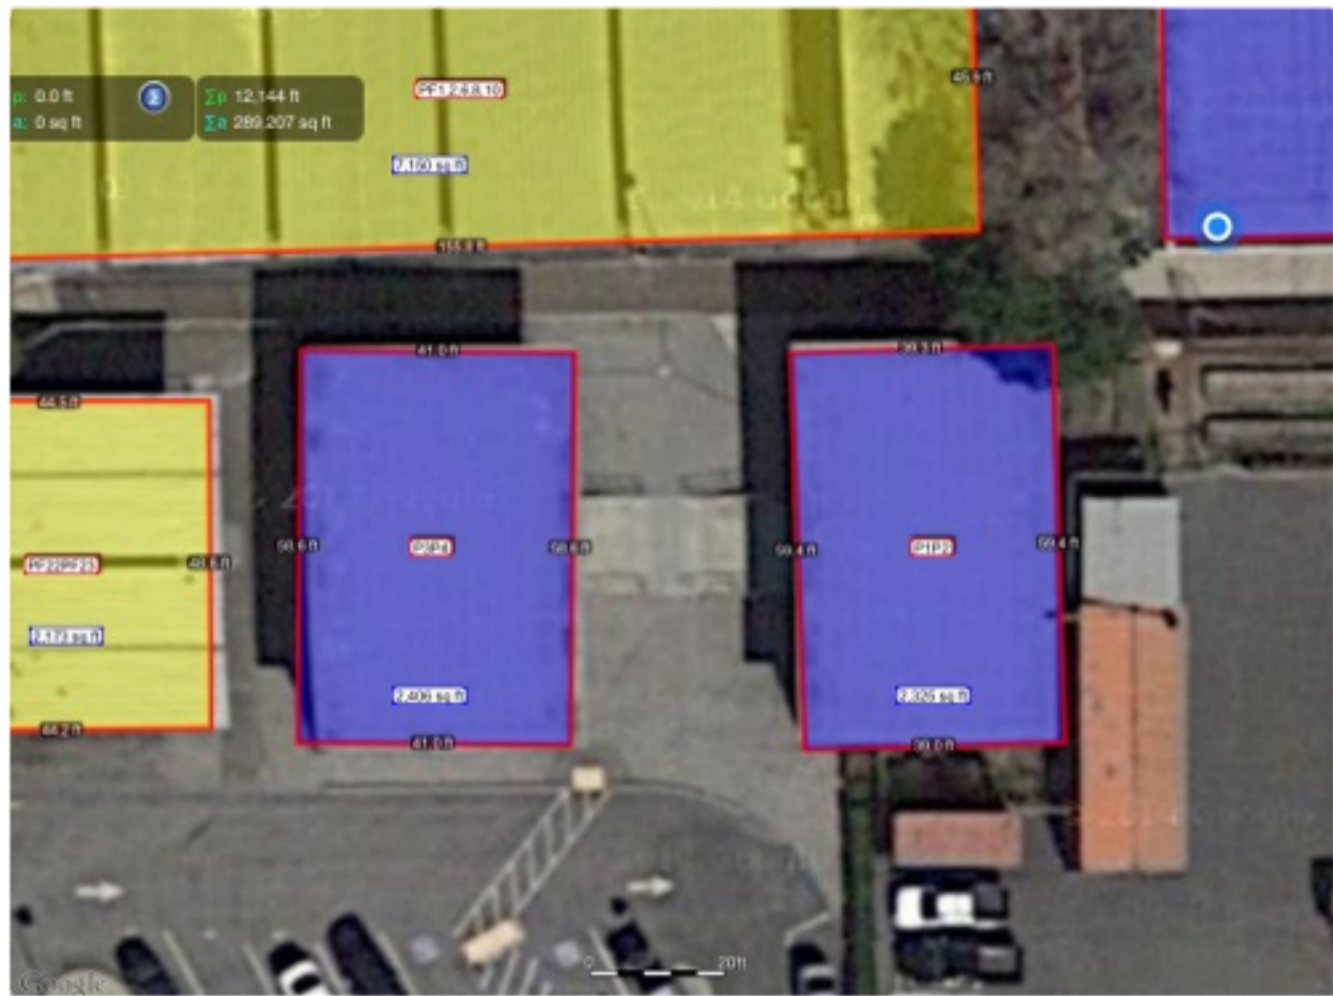
An aerial view of the building.

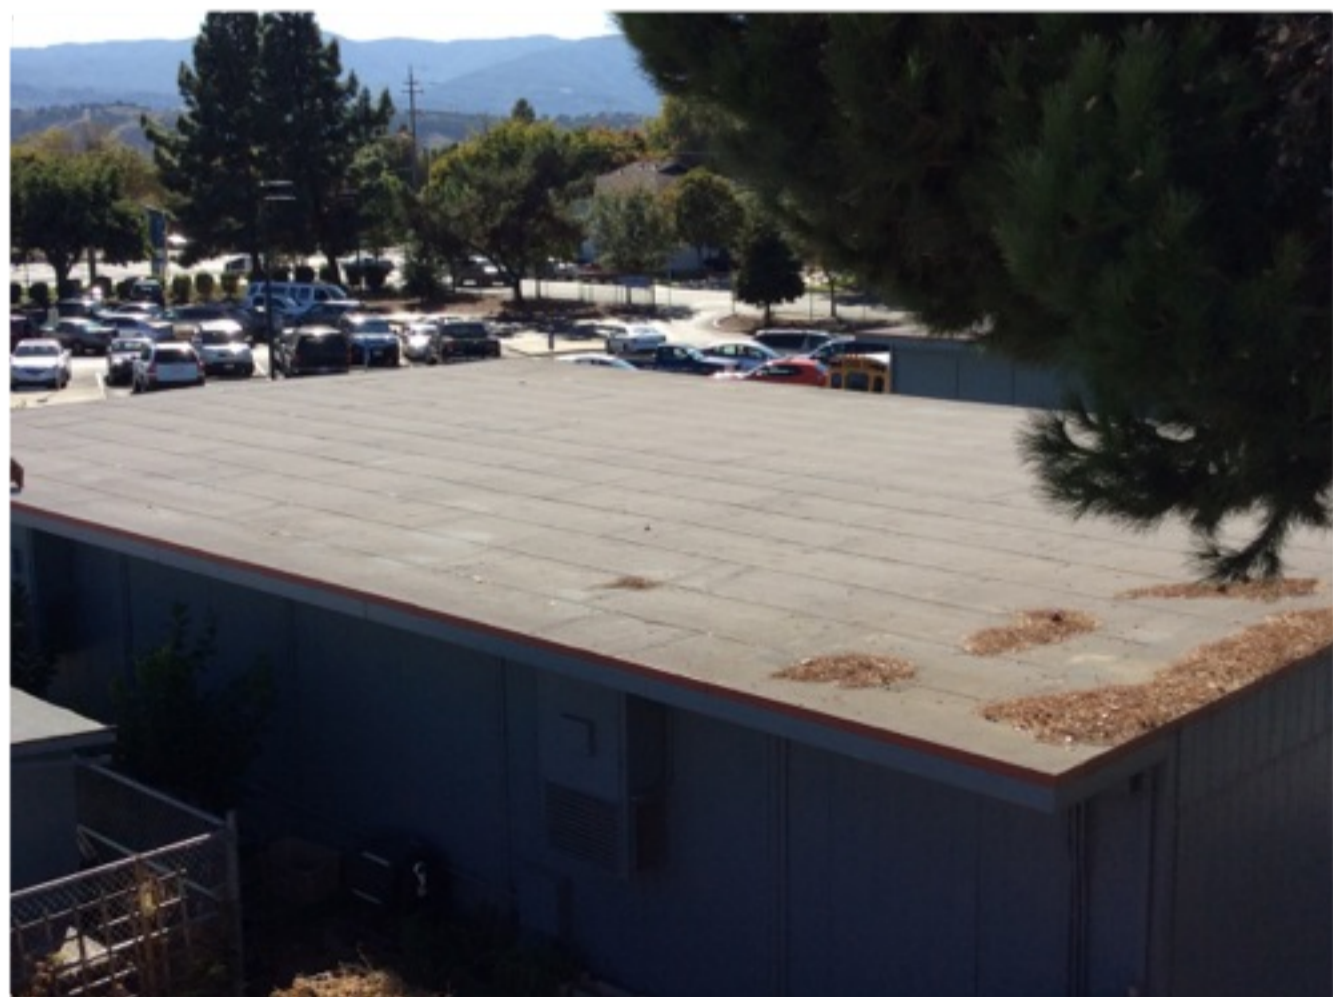
An overview photo from the roof level.

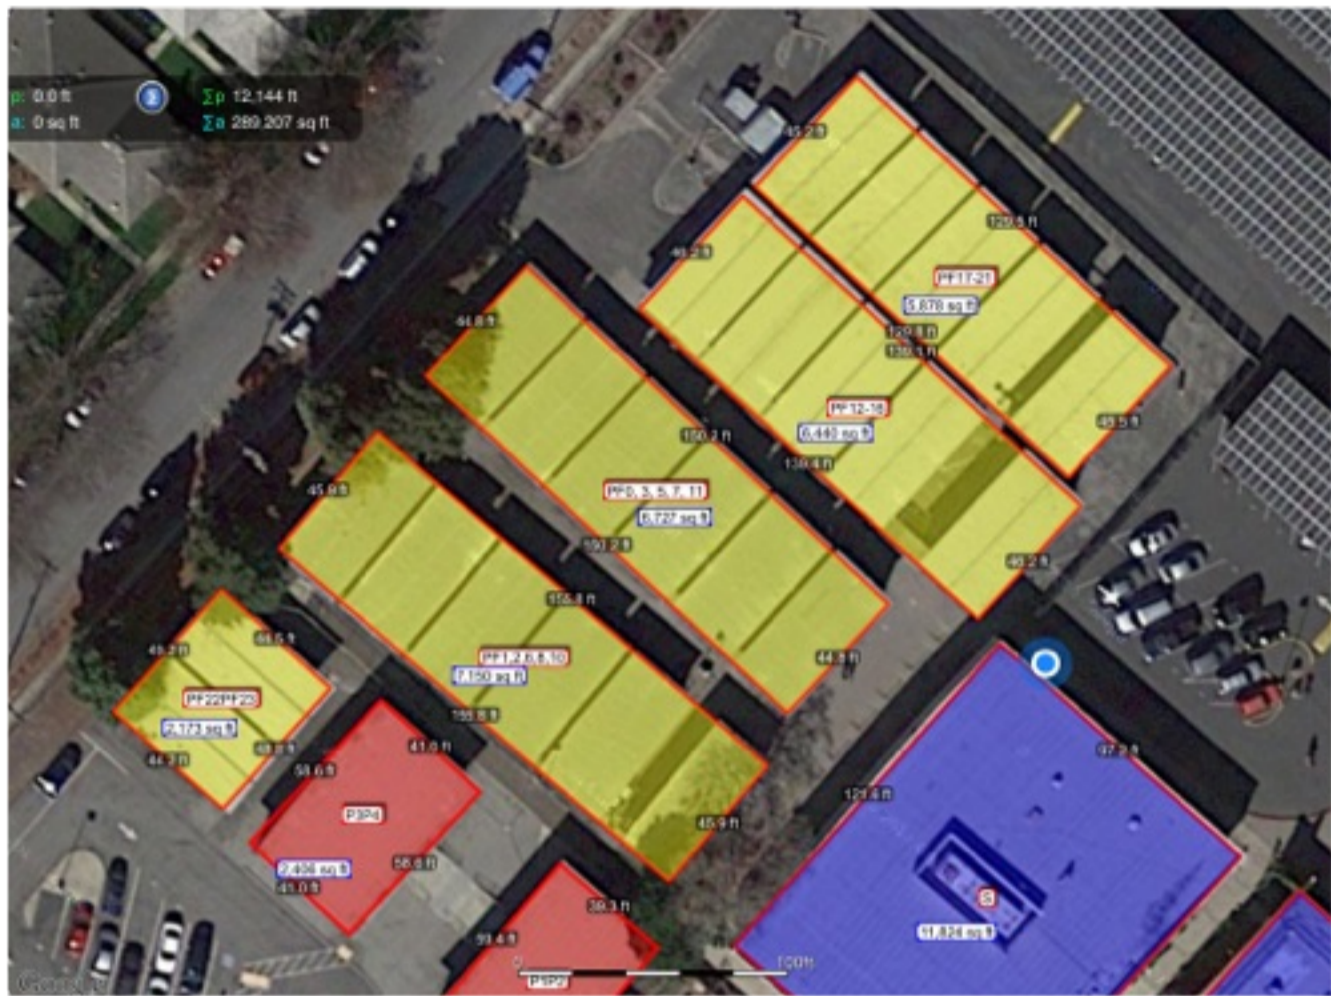
An aerial view of the building.
