BUILDING INFORMATION	
FACILITY	Oak Grove HS
DATE	October 23, 2014
BUILDING	A Admin, H1, H2
ROOF SQ FT	25,000

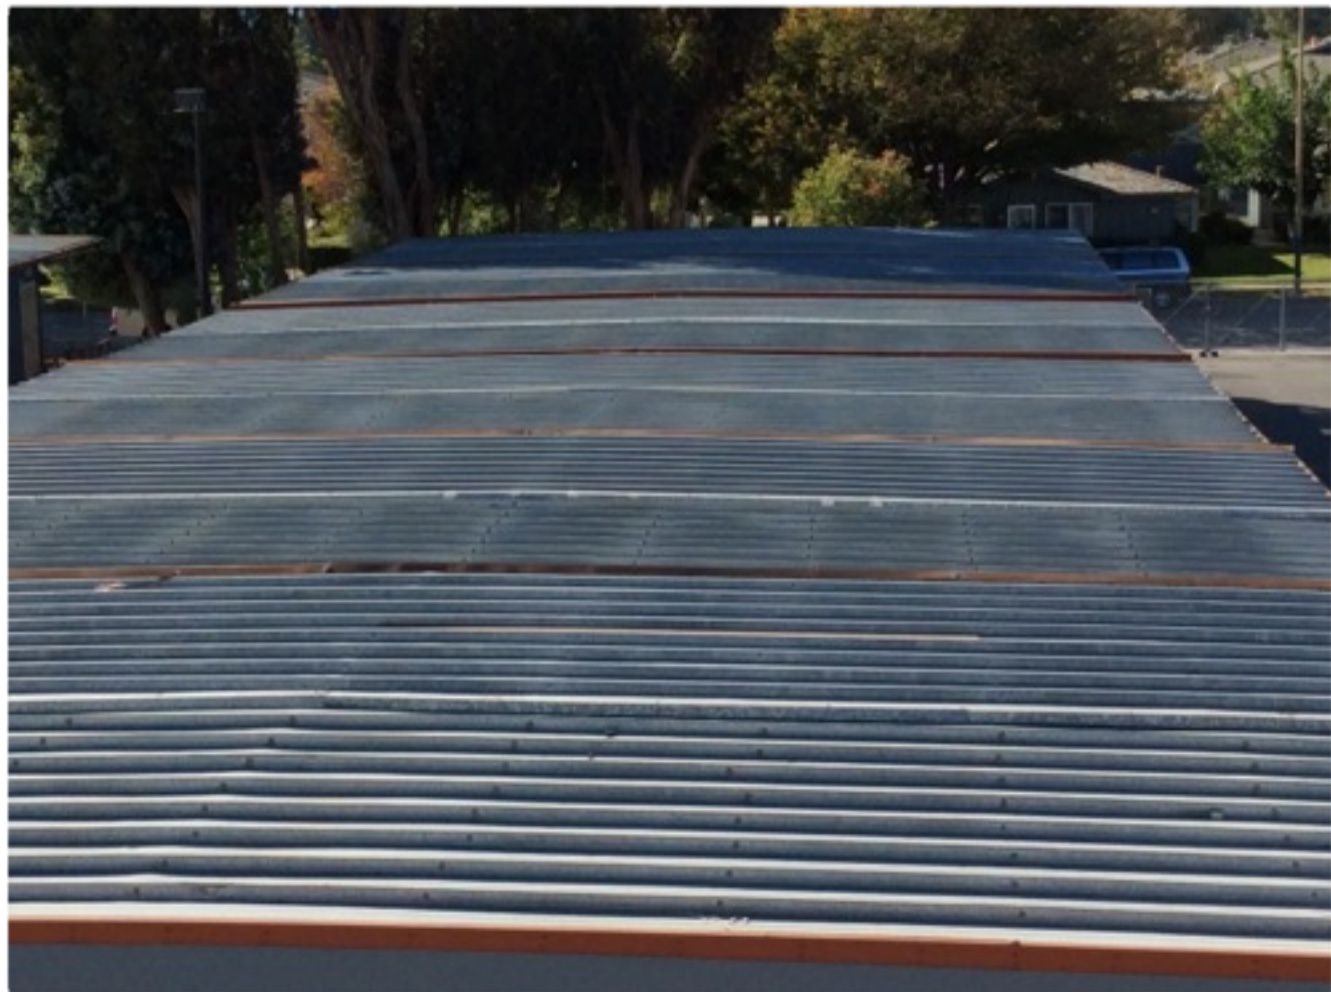
An overview photo from the roof level.

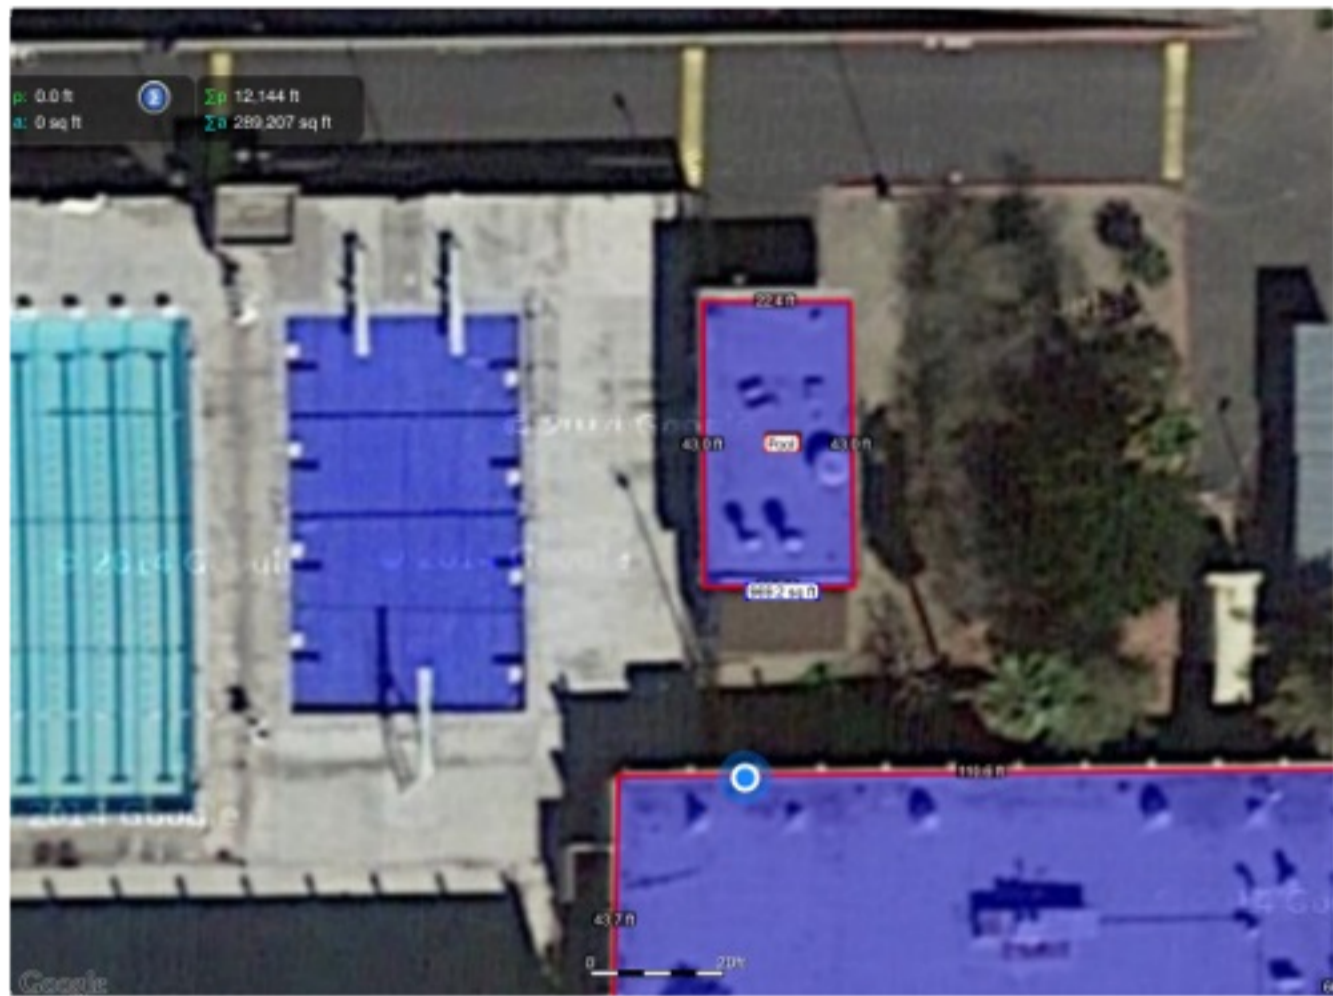
An aerial view of the building.

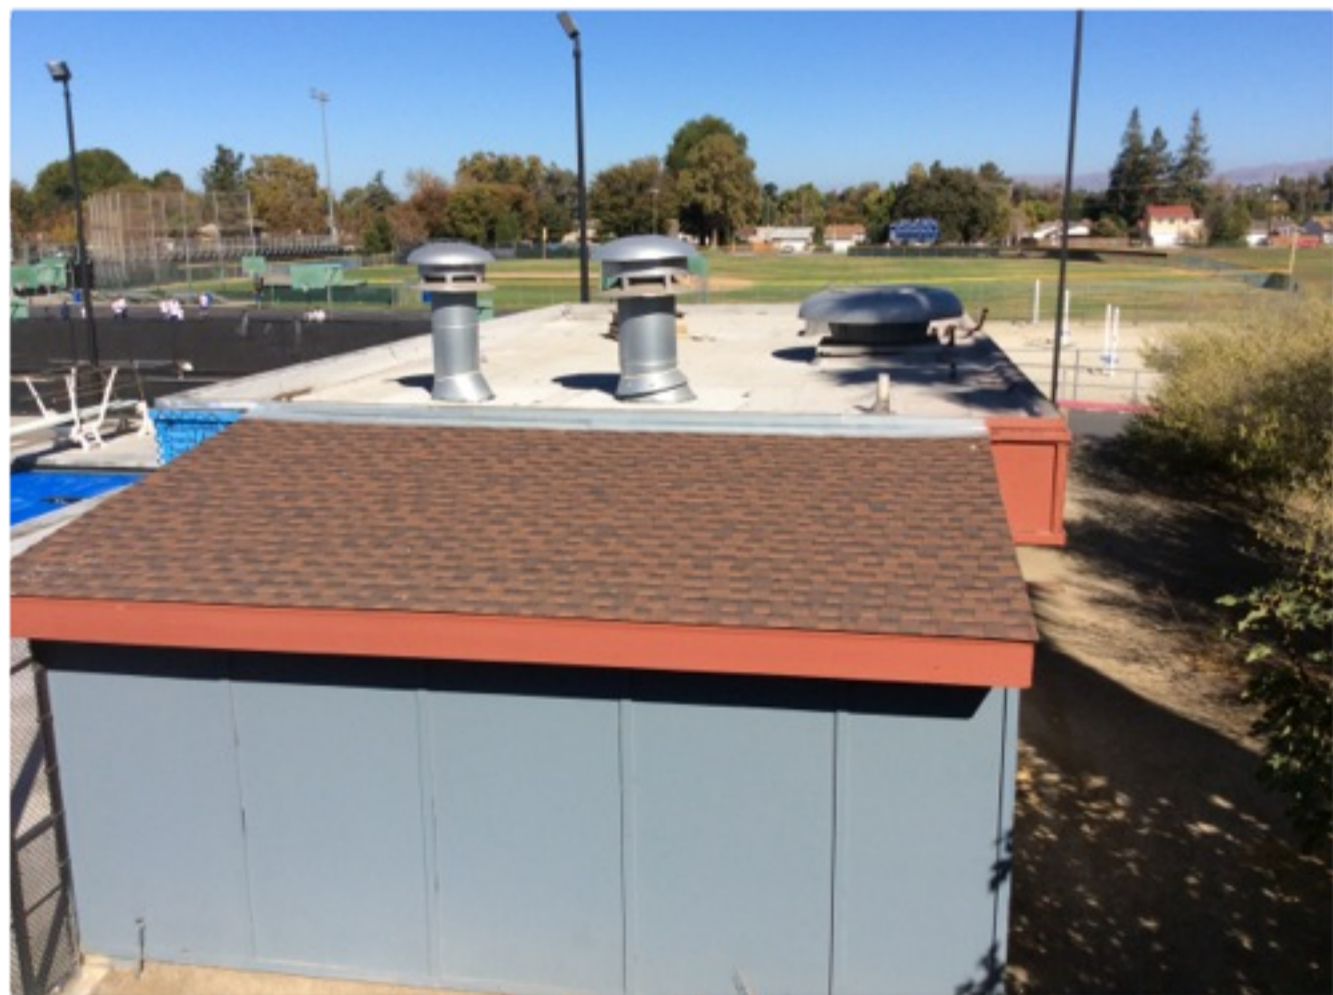
An overview photo from the roof level.

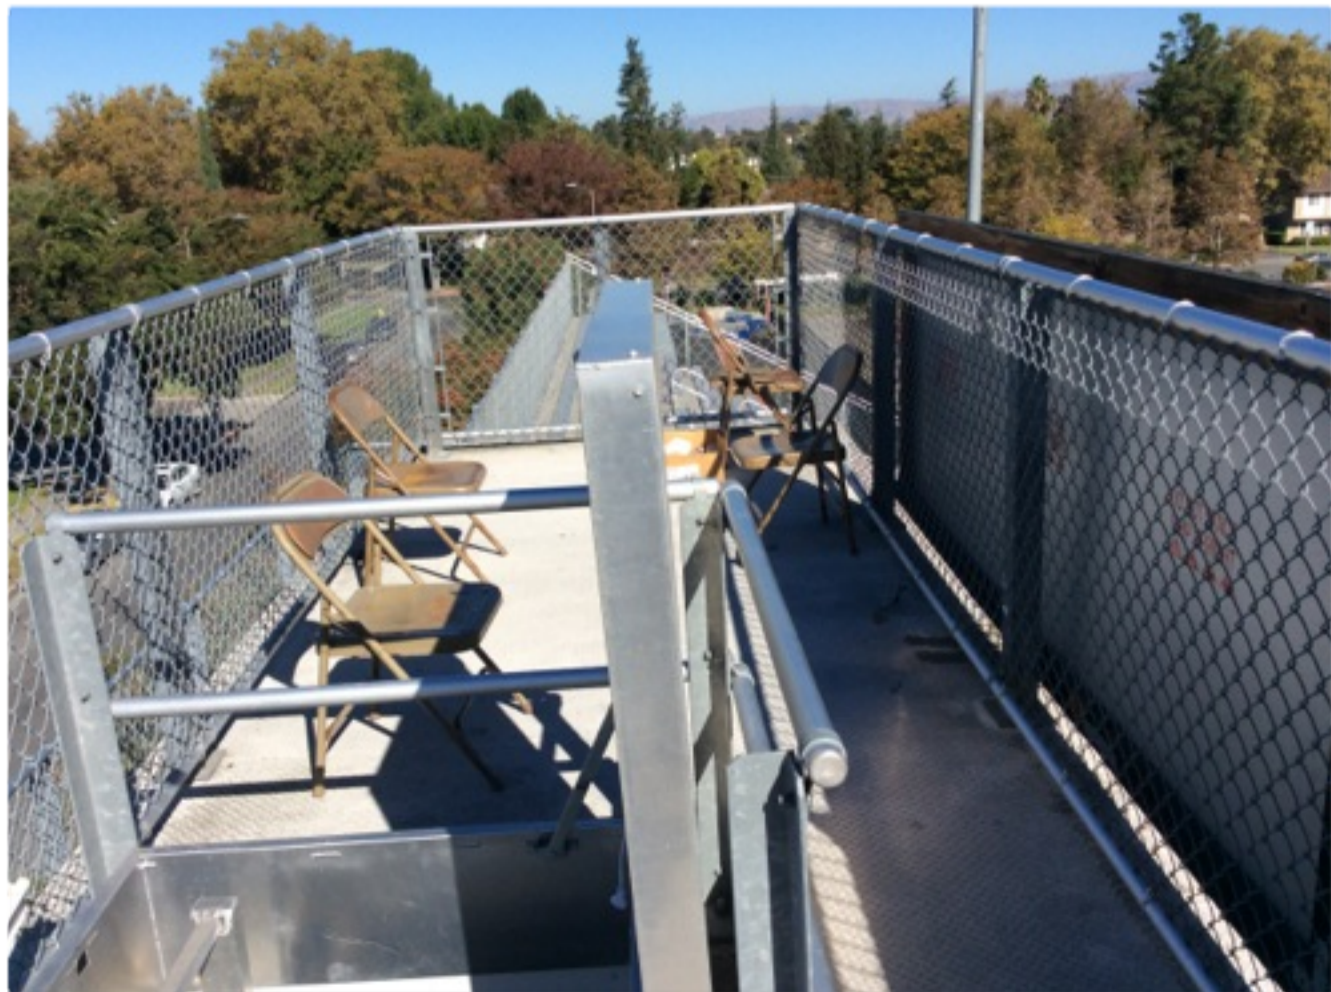
An overview photo from the roof level.

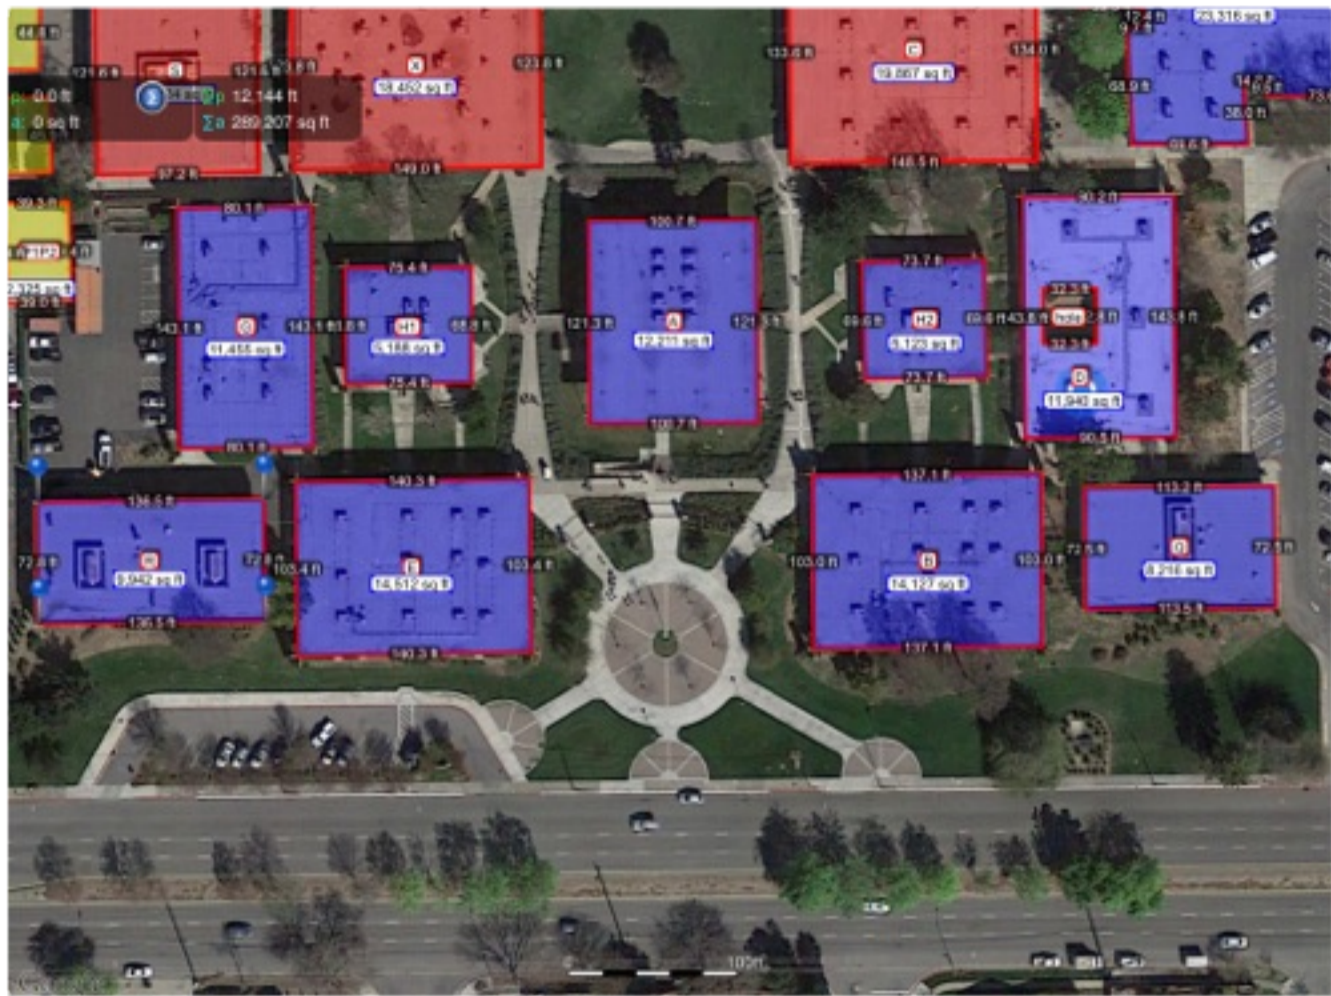
An aerial view of the buildings - R and Q.

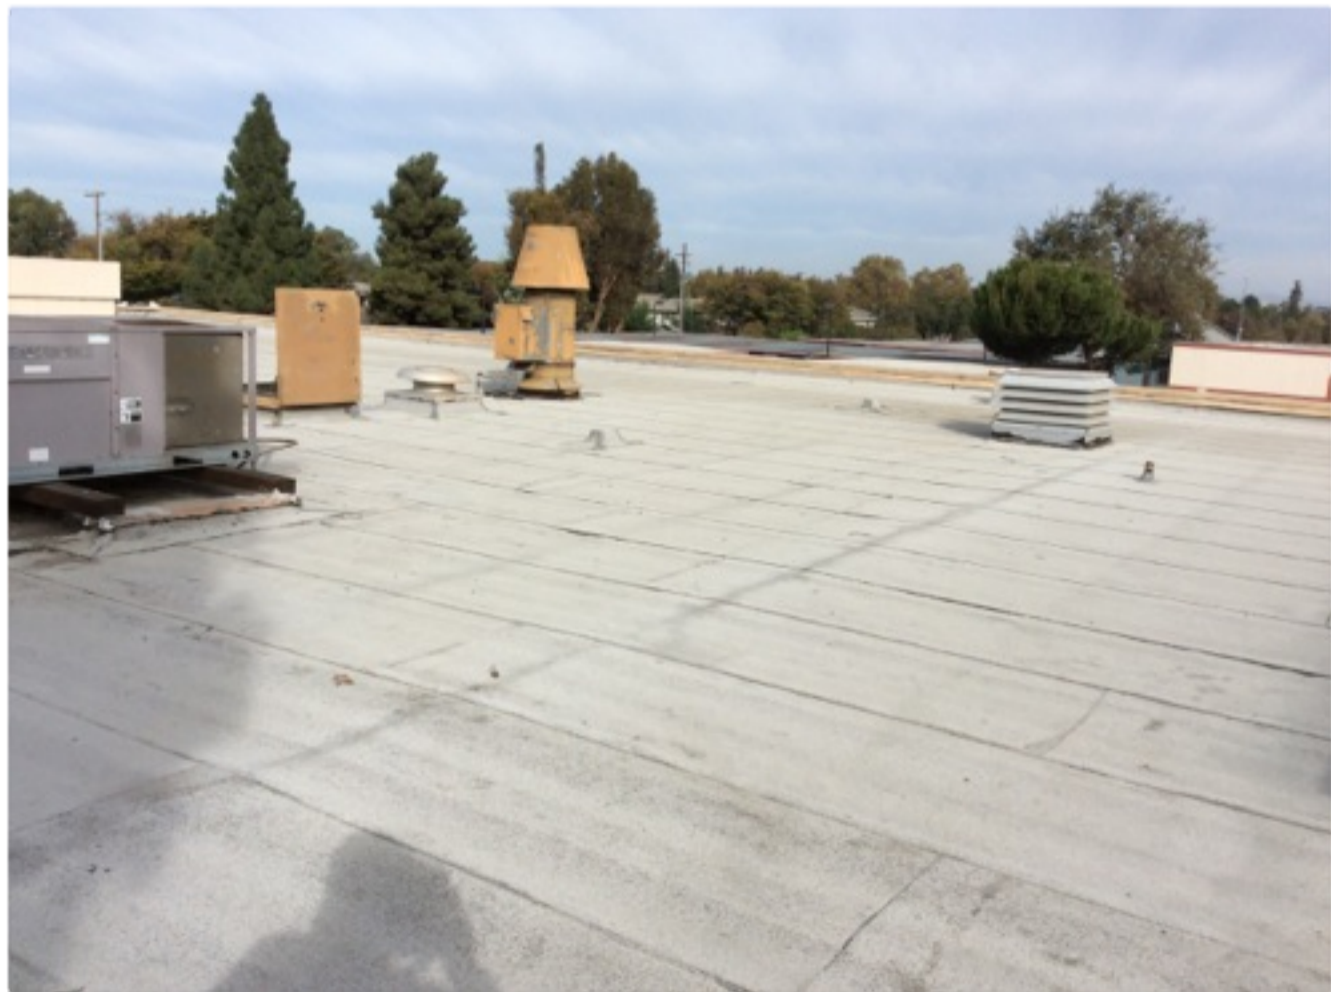
An overview photo from the roof level.

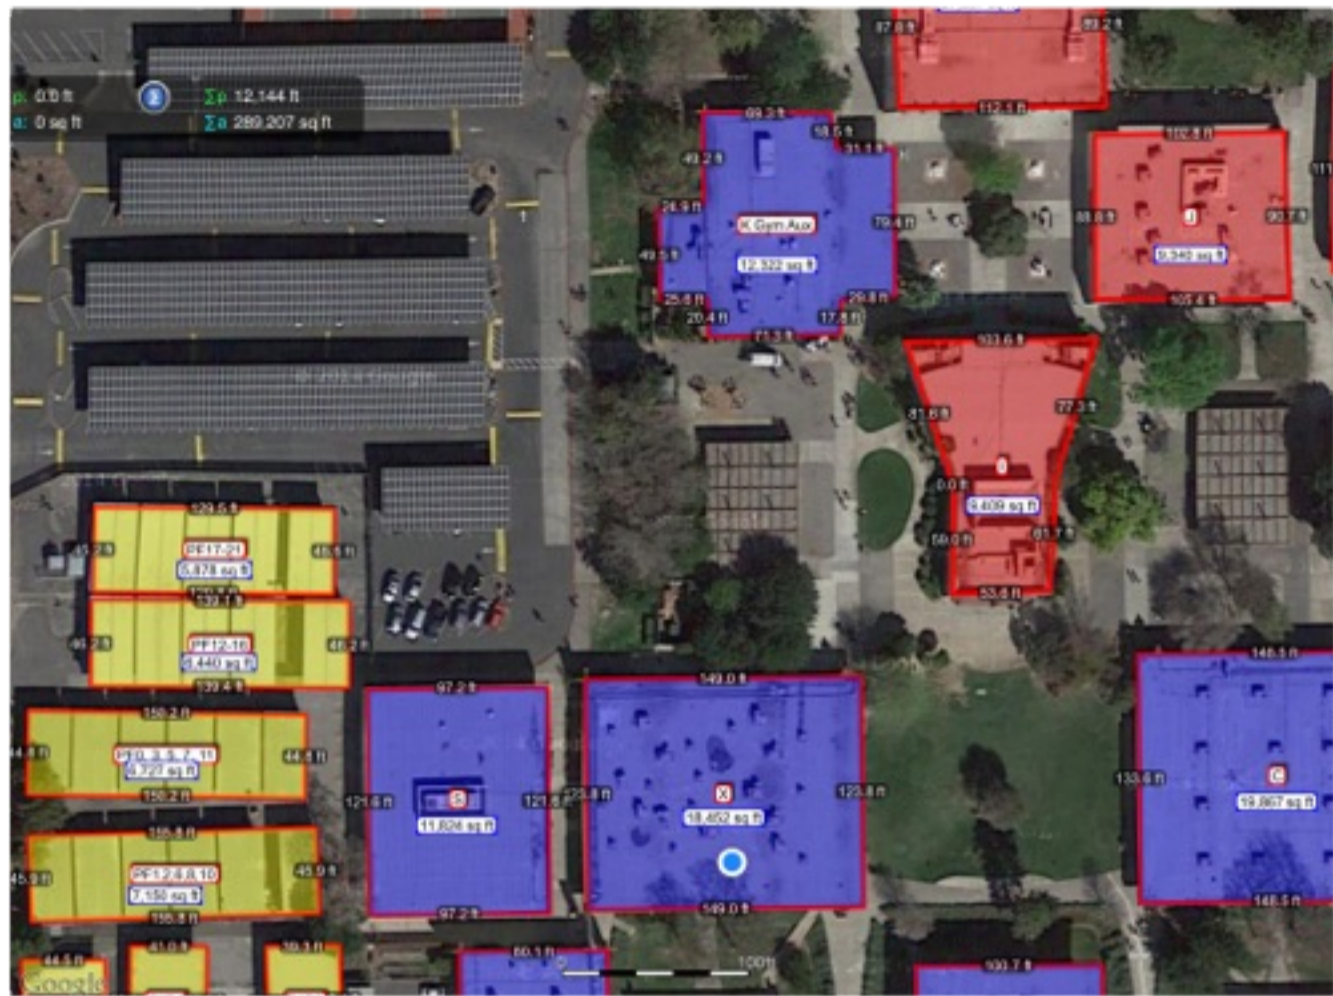
An aerial view of the buildings - S, X and K.

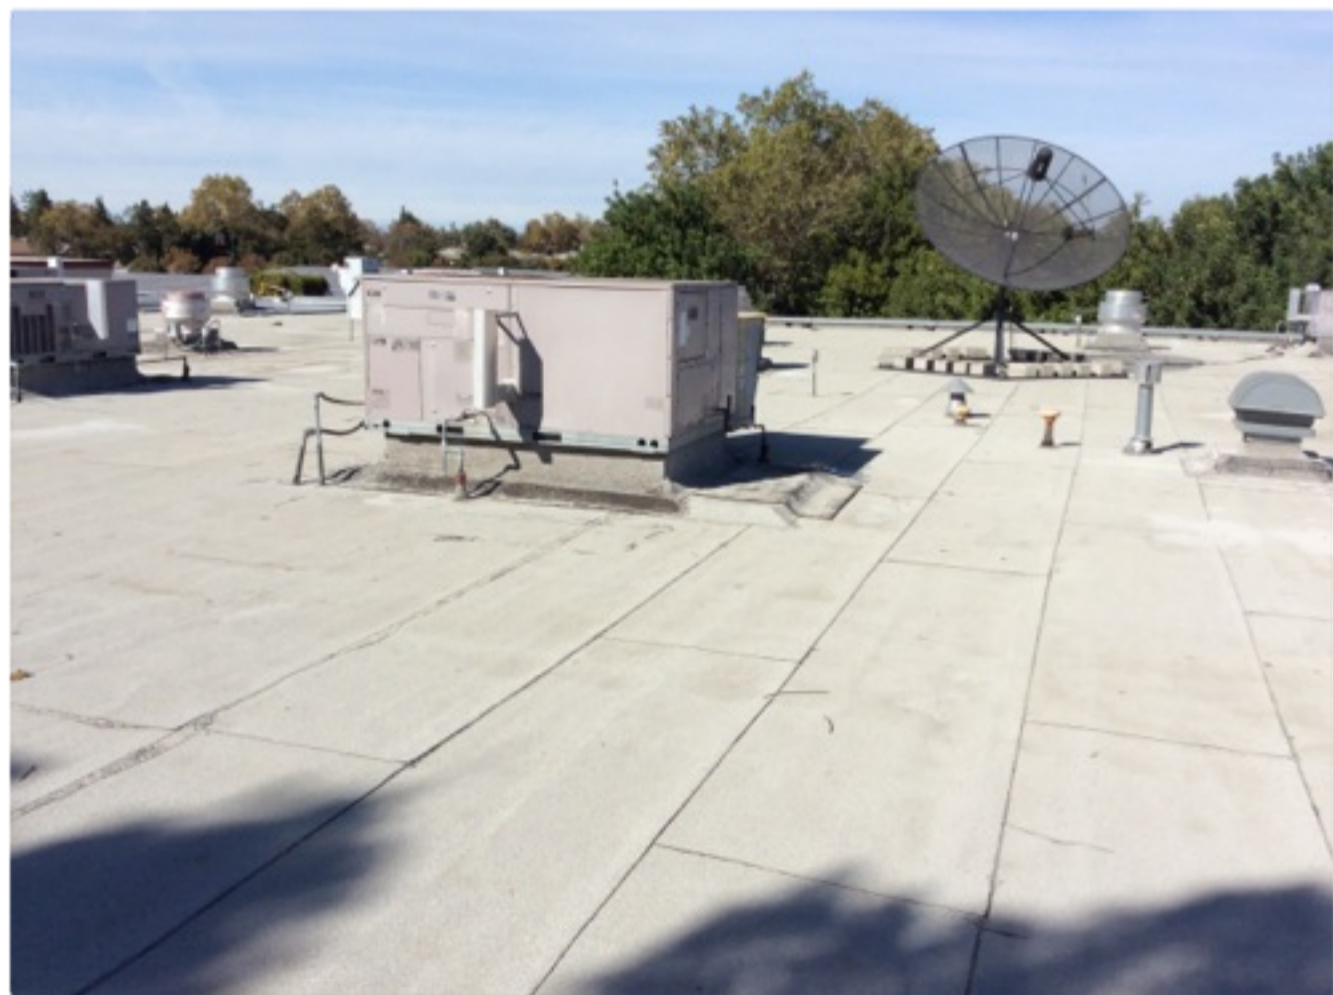
An overview photo from the roof level.

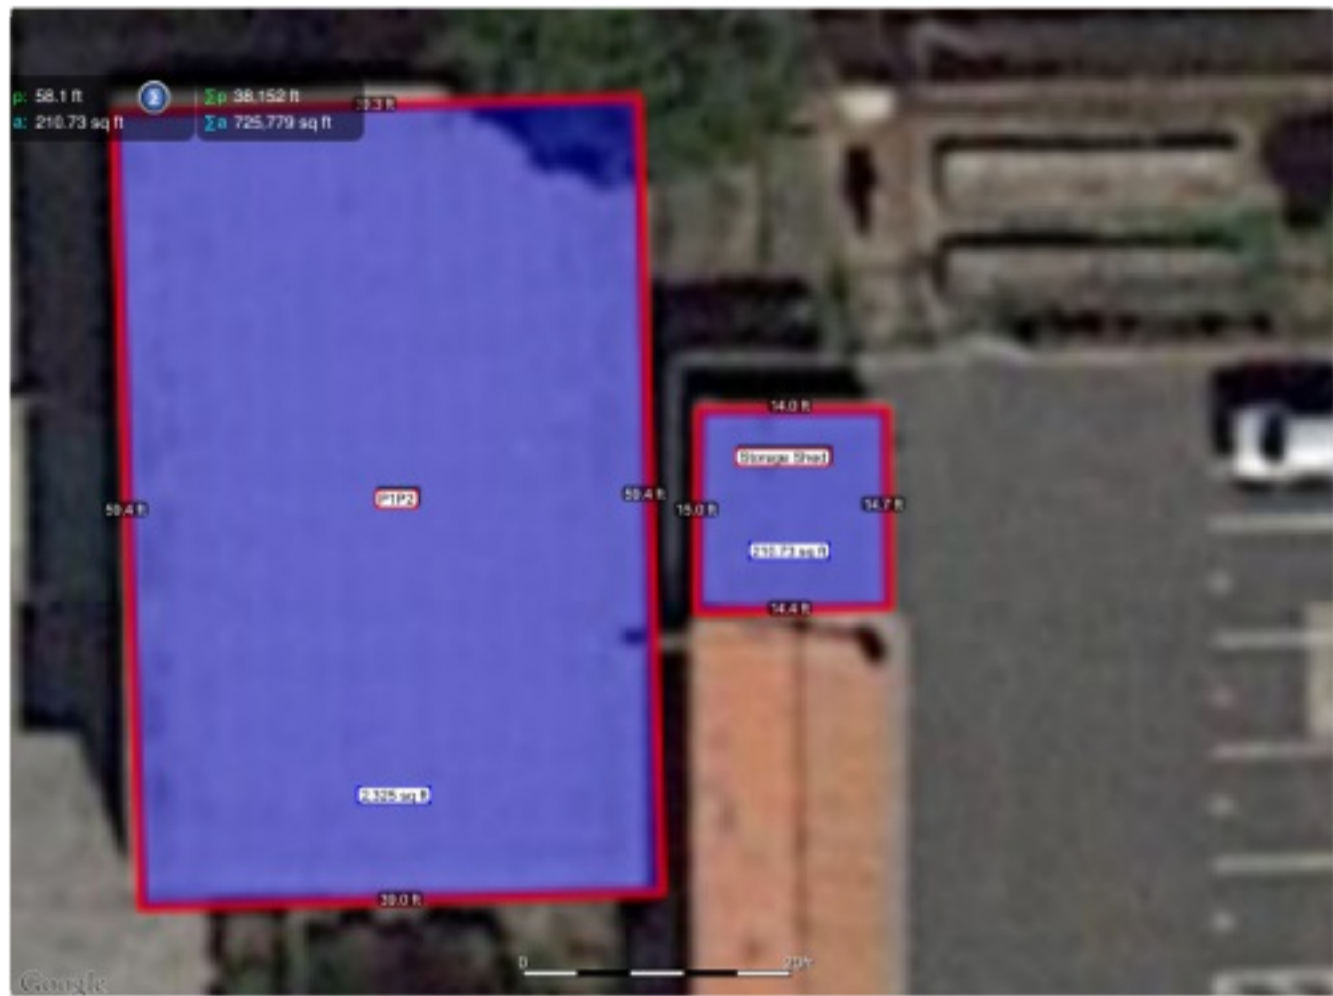
An aerial view of the building.

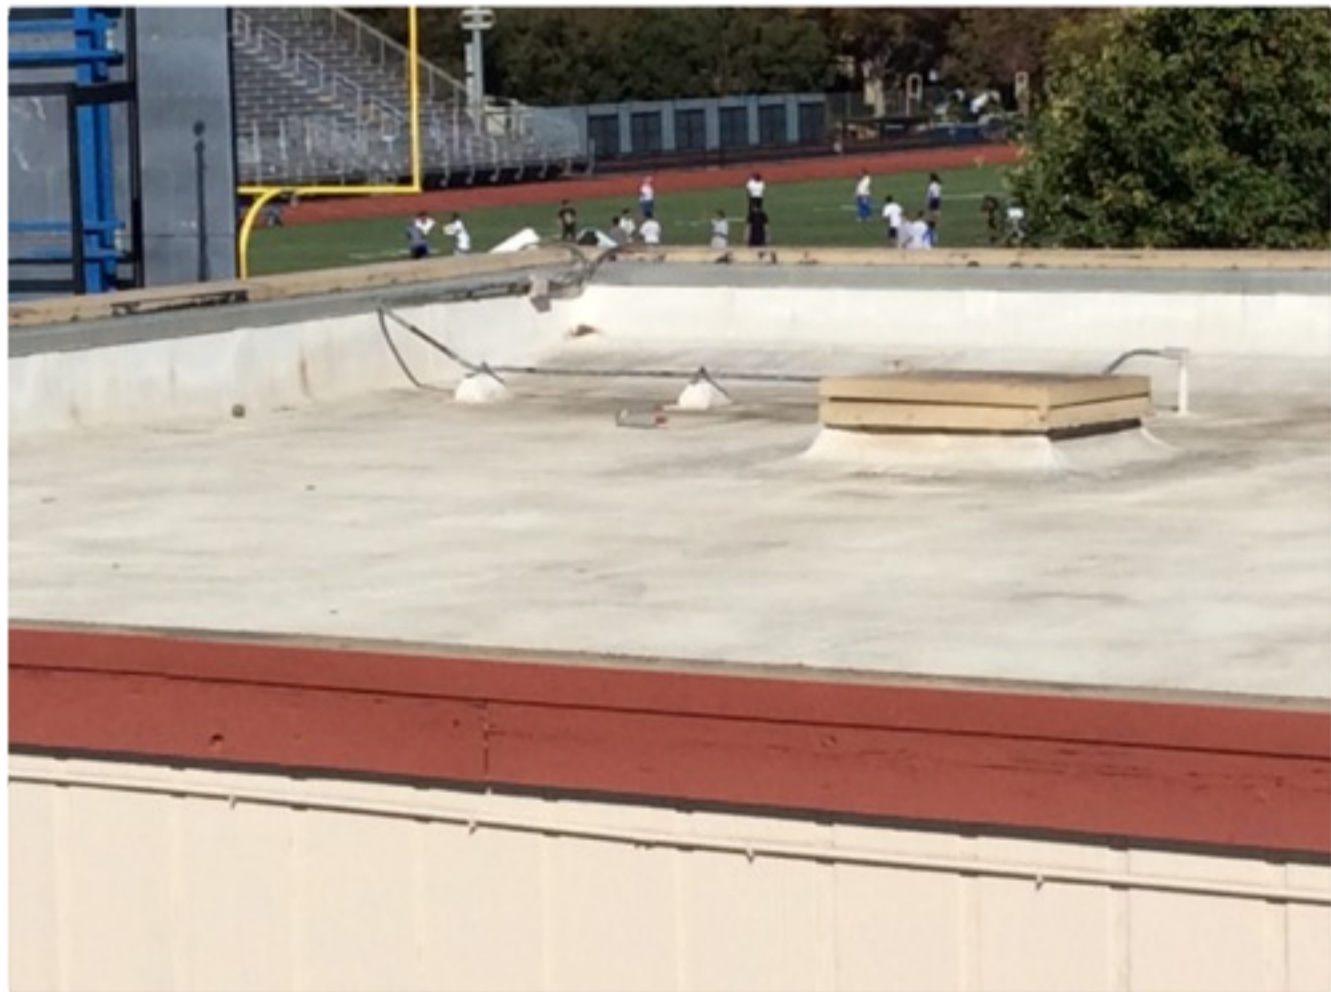
An overview photo from the roof level.

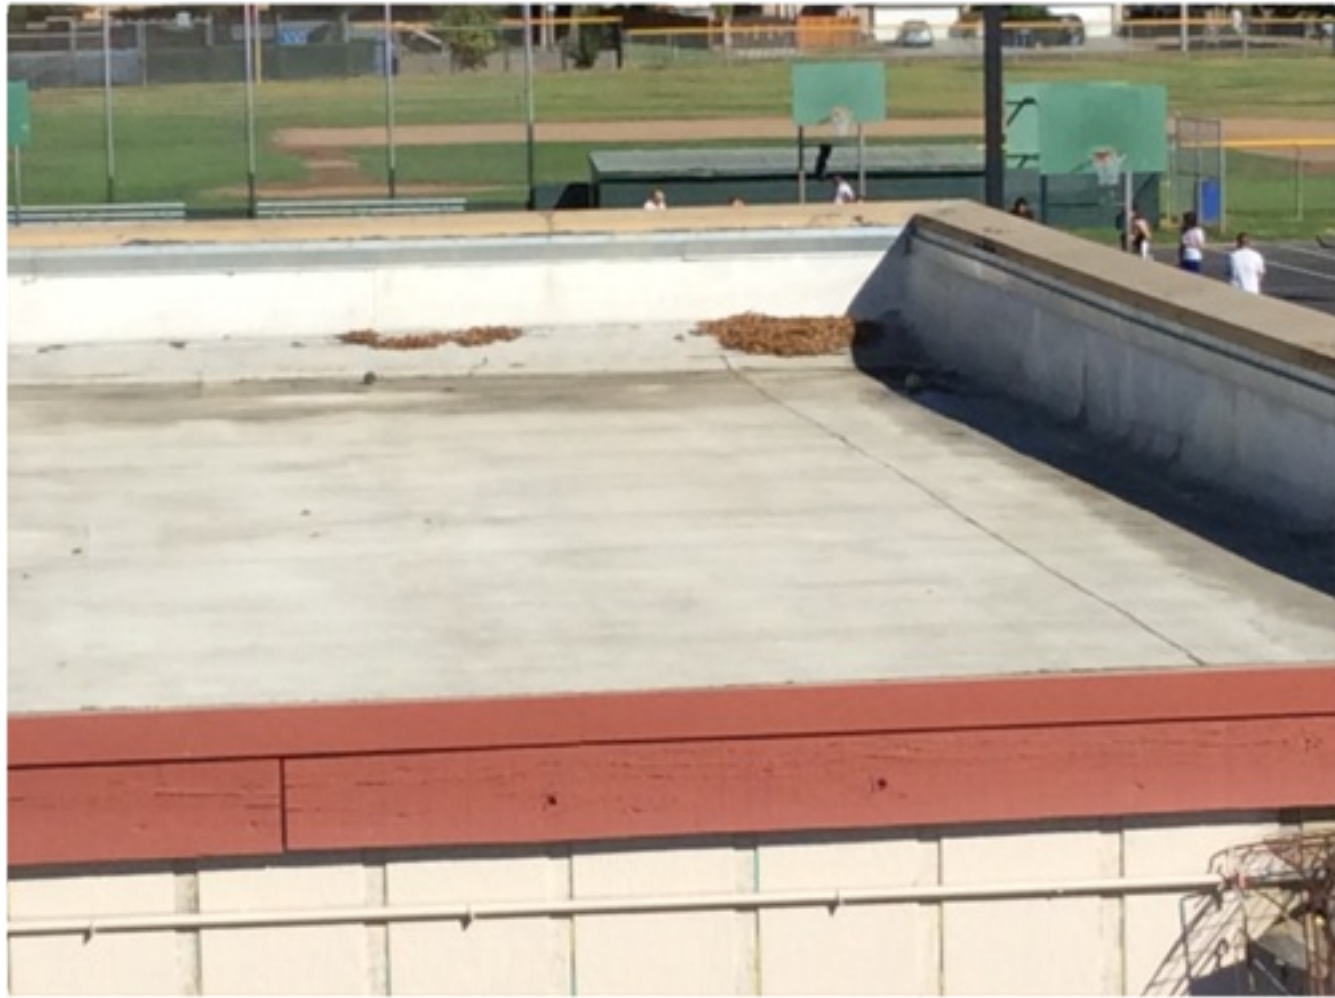
Another overview photo from the roof level..

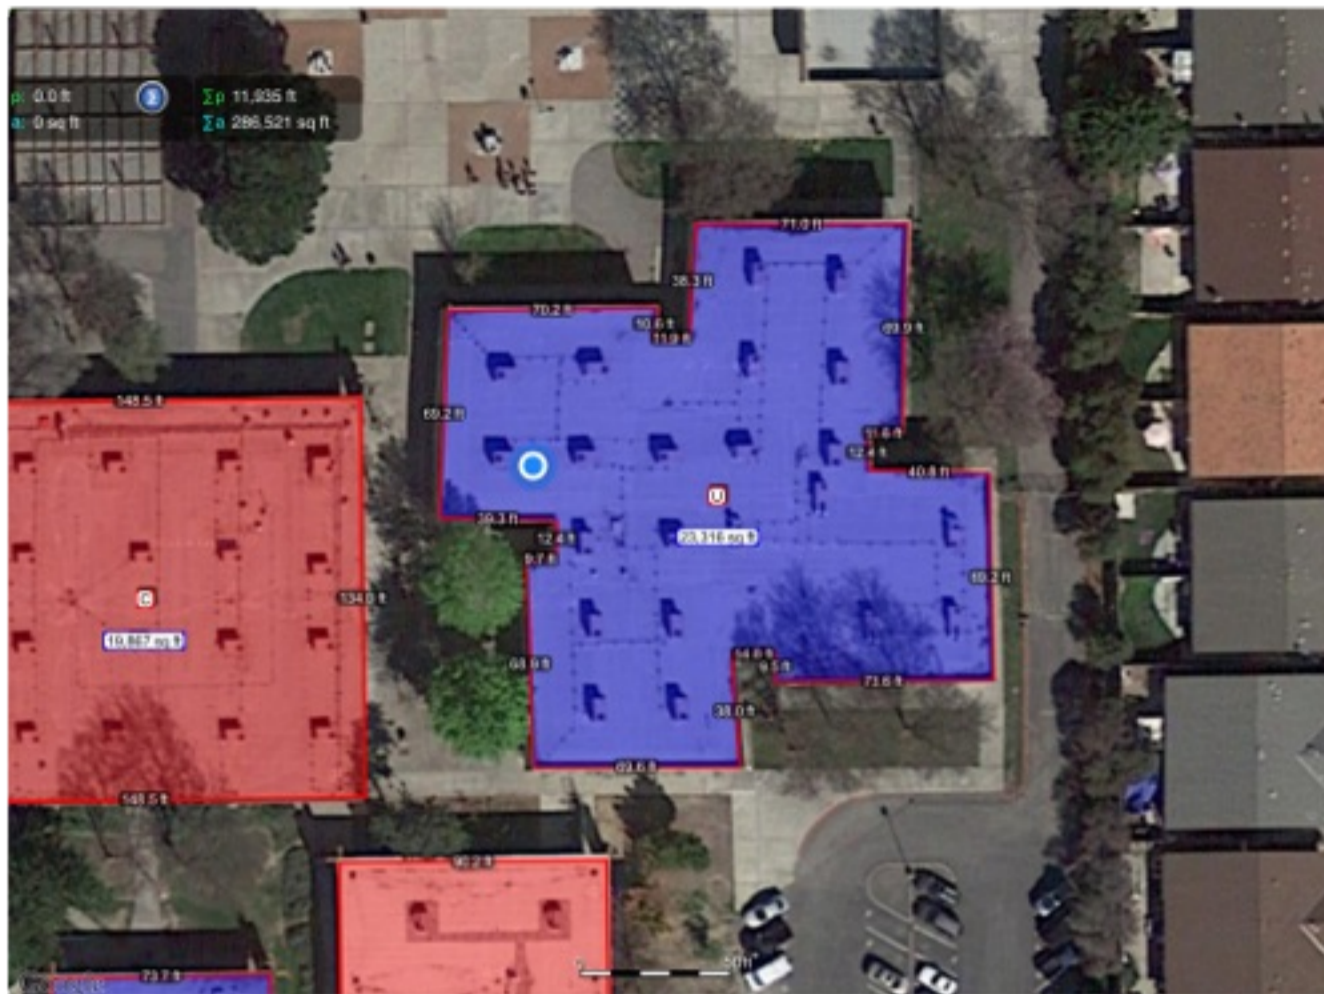
An aerial view of the building.

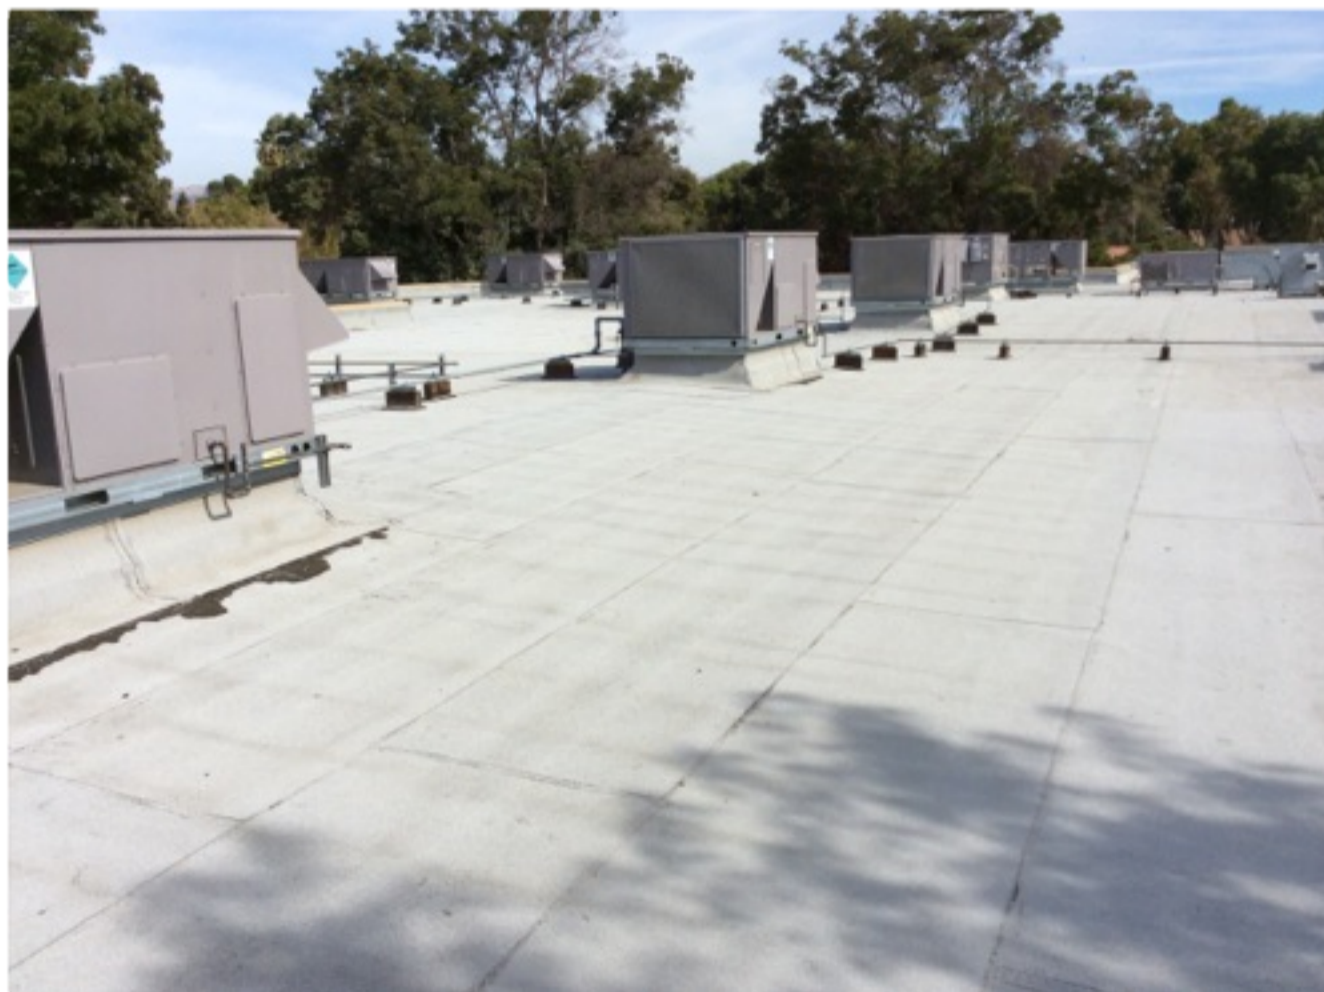
An overview photo from the roof level.

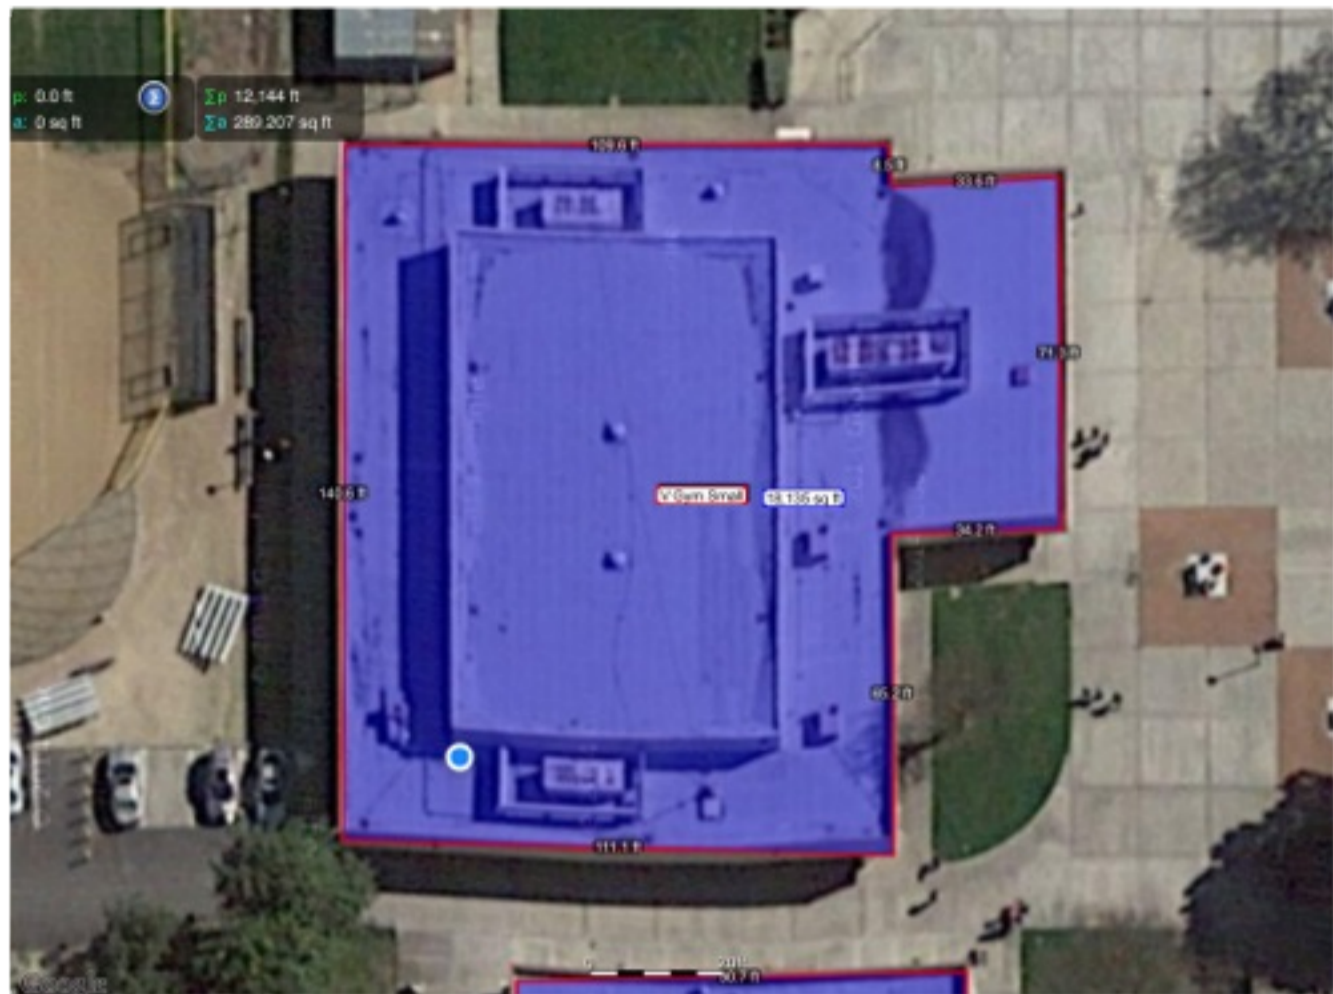
An aerial view of the buildings - S, X and K.

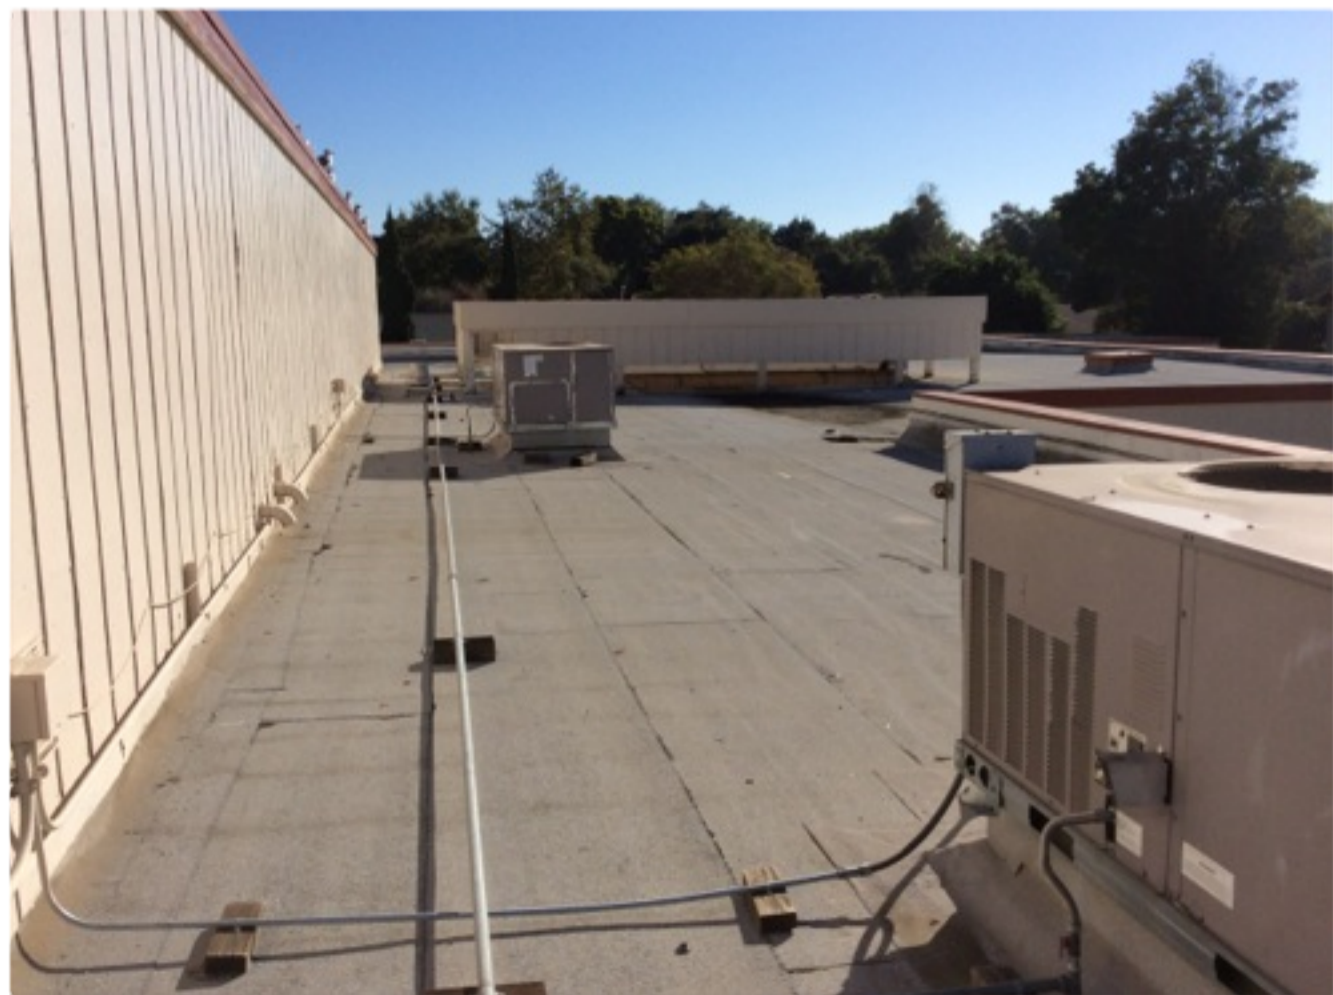
An overview photo from the roof level.
