BUILDING INFORMATION	
FACILITY	Foothill HS
DATE	August 18, 2014
BUILDING	Admin BUR
ROOF SQ FT	1,500

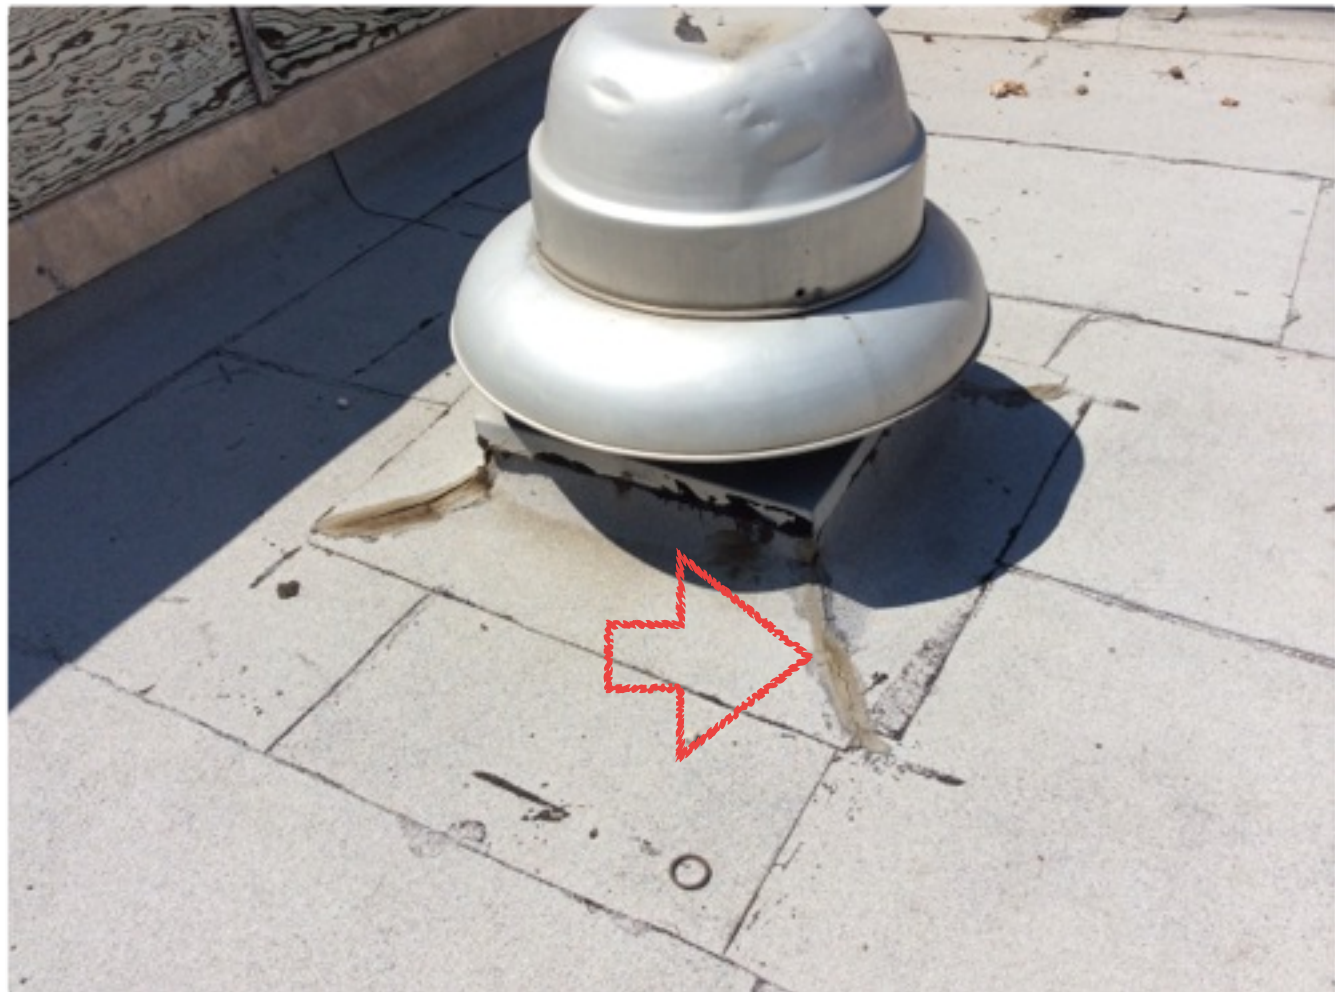
The photo below shows the need for resealing the penetrations.

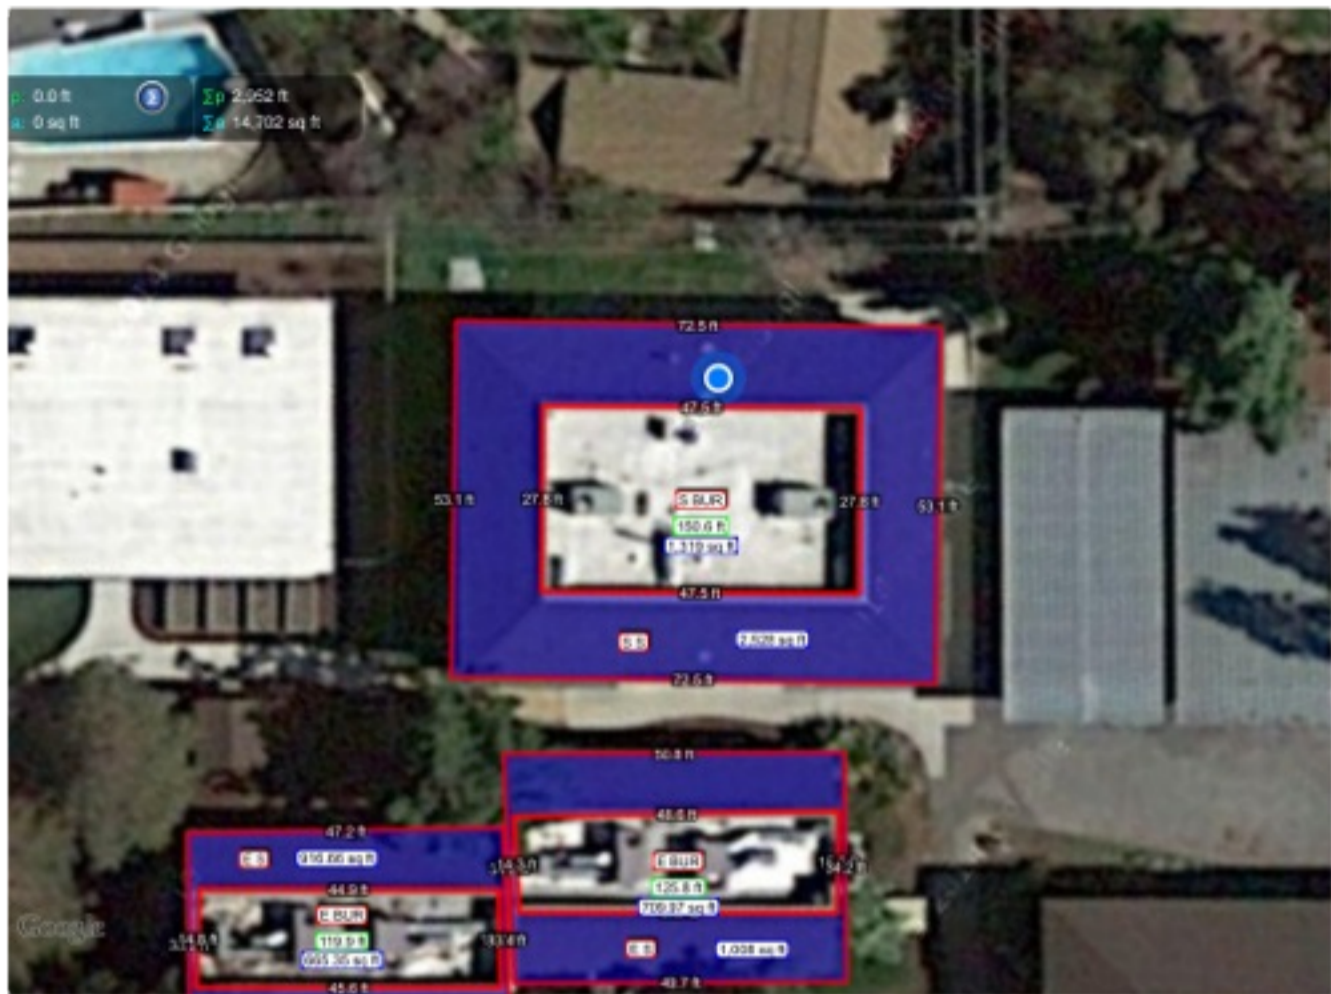
An aerial view of the building.

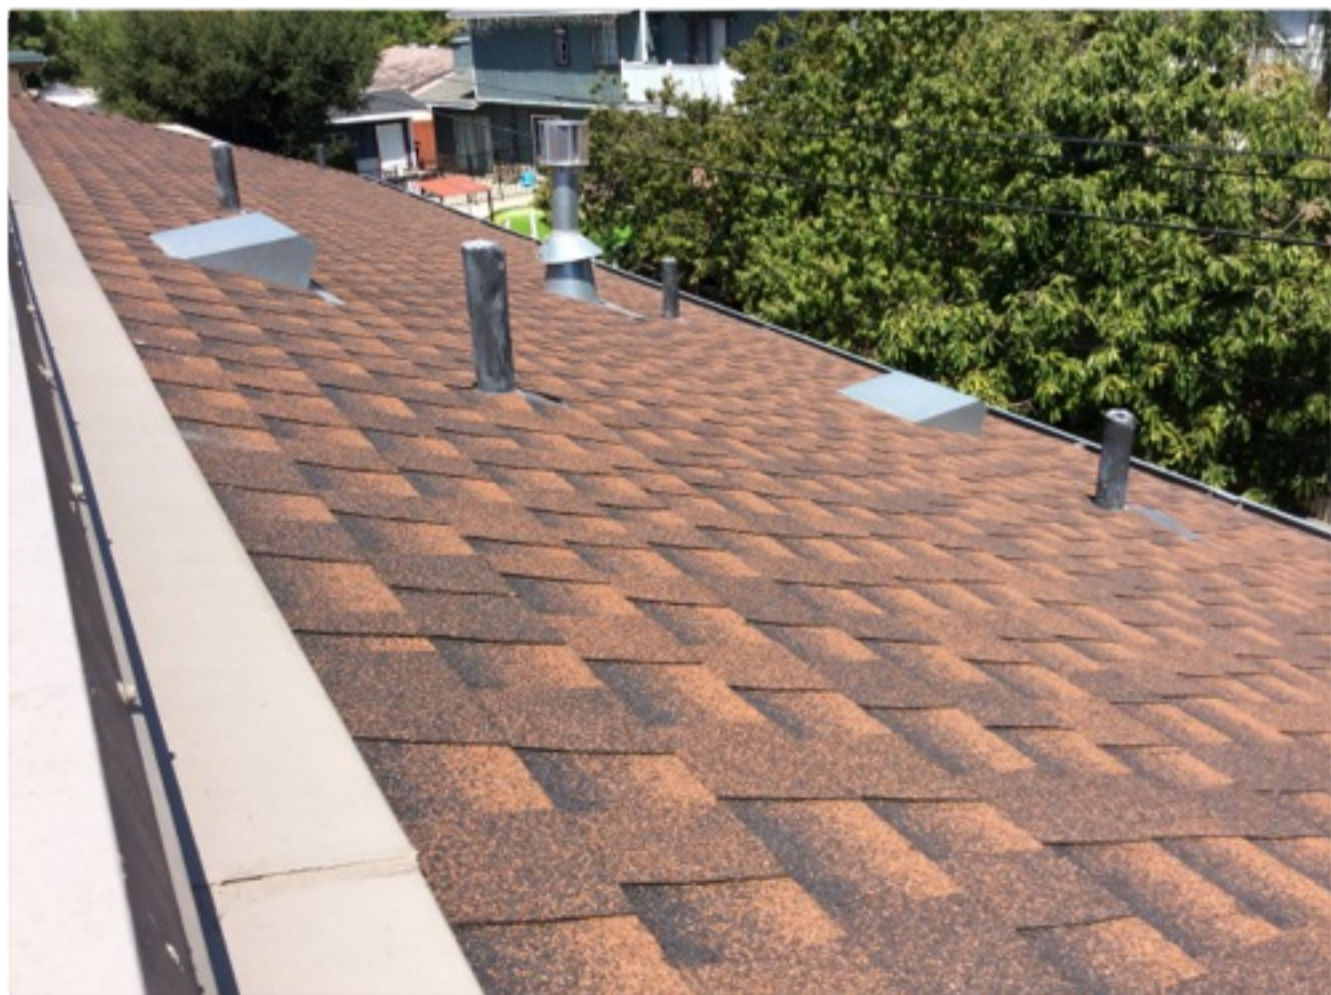
An overview photo from the roof level.
