BUILDING INFORMATION	
FACILITY	Santa Teresa HS
DATE	October 17, 2014
BUILDING	100, 900, 1000, and 1100
ROOF SQ FT	24,000

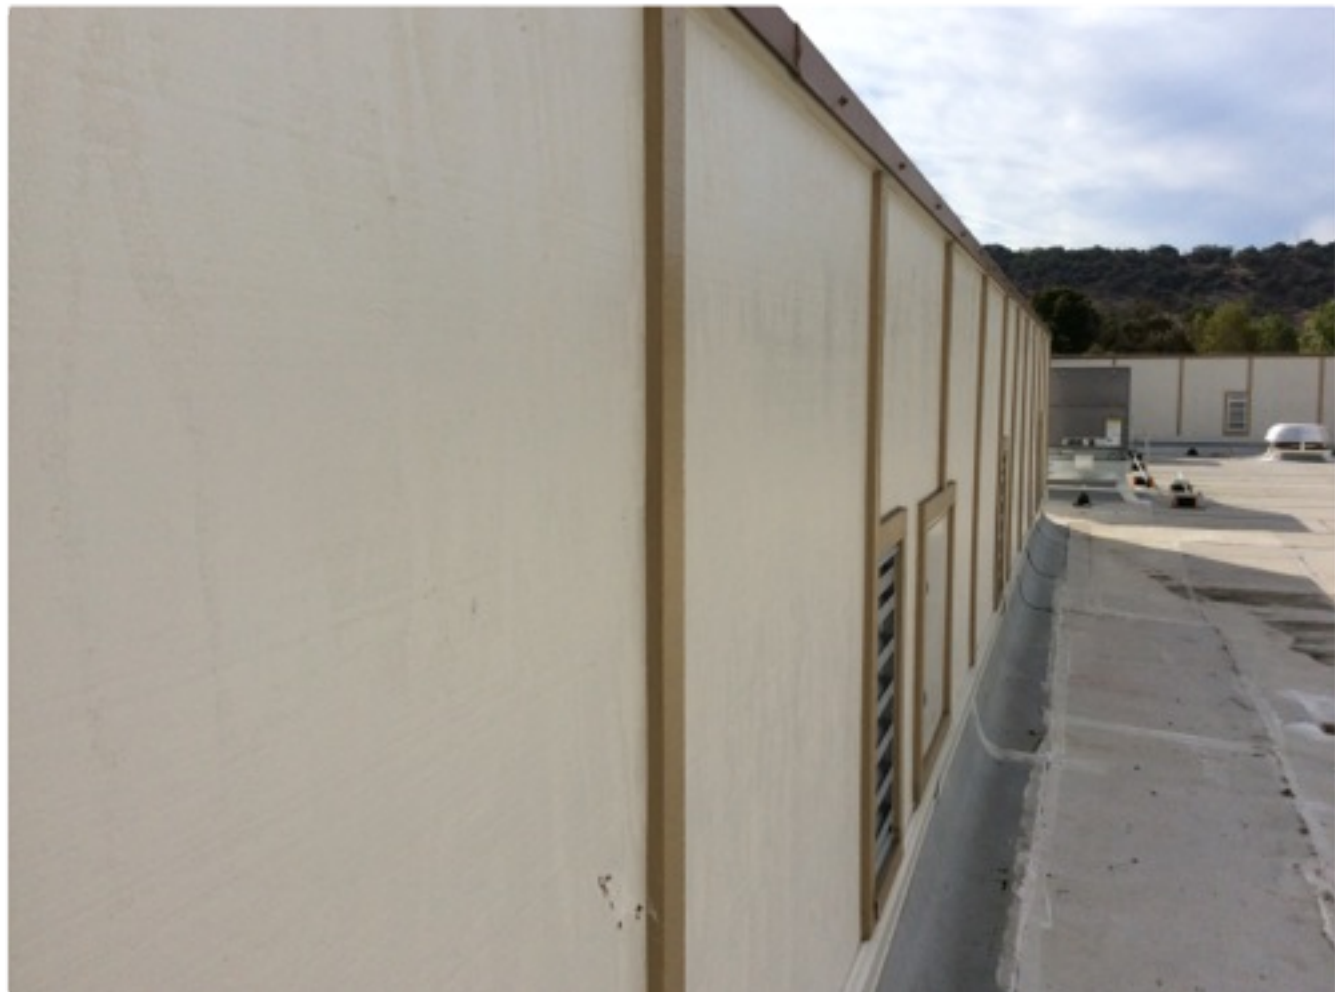
The photo below shows the wall in great shape.

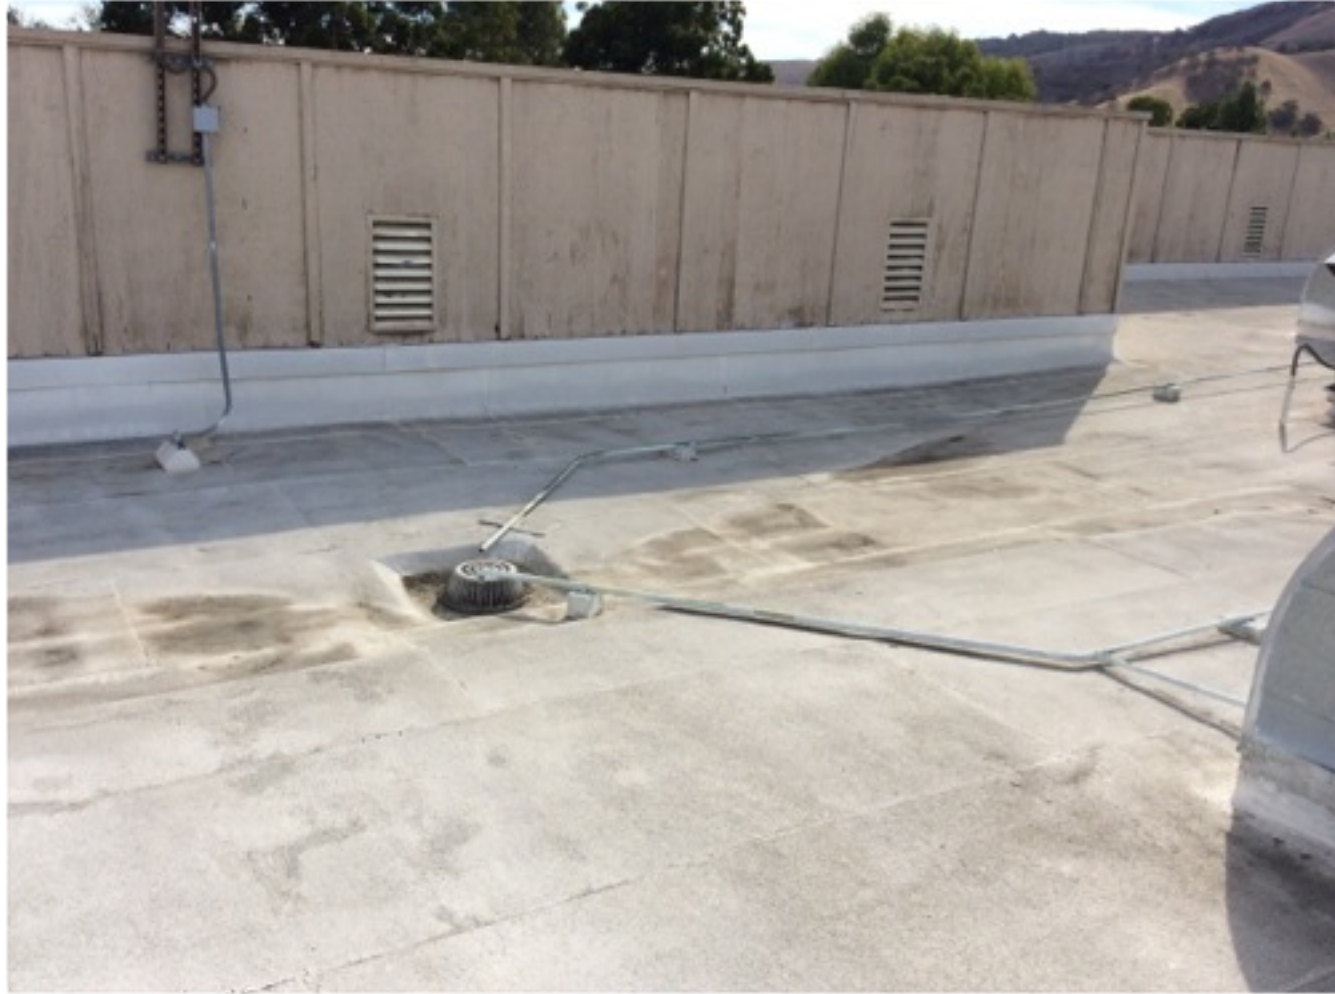
The photo below shows this roof draining well.

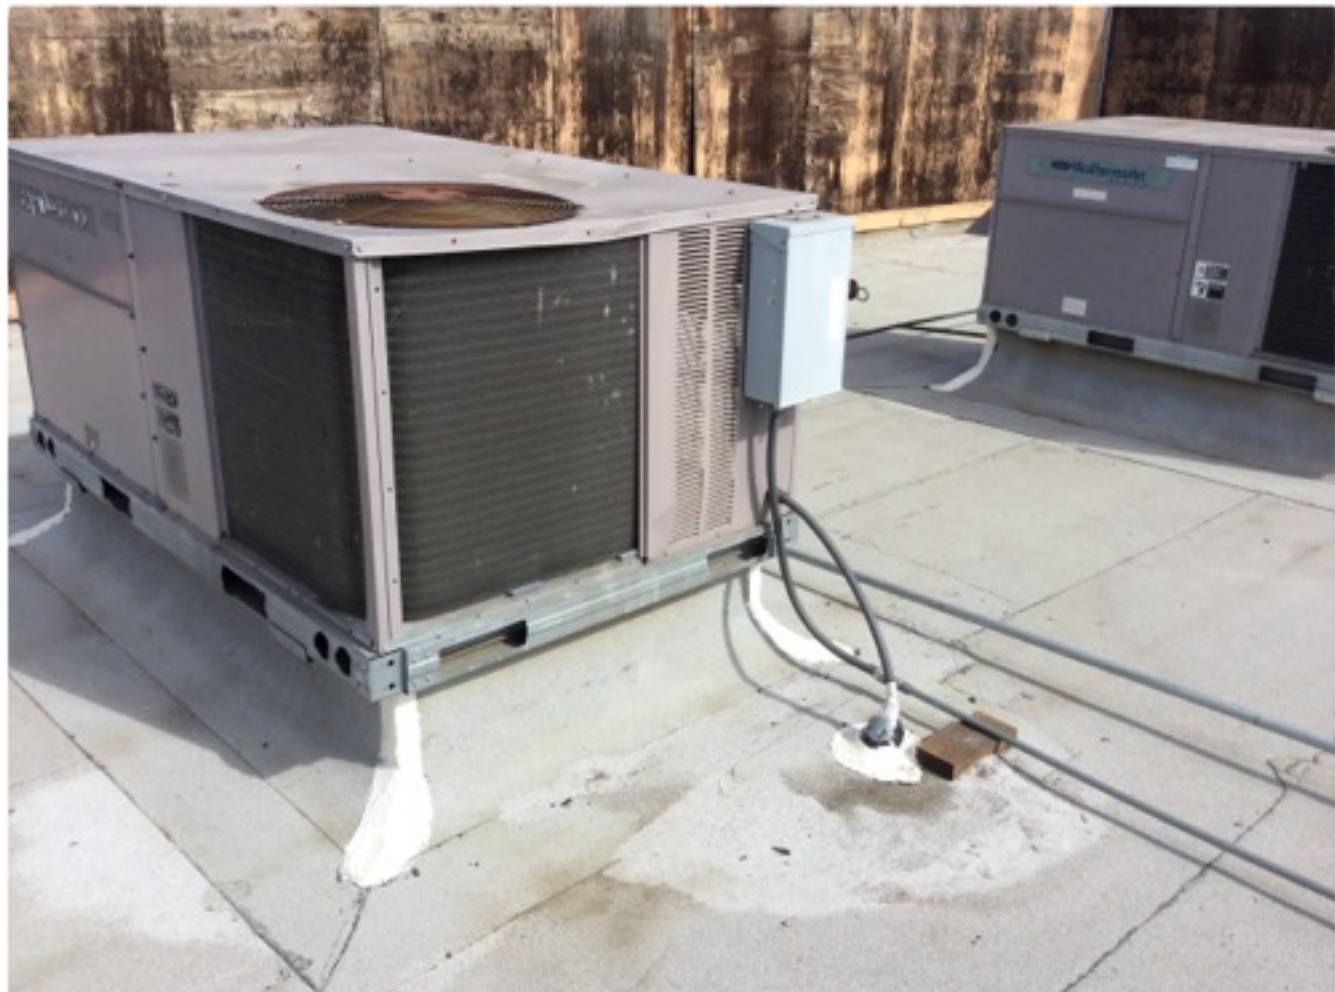
Looks like Marty has hit all the penetration corners - this helps.

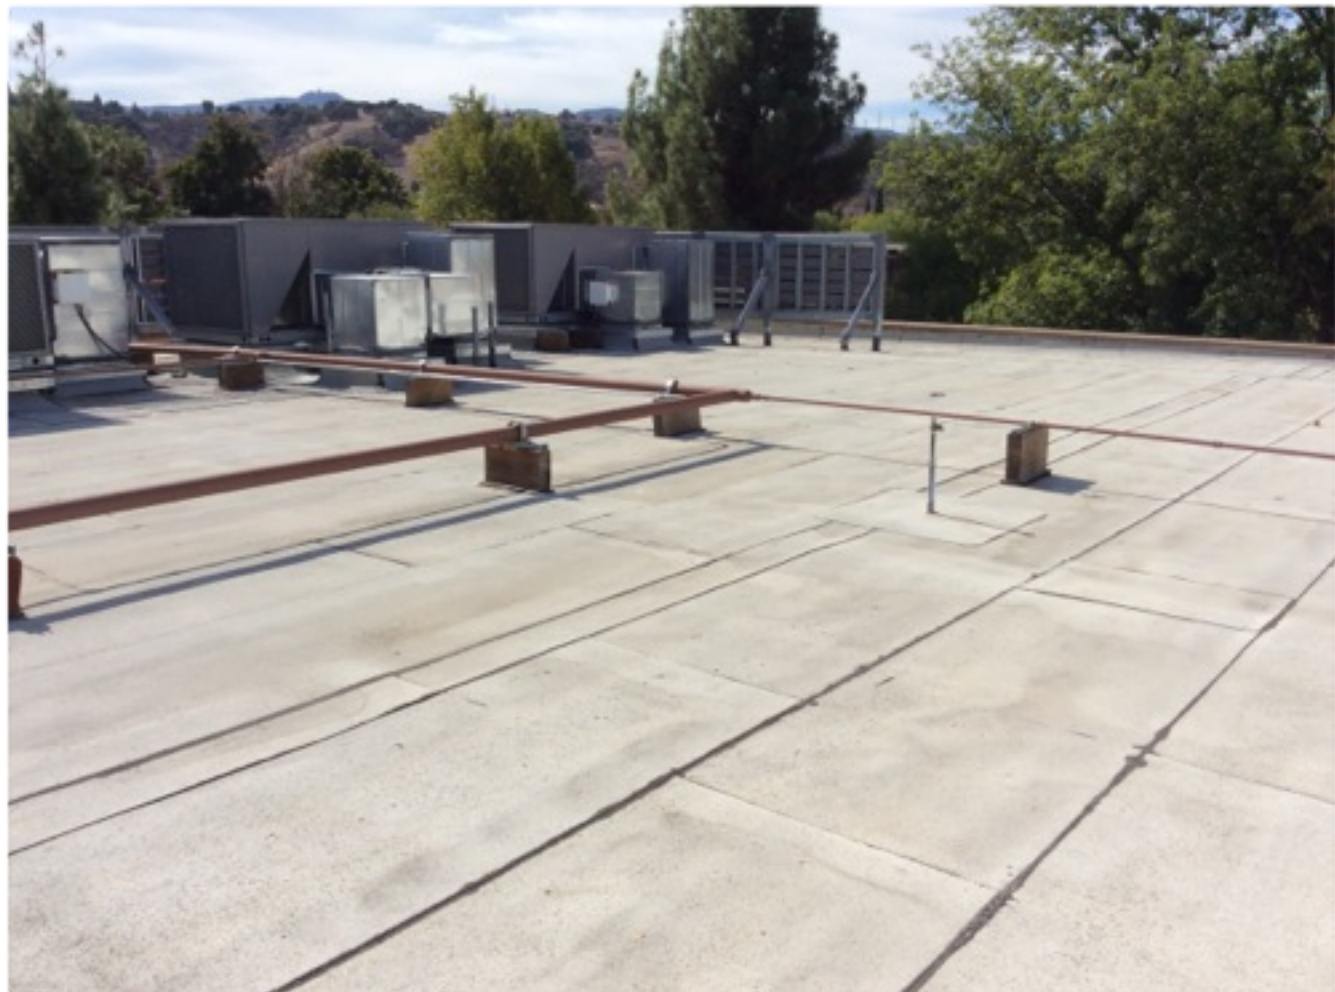
Another overview photo.

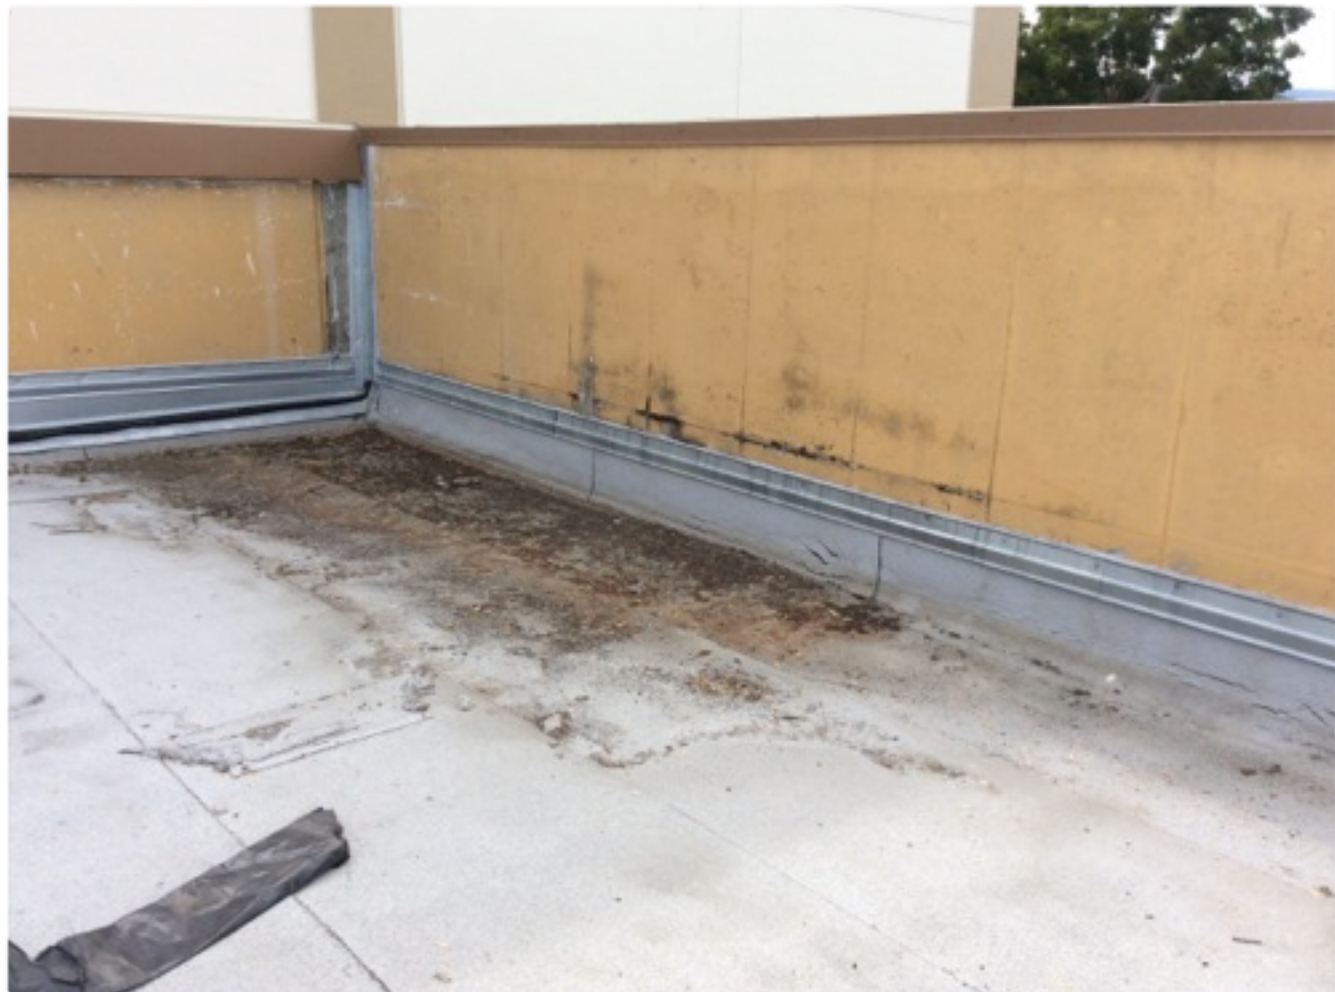
The photo below shows heavy ponding.

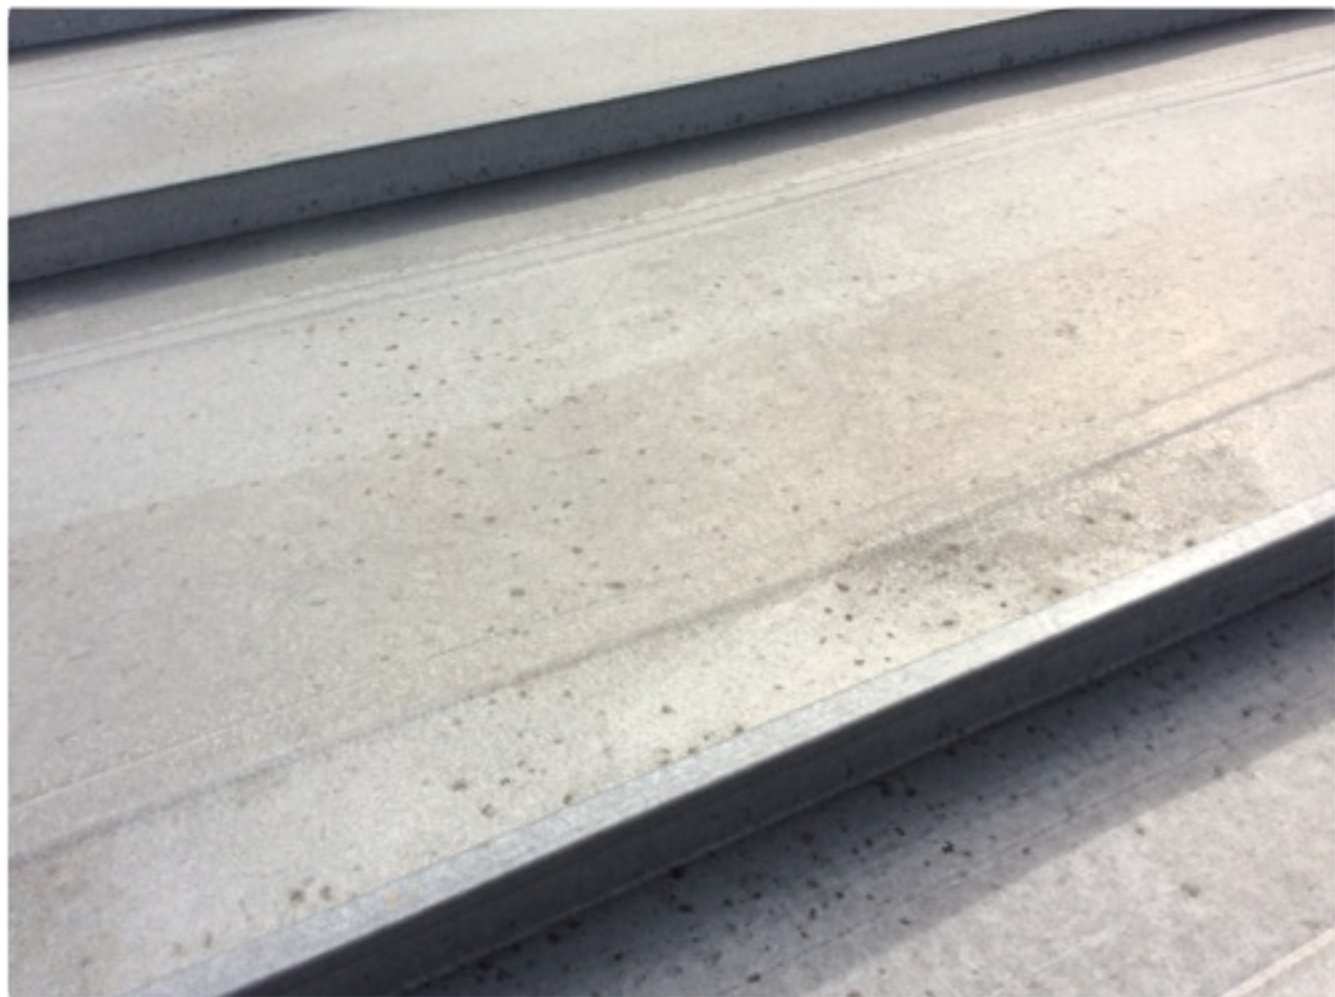
The photo below shows no signs of rust.
